Report No. 11-1225

INSPECTION REPORT

1300 ALBANY POST ROAD  
CROTON-ON-HUDSON NEW YORK

VILLAGE OF CROTON-ON-HUDSON

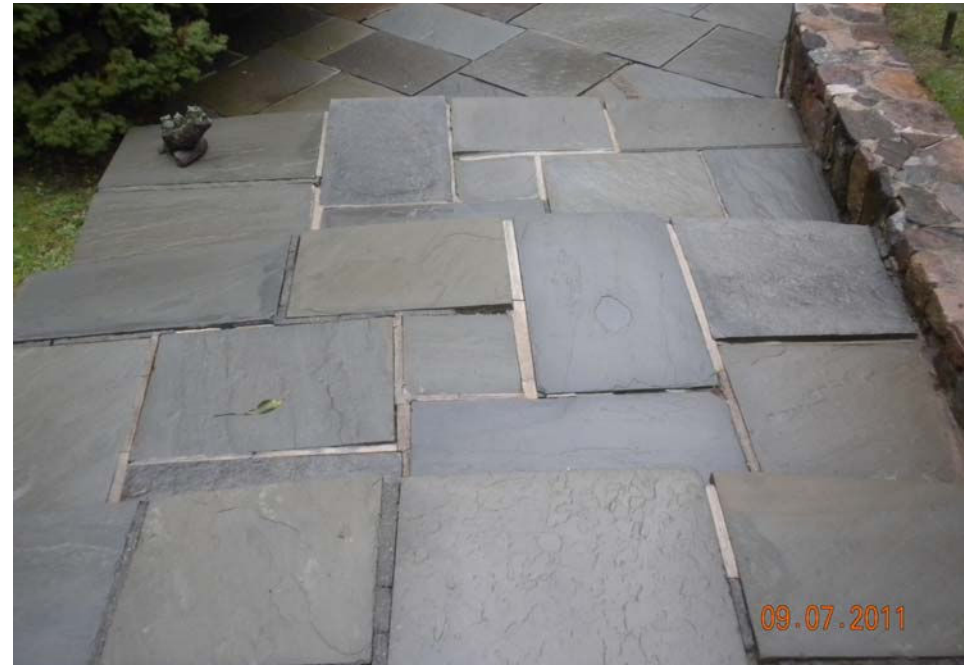
Reset uneven flags at entry walk

4. Re-setting uneven flagstones at the entry walk steps is recommended.
5. Pointing maintenance is recommended at the flagstone entry walk and patio.
6. Trees at the perimeter of the home are overhanging the roof. Removal or cutting back limbs is recommended.

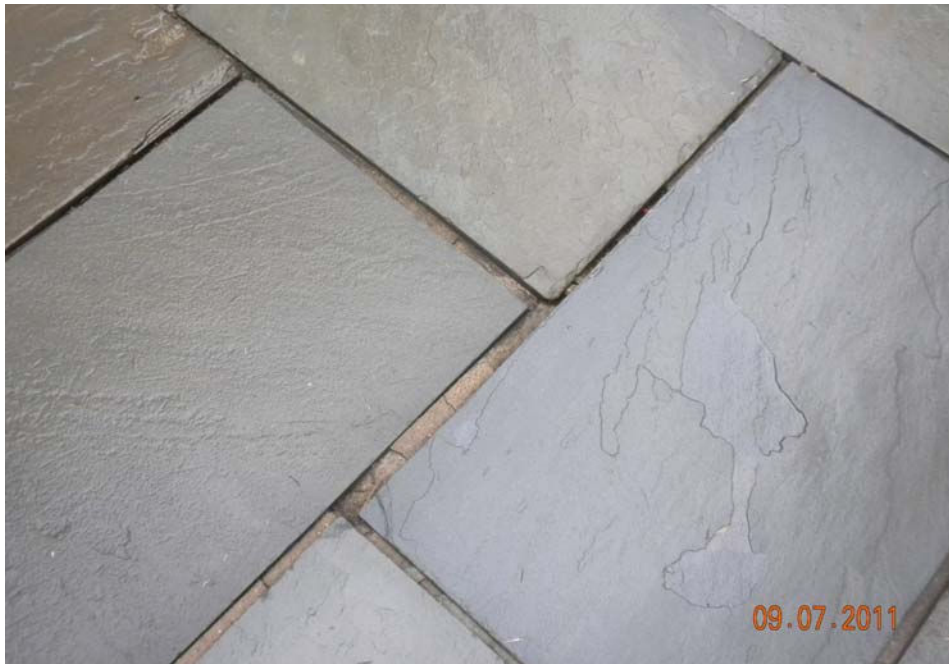
Pointing maintenance is recommended at walk and patio of main house

The flagstone patio installed at the south side of the Main House is generally in good condition. Pointing maintenance is required.

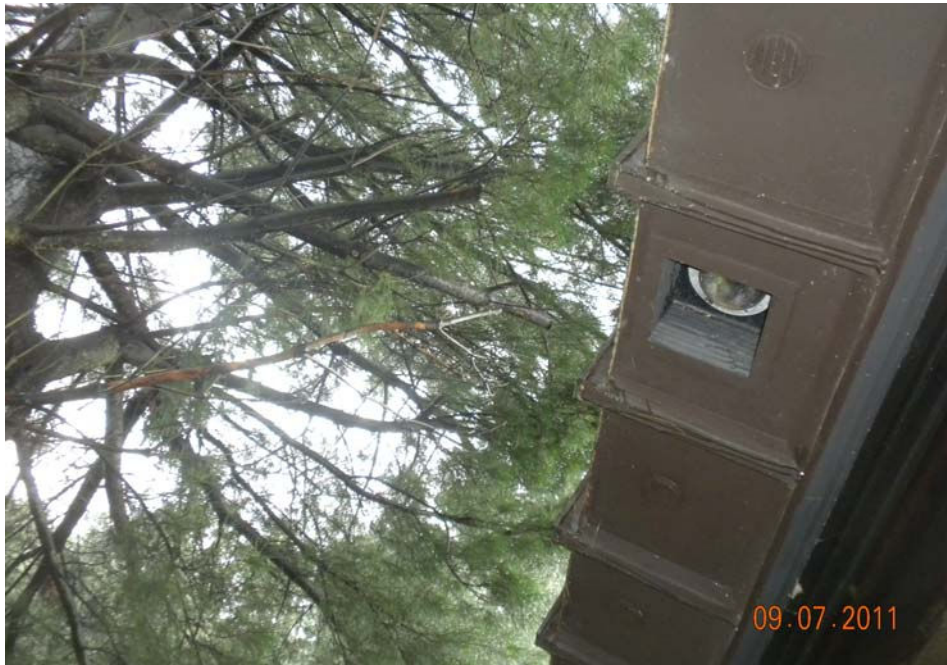
Trim back tree limbs overhanging main house roof

Keep tree branches trimmed back off roof line. Any existing dead trees or branches should be removed. Annual inspection of trees is recommended. The services of a tree specialist are recommended.

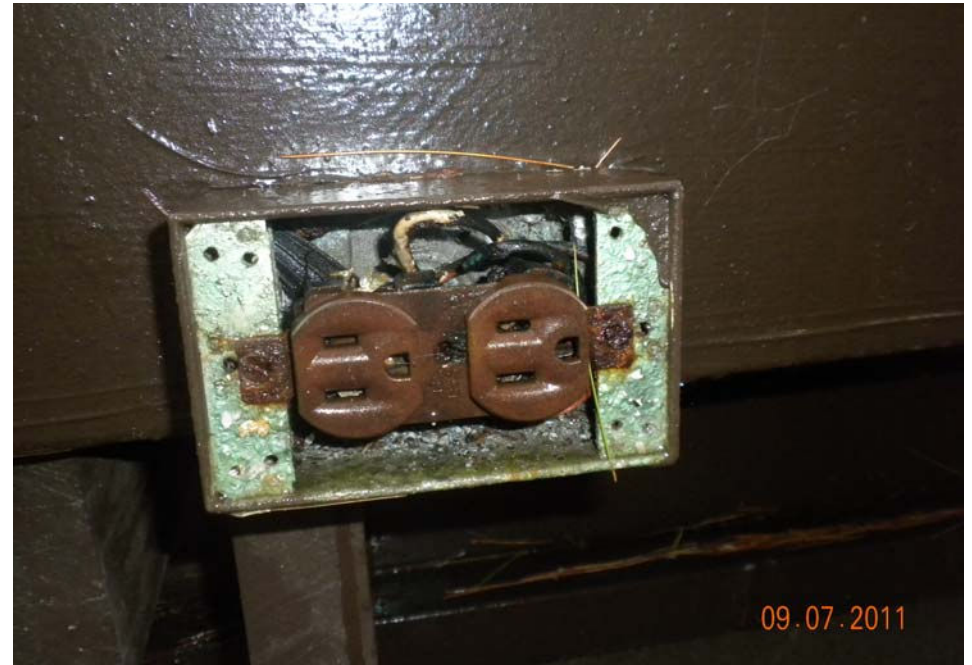
replace exterior outlets with GFCI weatherproof type

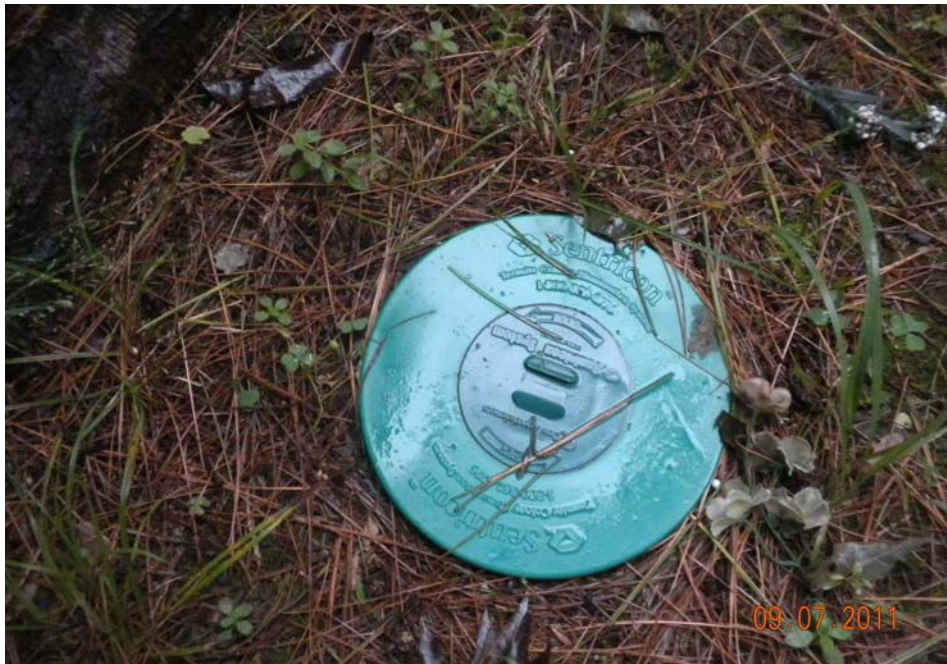
Termite treatment at perimeter of main house

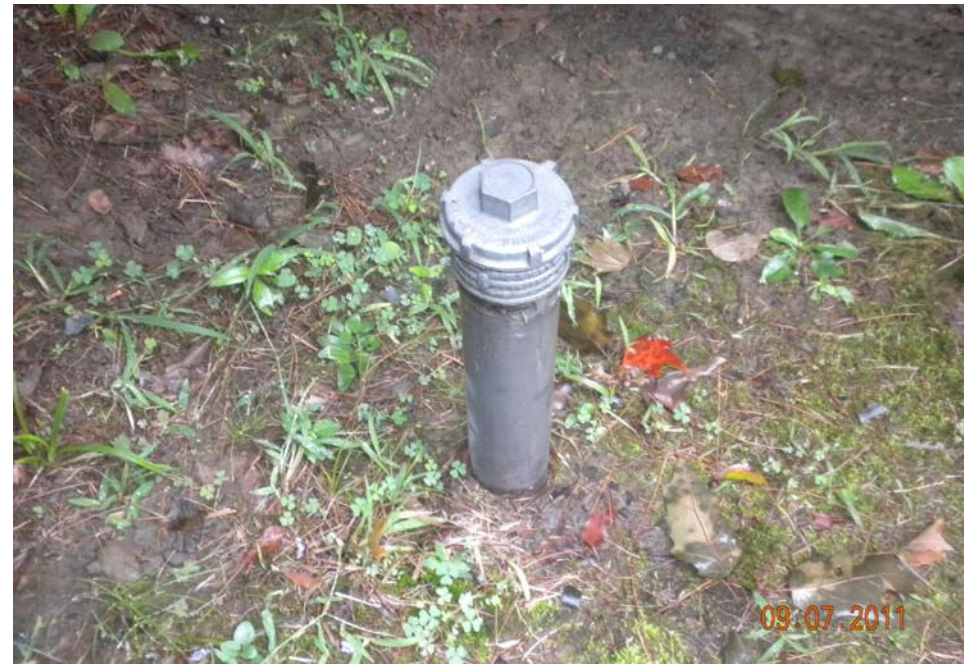
1. A 1,000 gallon underground oil storage tank is located at the north side of the house for the oil fired heating system. The tank is reported to have failed a tightness test. Tank must be addressed in accordance with the requirements of the NYSDEC and Westchester County Department of Health prior to closing.

Oil tank fill pipe at the north side of main house

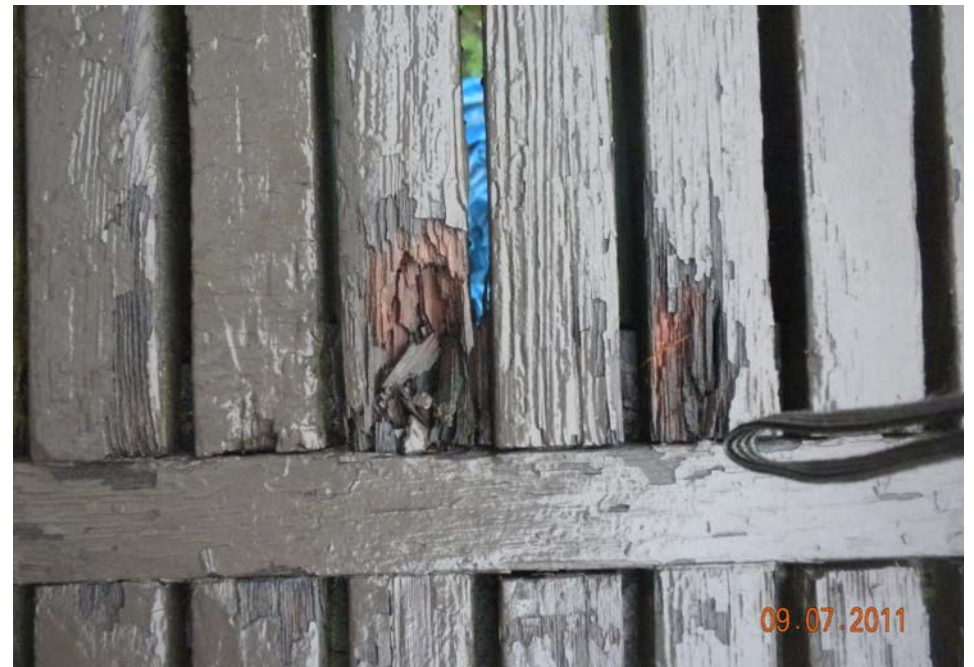
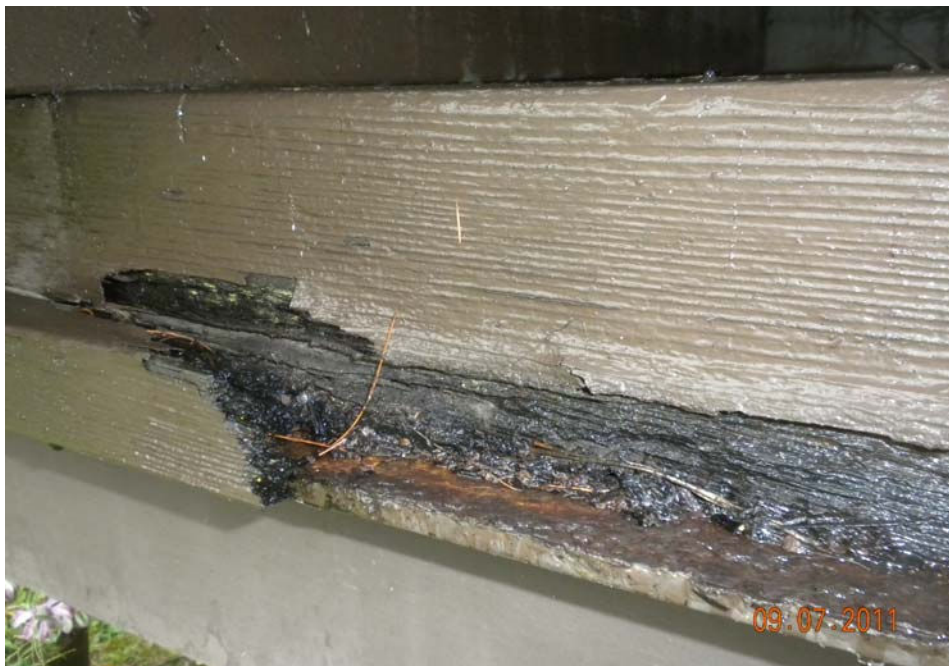
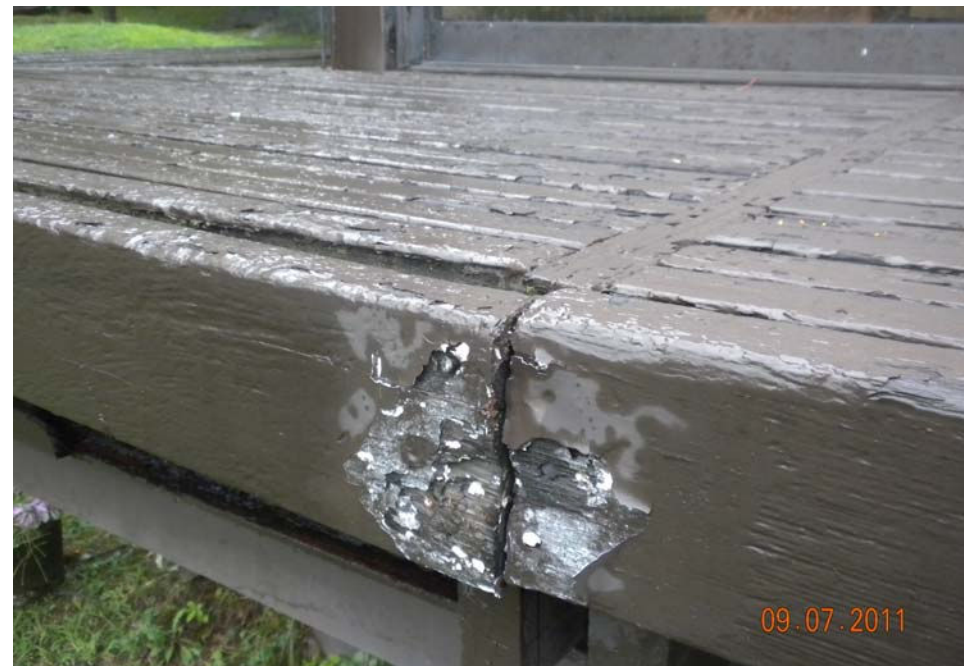
A wood deck/walkway has been installed at the perimeter of the home. Deck is wood framed supported by steel girders. Sections of the decking, joists, sills of the deck are rotted. Replacement of the entire deck is recommended due to noted rot and safety issues. Installation of a railing will be required during up-date.

Wood rot at perimeter deck of main house

3. Sections of the deck at the perimeter of the home are rotted. Wood is not pressure treated type. Deck is installed without safety railings. Replacement of entire deck is recommended due to rot and safety issues. Installation of a railing will be required during up-date.

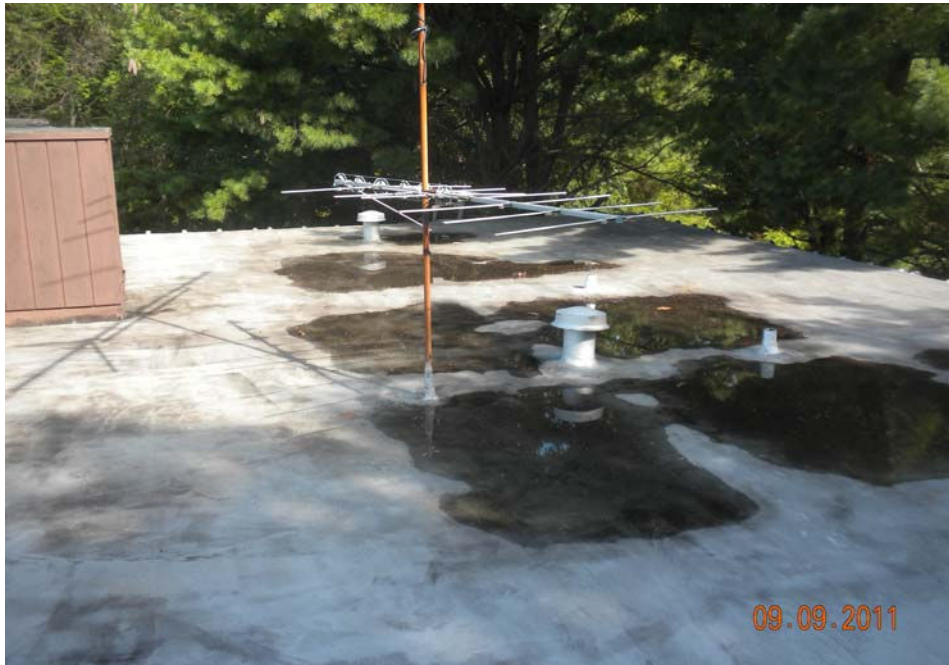
Roofing at the Main House is built-up type and in fair condition. Re-coating roofing with an aluminized paint is recommended at this time. Ponding was noted at low lying areas of the roof. Roofing material is at the end of its useful life.

Ponding water on roof

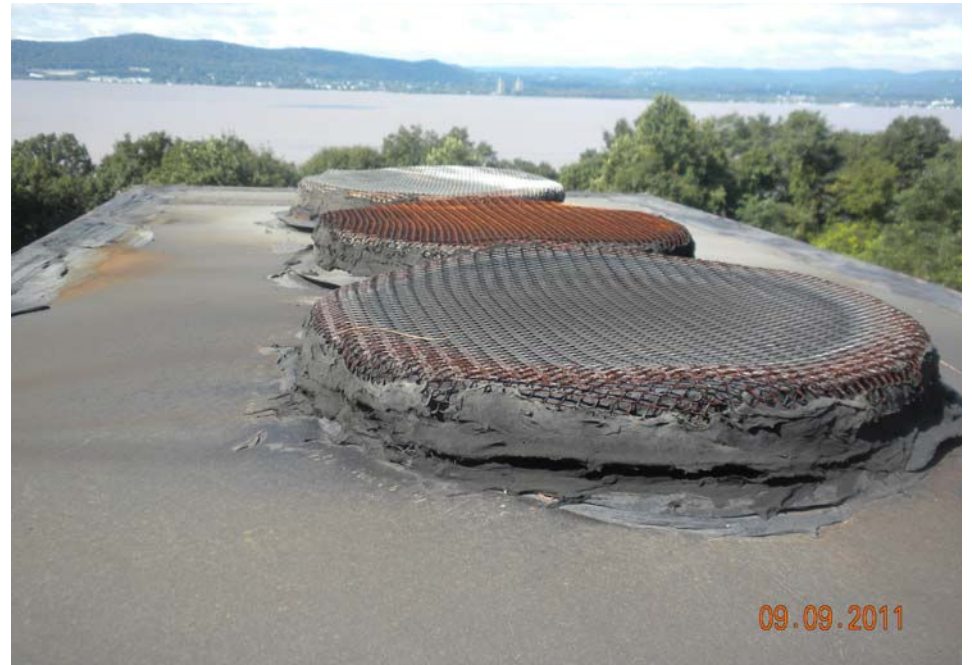
Open joint at chimney flues

- Replace rotted section of wood siding at the east side of the chimney
- Seal open joint at the flues to crown
- Install chimney caps

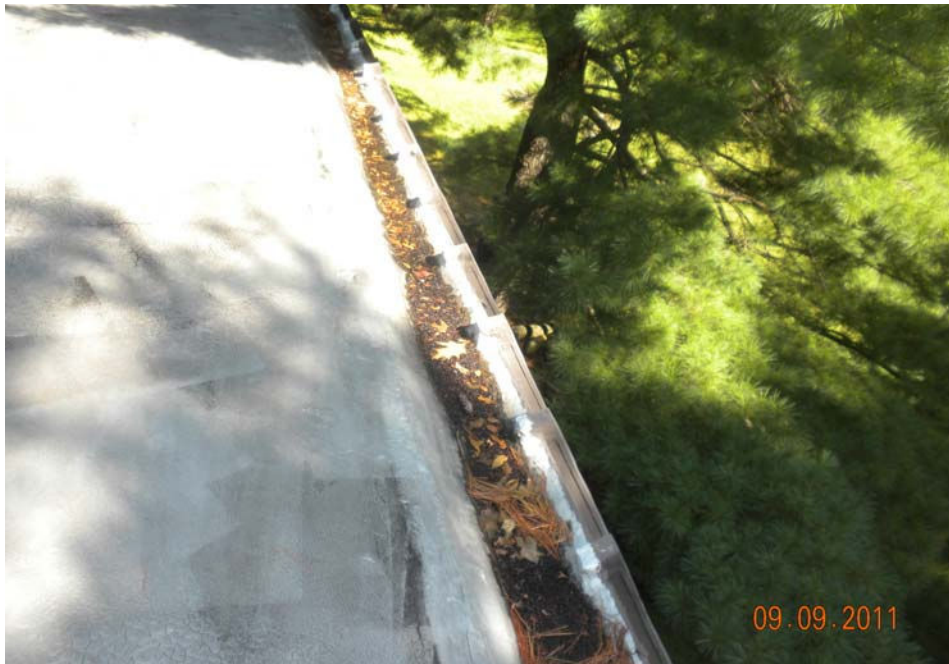
Clogged built-in roof gutters at main house

Existing gutters and leaders should be cleaned several times each year (late spring and late fall). Underground drainage piping is installed at some roof leaders. This is important for removing water away from the structure. Check for good leader base outflow at cleaning periods. Discharge locations were not verified as part of this inspection and should be reviewed with the owner prior to closing. Periodic cleaning of drainage pipes and/or replacement of drywells will be required as part of normal maintenance.

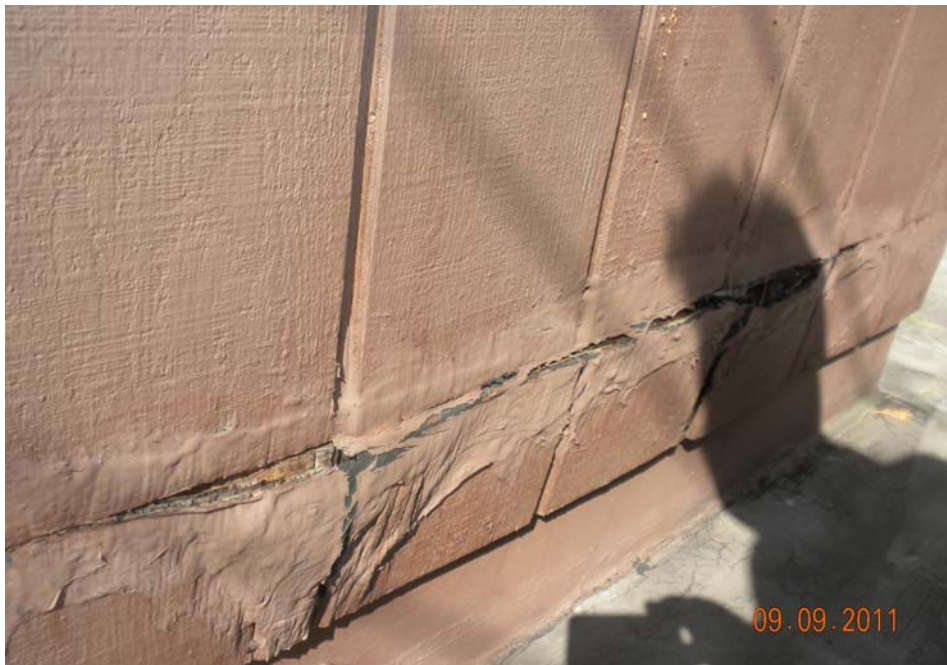
Rotted siding at main house chimney

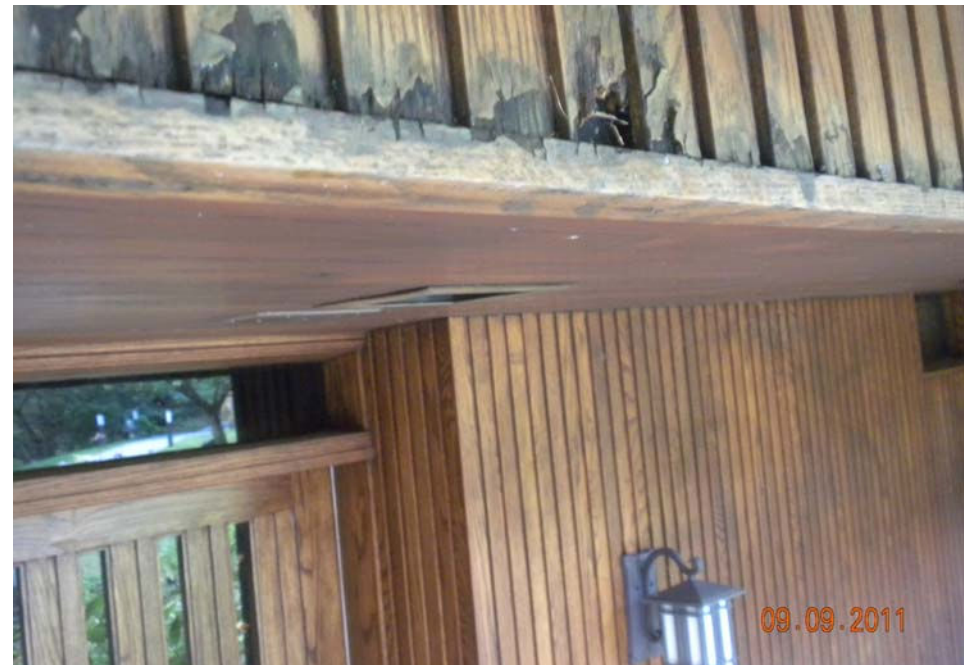
Wood wainscoting siding is installed at the entry door and is in fair condition. Rotted sections at the base of the siding and over the entry door require sectional replacement.

Wood Rot above entry door at main house

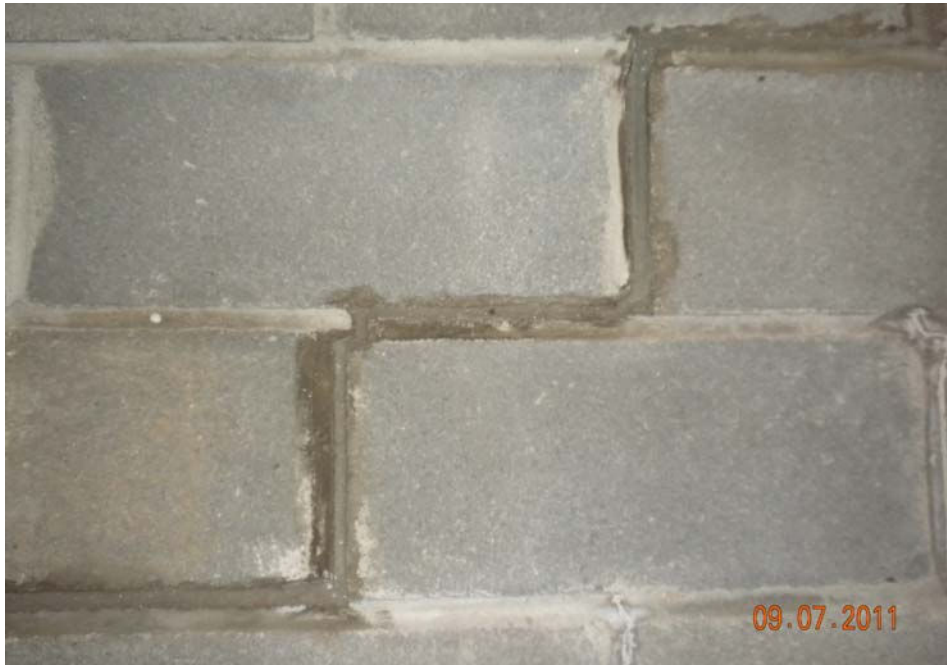
Foundation walls for the Two Car Garage are a combination of concrete and masonry block. More than the normal movement, settlement and cracking have taken place in the west masonry foundation wall of the garage. Cracks have been resealed with mortar materials. On a one inspection basis, it cannot be determined whether this condition will continue. Settlement cracking is not of a major structural concern in its present state. However, cracks should be monitored and, if any further movement is noted, Tri-State should be contracted to re-evaluate this condition.

Foundation cracking at west wall of garage

Removal of vegetation at the south and west side of the garage is recommended. Large tree at the south side of the building adjacent to the cracking should also be removed. Patching spalling stucco at the south foundation is also required.

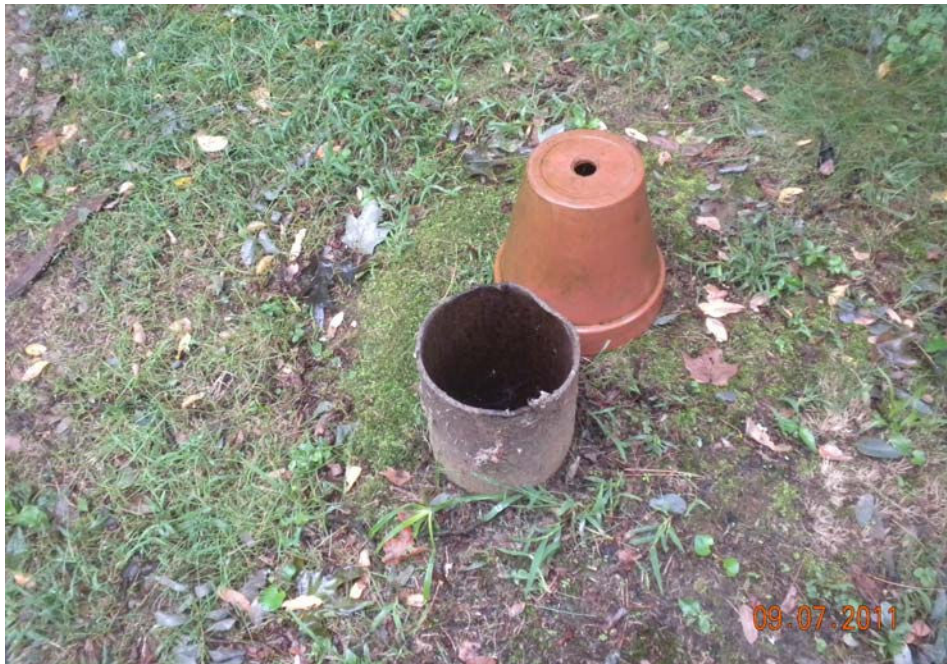
Open well casing needs to be sealed

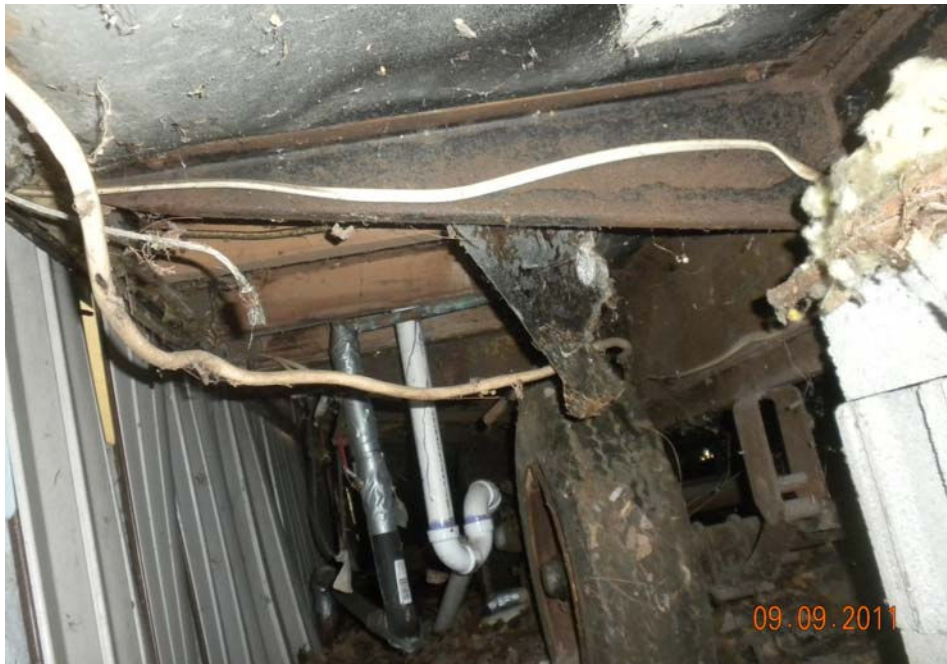
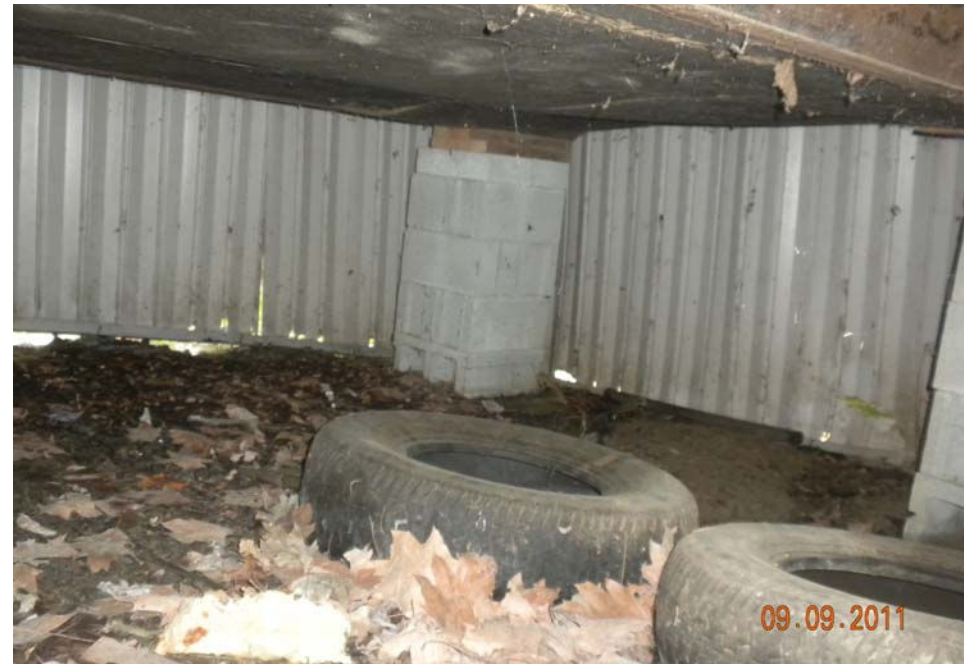
Crawl space under mobile home

Crawl Space under Mobile Home

- 29. The structure is generally in fair condition.
- 30. Vinyl skirt is in poor condition.
- 31. Crawl space under structure should be cleaned out and covered with plastic and crushed stone.
- 32. Sections of the roof have buckled.
- 33. Status of sanitary system is unknown.

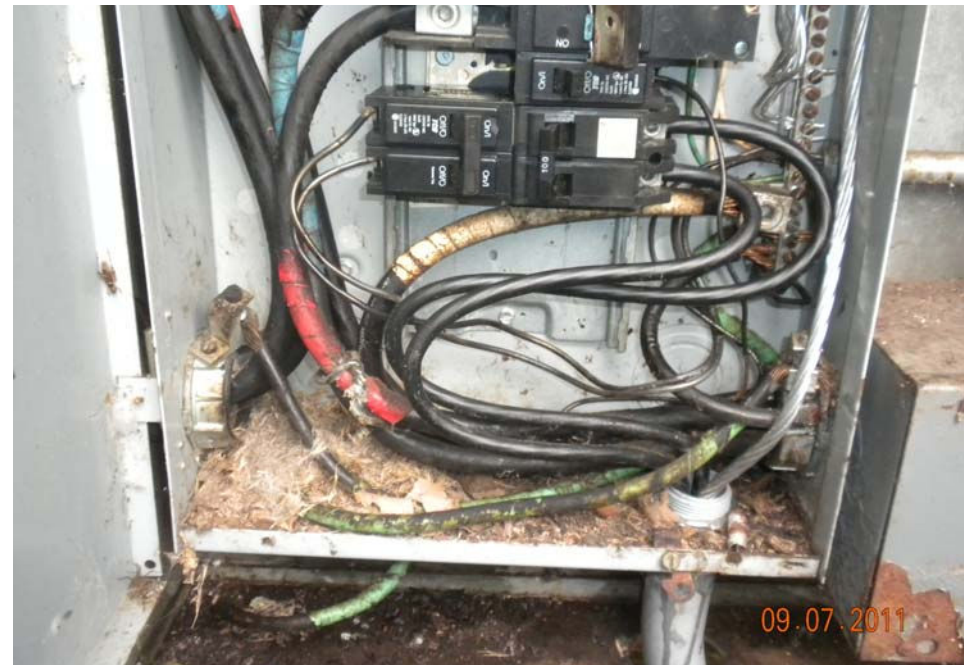
41. The main service is located in a metal panel on the east side of the property. A hole has been cut into the metal panel door. The main electrical service breaker is broken. The main panel cover is not properly installed. A nest was noted inside the panel. Installation of a new weatherproof enclosure/cabinet is recommended due to the hole cut into one of the doors. Up-dating service panel is also recommended.
42. A pond is located on the subject property. Inspection and/or testing of pond water is not included herein.

Nest in bottom of main electrical panel

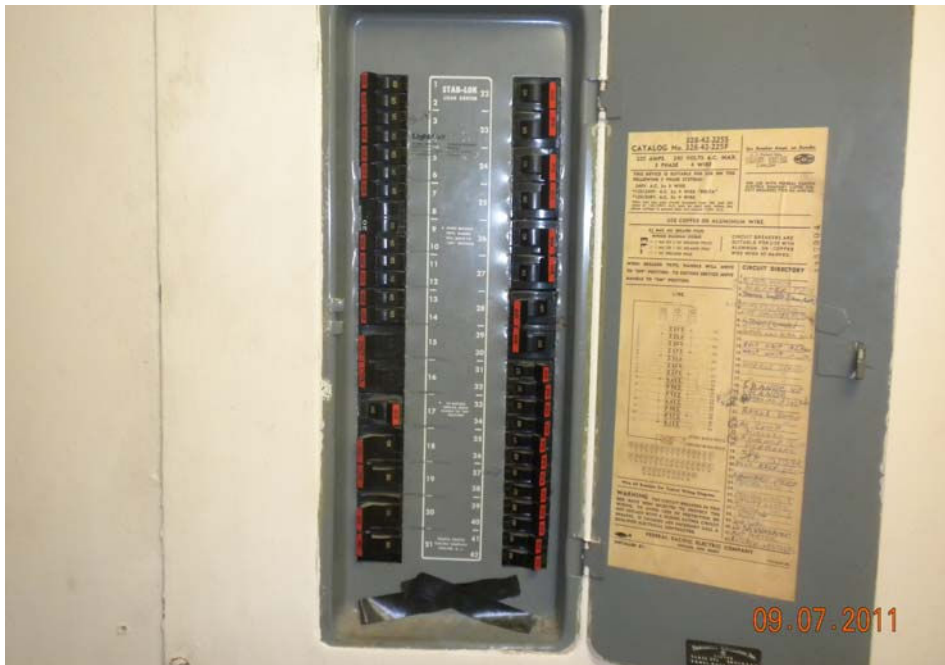
Federal Pacific electrical panel at main house

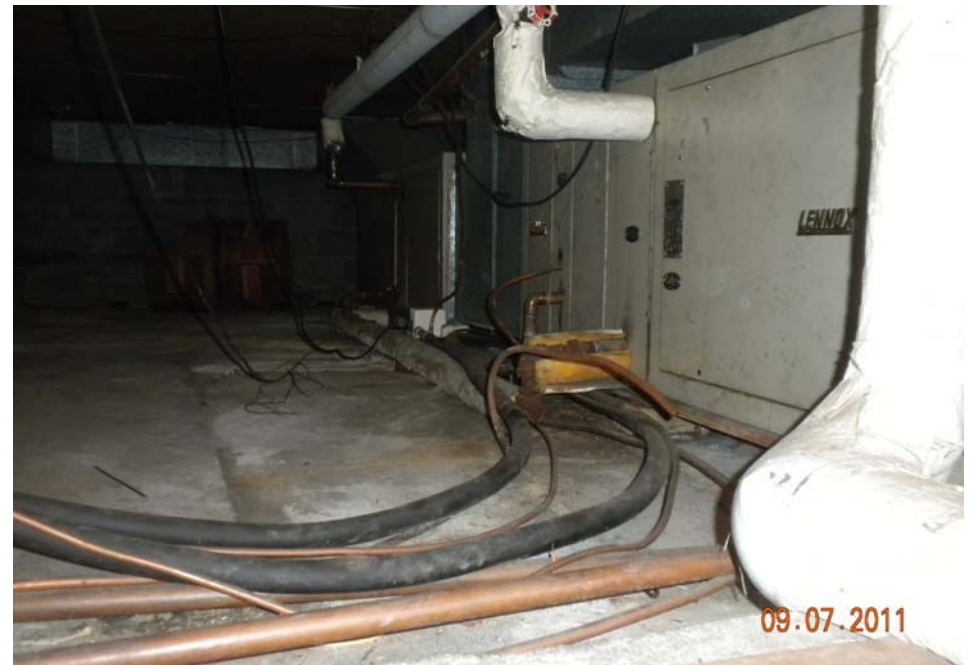
13. The three air handlers are past their normal service life.
14. Exterior glass at window walls and sliding doors should be tempered type for safety.
15. The structure has been treated for termites.
16. The main electrical panel for the main house is manufactured by Federal Pacific. This type of panel has had a problematic history and should be considered a safety hazard. Replacement of panel is recommended.
17. The HVAC system for the lower level was not functional.
18. Up-dating the open railing at the spiral stairs is recommended for safety.
19. The propane fireplace at the lower level was not tested. A 20# propane tank is installed in the boiler room for the fireplace. Tank must be removed for safety.
20. Unit heaters at the lower level bedroom were not functional.

Air handlers at main house are aged
