**VILLAGE OF CROTON-ON-HUDSON**

**GEORGIA LANE/WALDWOOD SUBDIVISION  
STORM WATER MANAGEMENT BASIN**

**FINAL  
ENGINEERING DESIGN REPORT**

**AUGUST 2011**

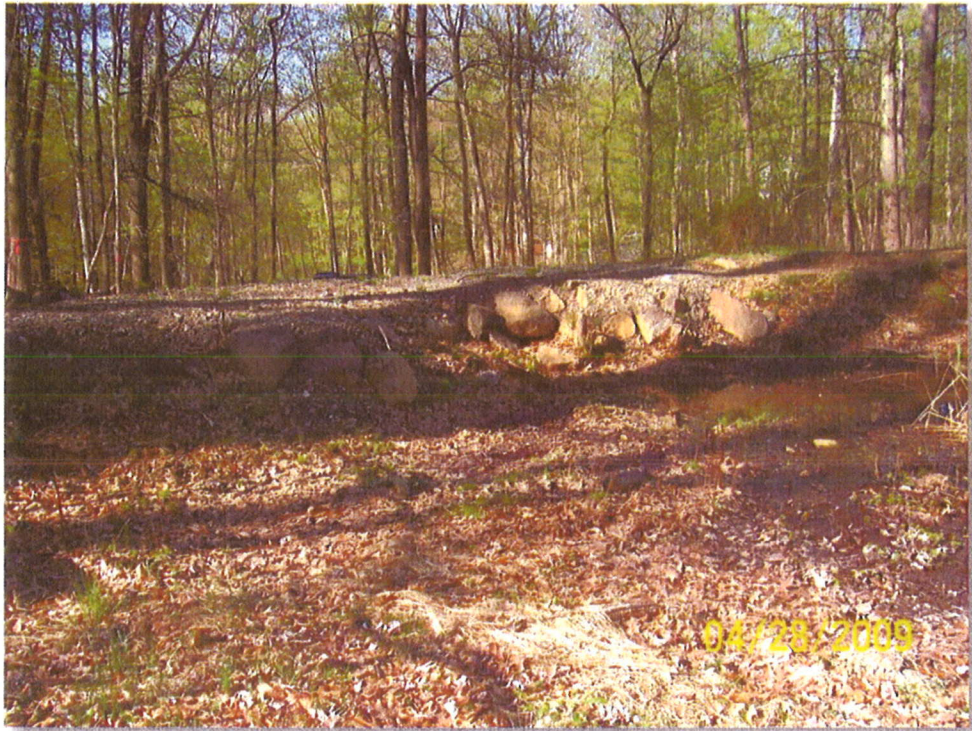
**Emergency Spillway**

The emergency spillway of the storm water management basin consists of a low section on the embankment with small diameter gravel that may be prone to erosion during storm events that top the crest of the emergency spillway

- The emergency spillway crest should be increased to 339.00 and the entire spillway should be covered or armored with stone rip-rap or other measures sized for the velocities it will be subjected to during the 100-year storm event to prevent erosion.

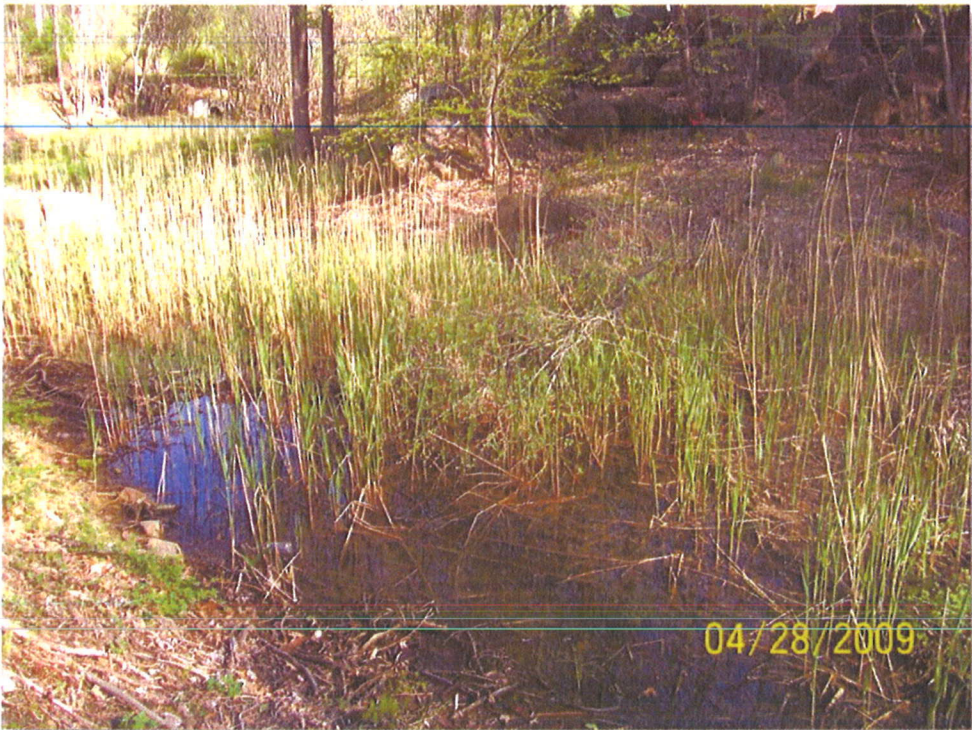
**Wetlands Plants**

It is also likely that bypassing the base flows around the basin will cause the wetlands that have developed in the basin to die off. These wetlands provide a storm water quality improvement feature to the basin as these plants take up nutrients, breakdown some heavy metals and trap sediments, as well as provide habitat.

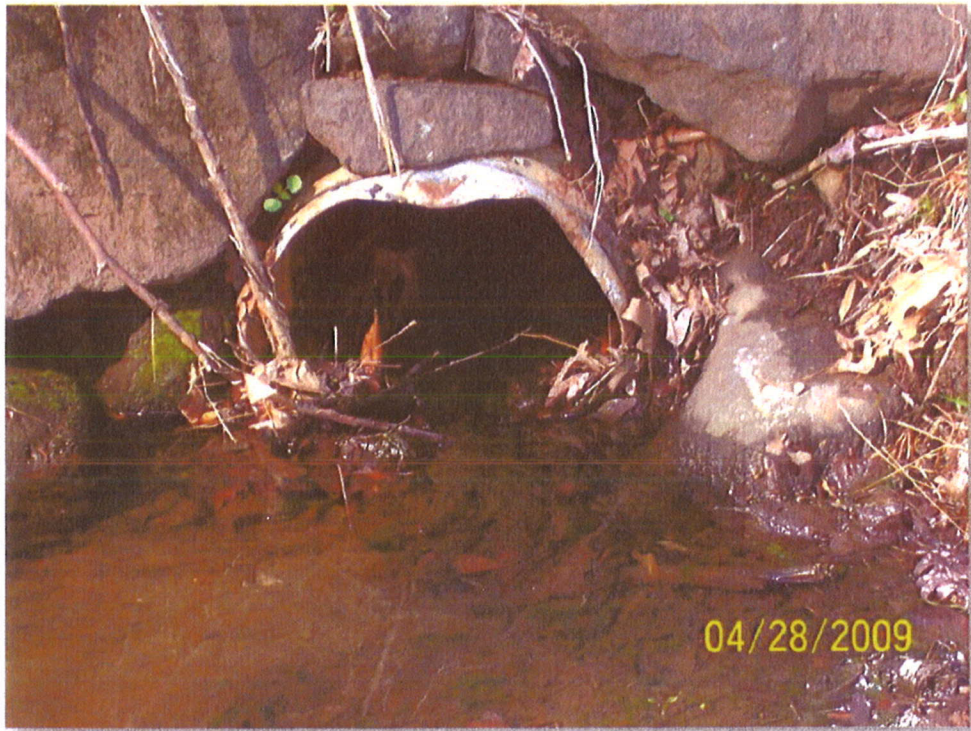
Existing 15"Ø Outlet Pipe

the basin becomes clogged with debris requiring constant monitoring by Village personnel and increasing the likelihood the basin will be overtopped during a storm event.

The existing outlet structure for the basin consists of a 15-inch corrugated metal pipe (cmp) with a slope of 3.8%. Based on the current configuration of the outlet structure in relation to the crest of the emergency spillway a maximum head of 4.19 feet can be applied to the pipe, which generates a maximum outflow capacity of approximately 9 cubic feet per second (cfs).

Installing a trash rack/inlet protection over the existing 15-inch cnp outfall will reduce the likelihood that the outfall becomes clogged with debris during a storm event. This will reduce the chances that the basin is overtopped during a 2-year storm event as a result of the outfall pipe being clogged. However, based on the model, the basin will still be overtopped for 5-year storm events and greater. The existing inflows, outflows and peak rates from the basin and at other critical areas in the watershed will not change as a result of this improvement. The Village will still need to inspect and clean the trash rack/inlet protection periodically. Because this alternative does not provide any reduction in the frequency that the basin is overtopped or any reduction in peak flows, it is not the recommended action.

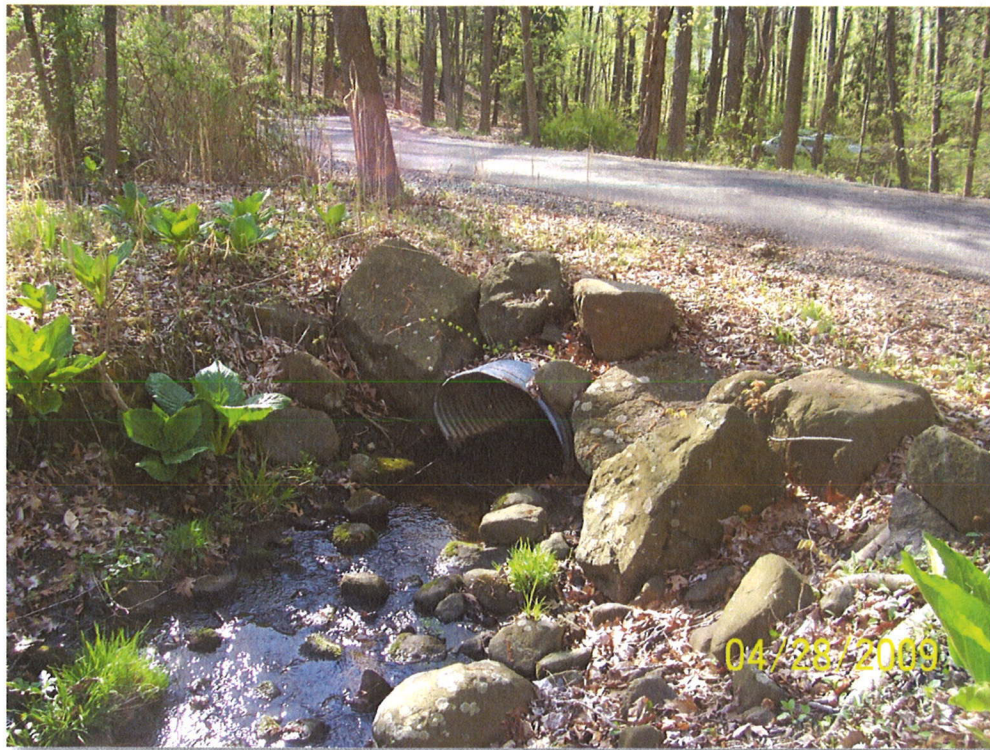
**22" x 34" Elliptical Pipe Under Park Trail**

\* Note: Capacity of 24" x 36" elliptical culver under Park Trail is approximately 30 CFS.

In addition, it is recommended that the culvert under Park Trail be improved to convey the 10-year storm event (51.72 cfs).

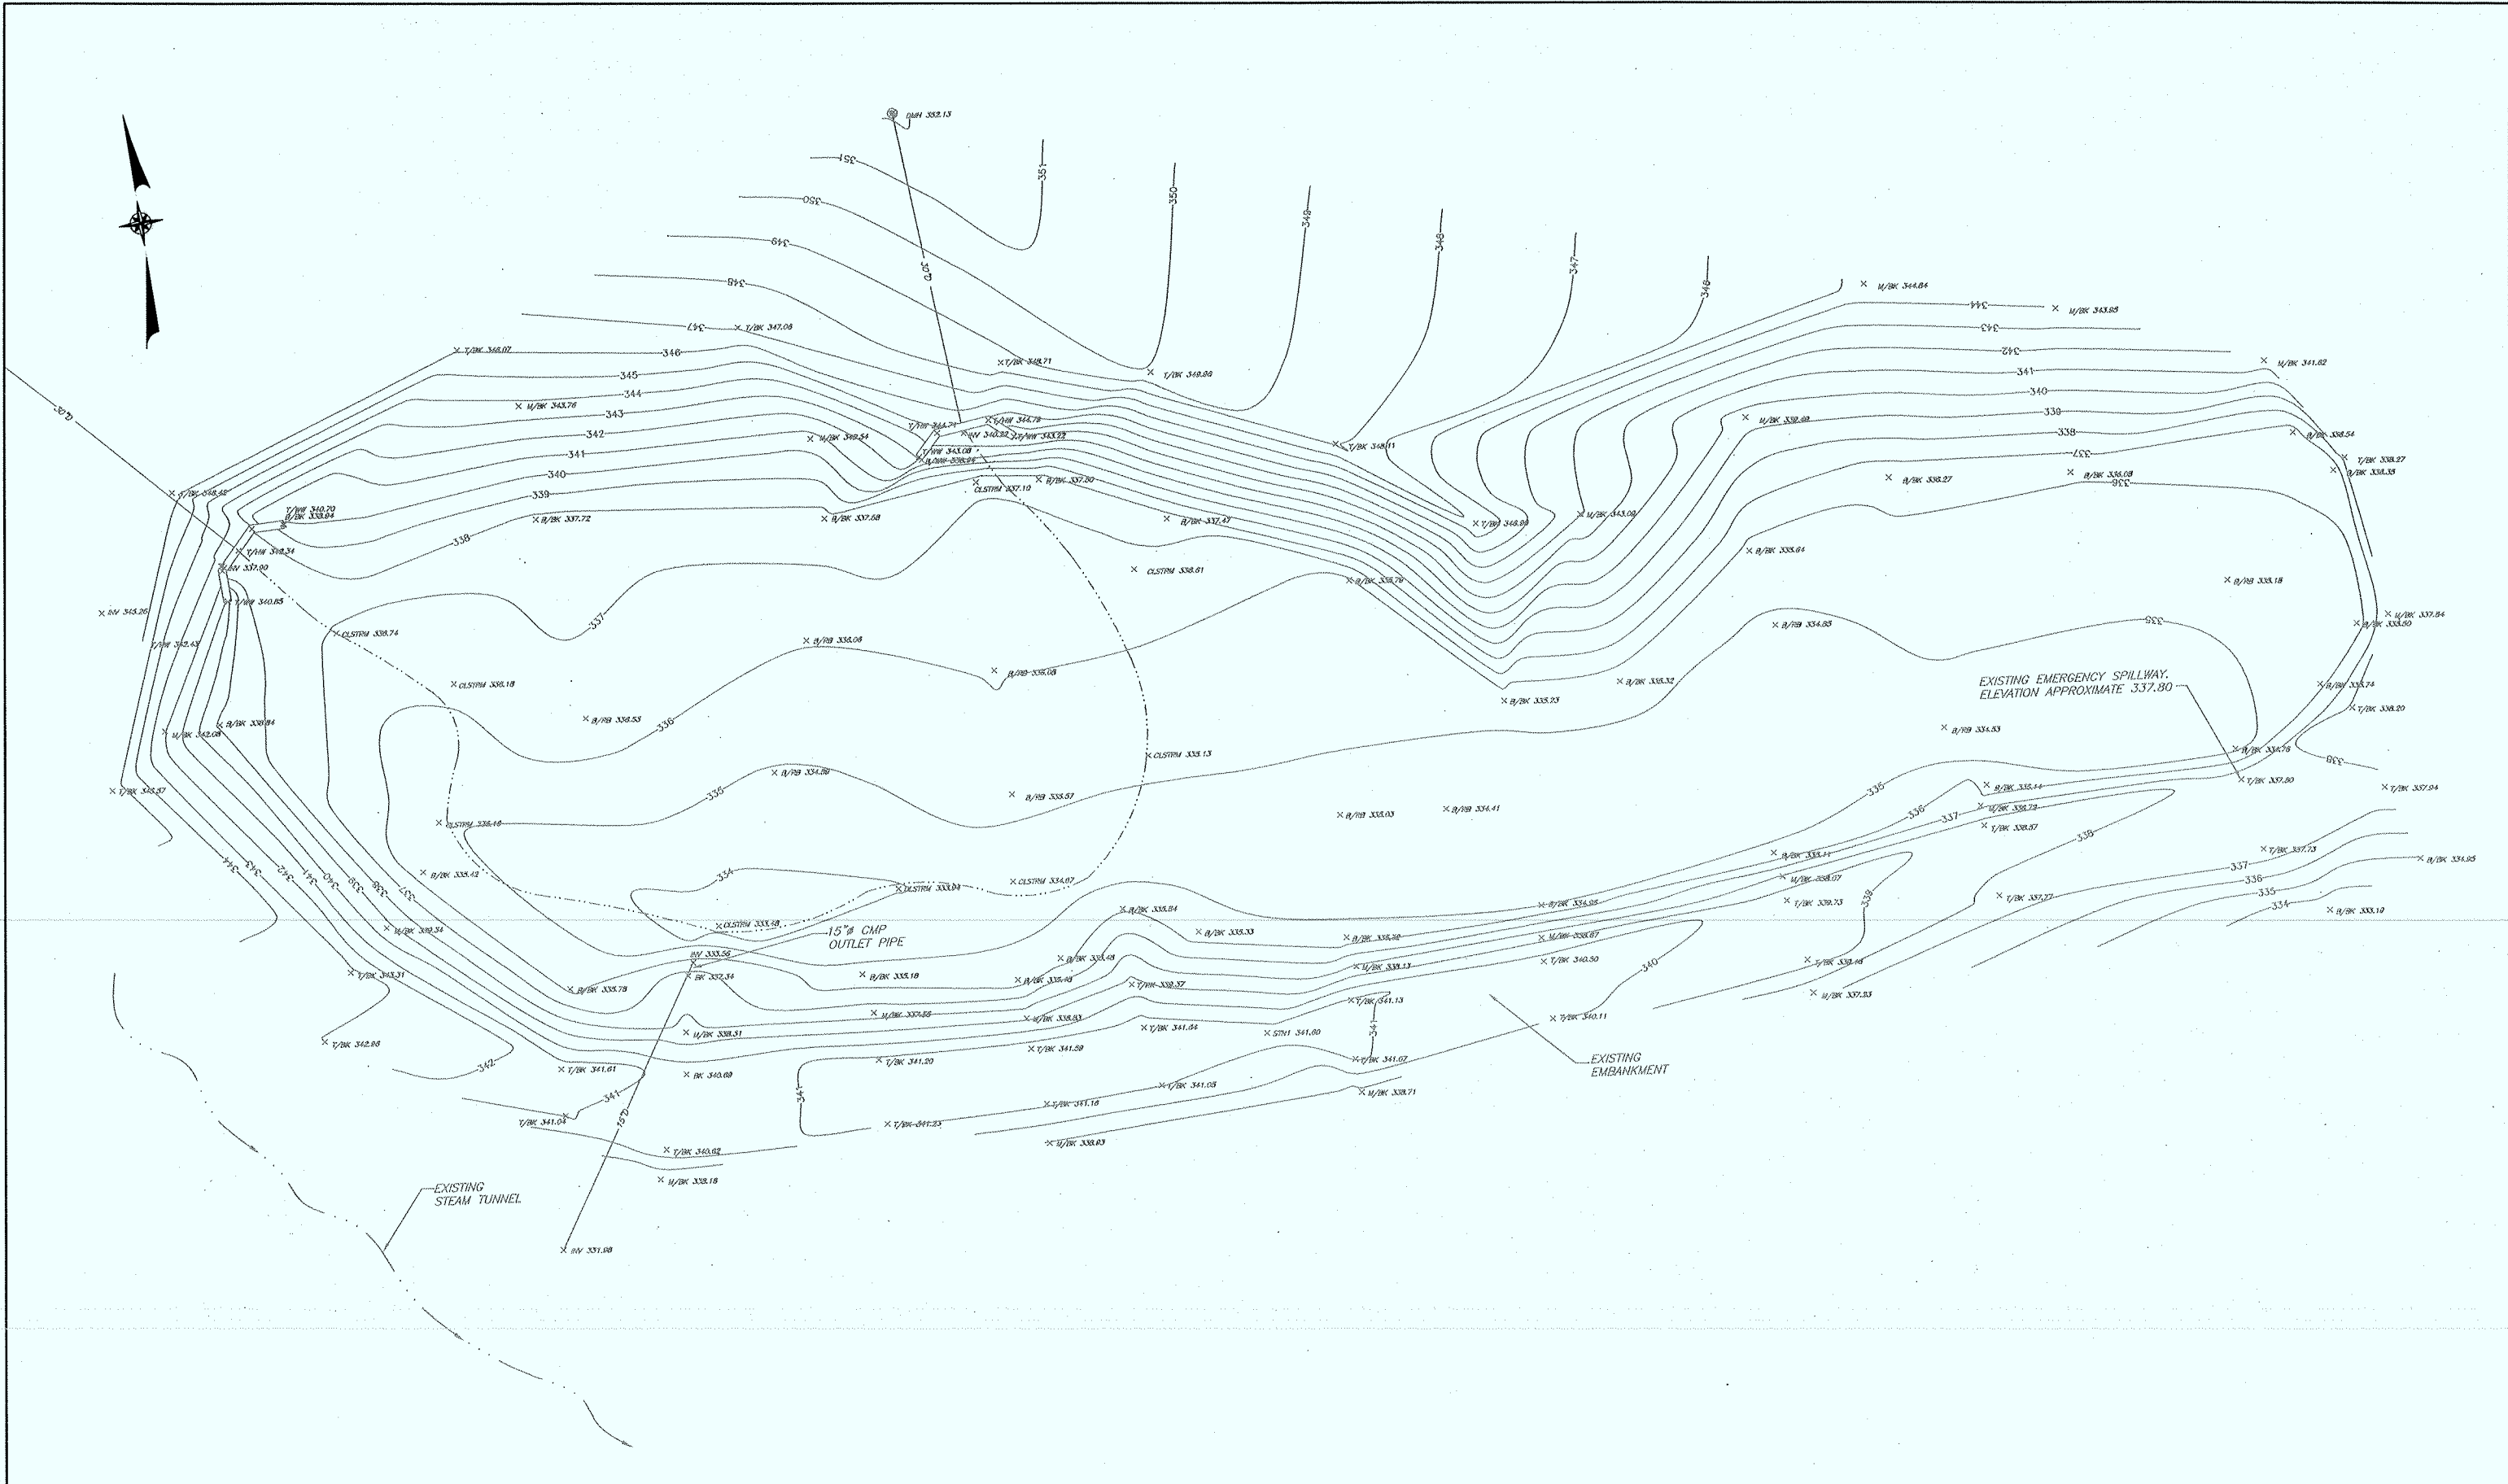
DRAWING NO.  
FIGURE  
2-7

D&B performed a partial topographic survey of the existing basin. Refer to Figure 2-7. Based on the survey performed by D&B the volume of the basin to the crest of the emergency spillway is approximately 30,000 cubic feet. The emergency spillway has a crest elevation of 337.80 feet.

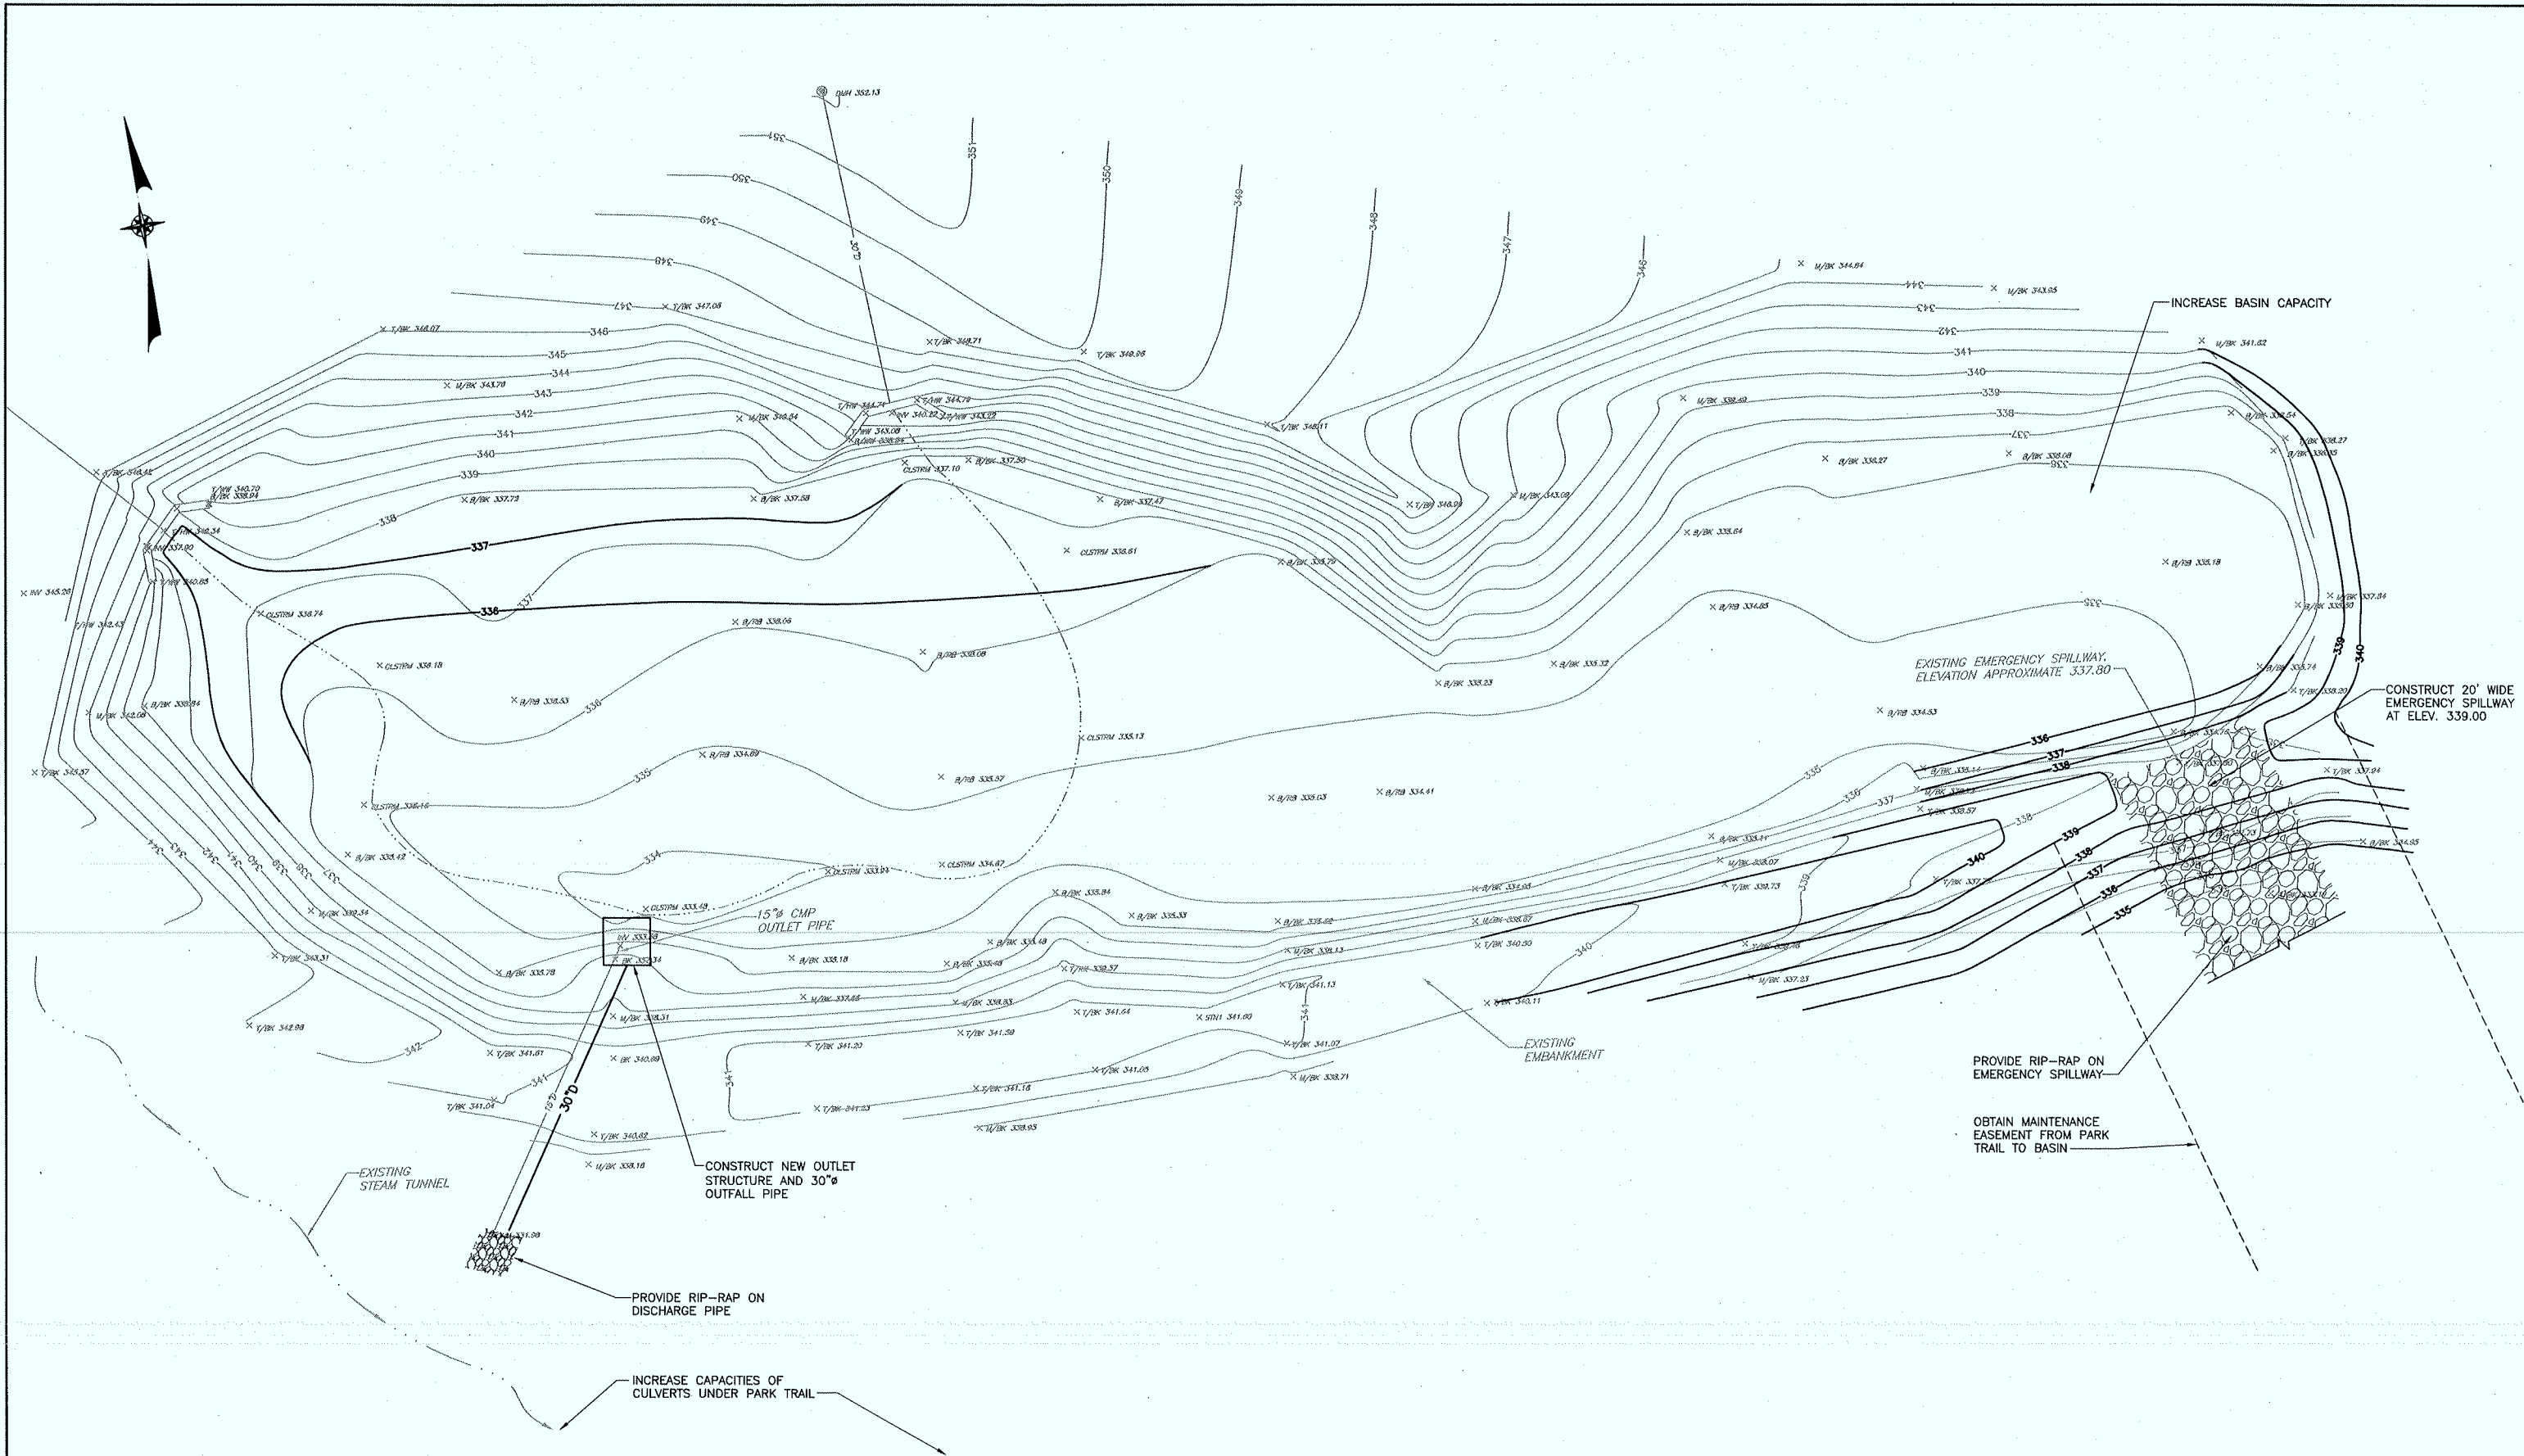
DRAWING NO. FIGURE 3-2

Given the existing relationship between the invert and diameter of the outfall pipe and the crest elevation, the outfall pipe has a capacity of approximately 9 cfs. In order to reduce the occurrence of overtopping the basin the capacity of the existing outfall must be increased in addition to raising the emergency spill crest elevation. In addition to increasing the diameter of the outfall, a tiered outfall structure or riser pipe would be required to provide for maximum attenuation of storm water flows, while safely maintaining the water surface elevation for the 2-, 5- and 10-year event within the basin. The proposed outfall pipe consists of a 30" diameter high density polyethylene pipe (HDPE). The outlet structure could be constructed from a pre-cast concrete catch basin or manhole modified to provide the necessary inlets at the proper elevations. The outlet structure recommended should have a 12-inch low flow orifice to convey the base flows through the basin. This low flow orifice should be equipped with a trash rack to prevent clogging. In addition, the outlet structure will require a 6-foot long weir set at elevation 337.50. This is a conceptual description of an outlet structure, which could be modified during the design

Refer to Figure 3-2 for recommended improvements.
