# *Why Do You Think They Call it Brook Street?*

Friends of History Presentation – Croton Free Library  
Daniel O'Connor, P.E. Village Engineer

Date: 9/16/10

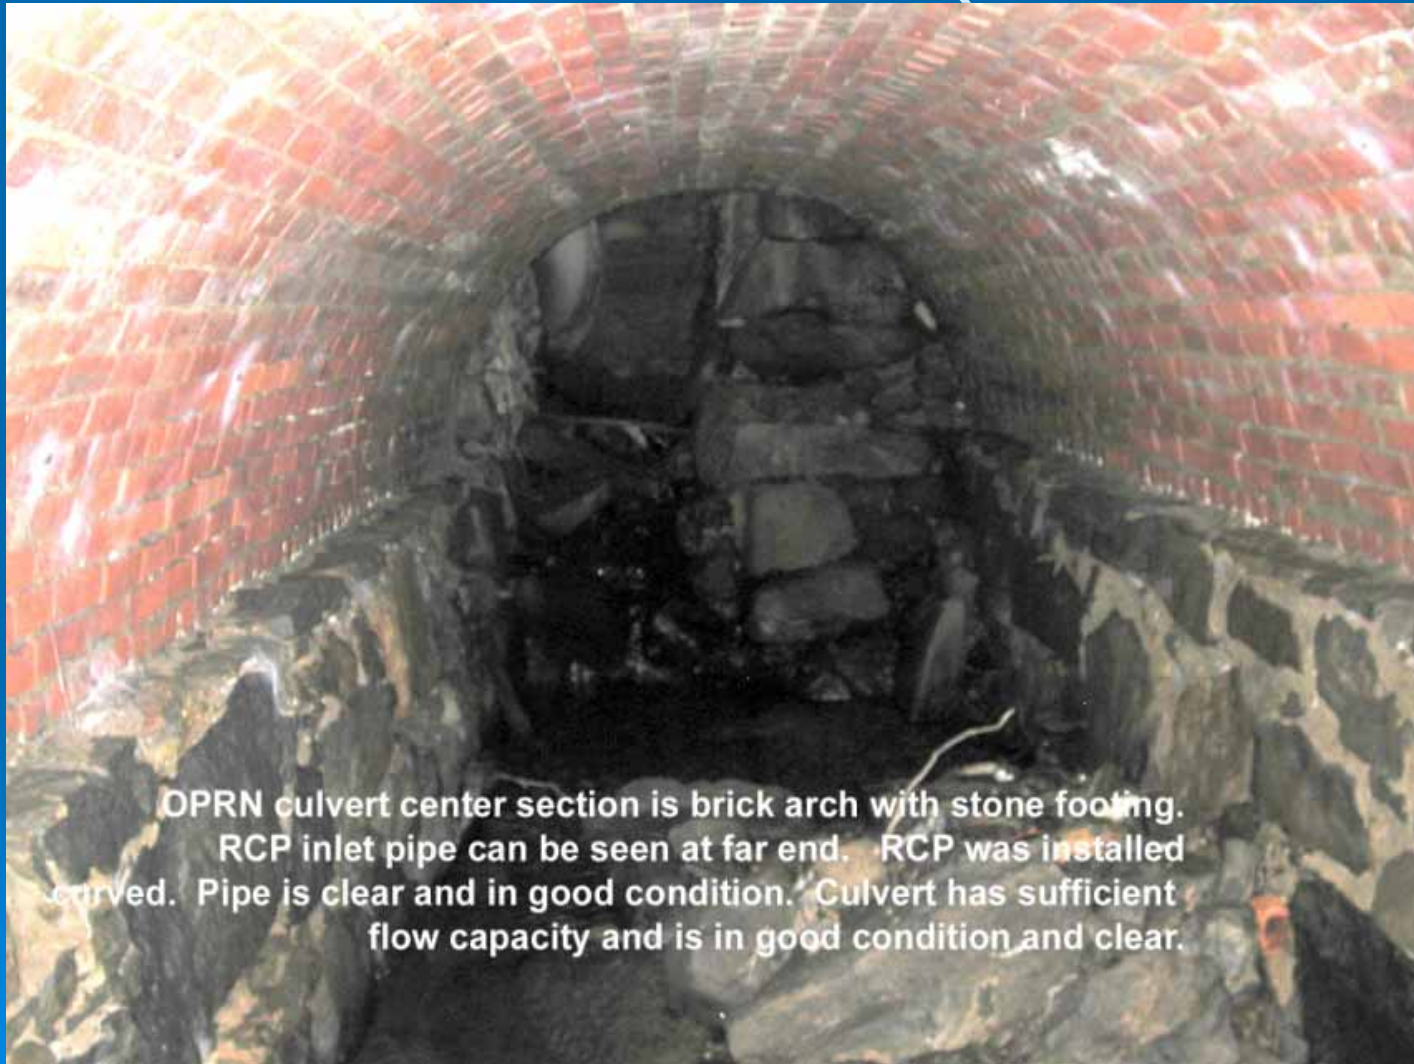
# Culvert Outlet at West side of Old Post Road North (inside view)

OPRN culvert center section is brick arch with stone footing. RCP inlet pipe can be seen at far end. RCP was installed curved. Pipe is clear and in good condition. Culvert has sufficient flow capacity and is in good condition and clear.

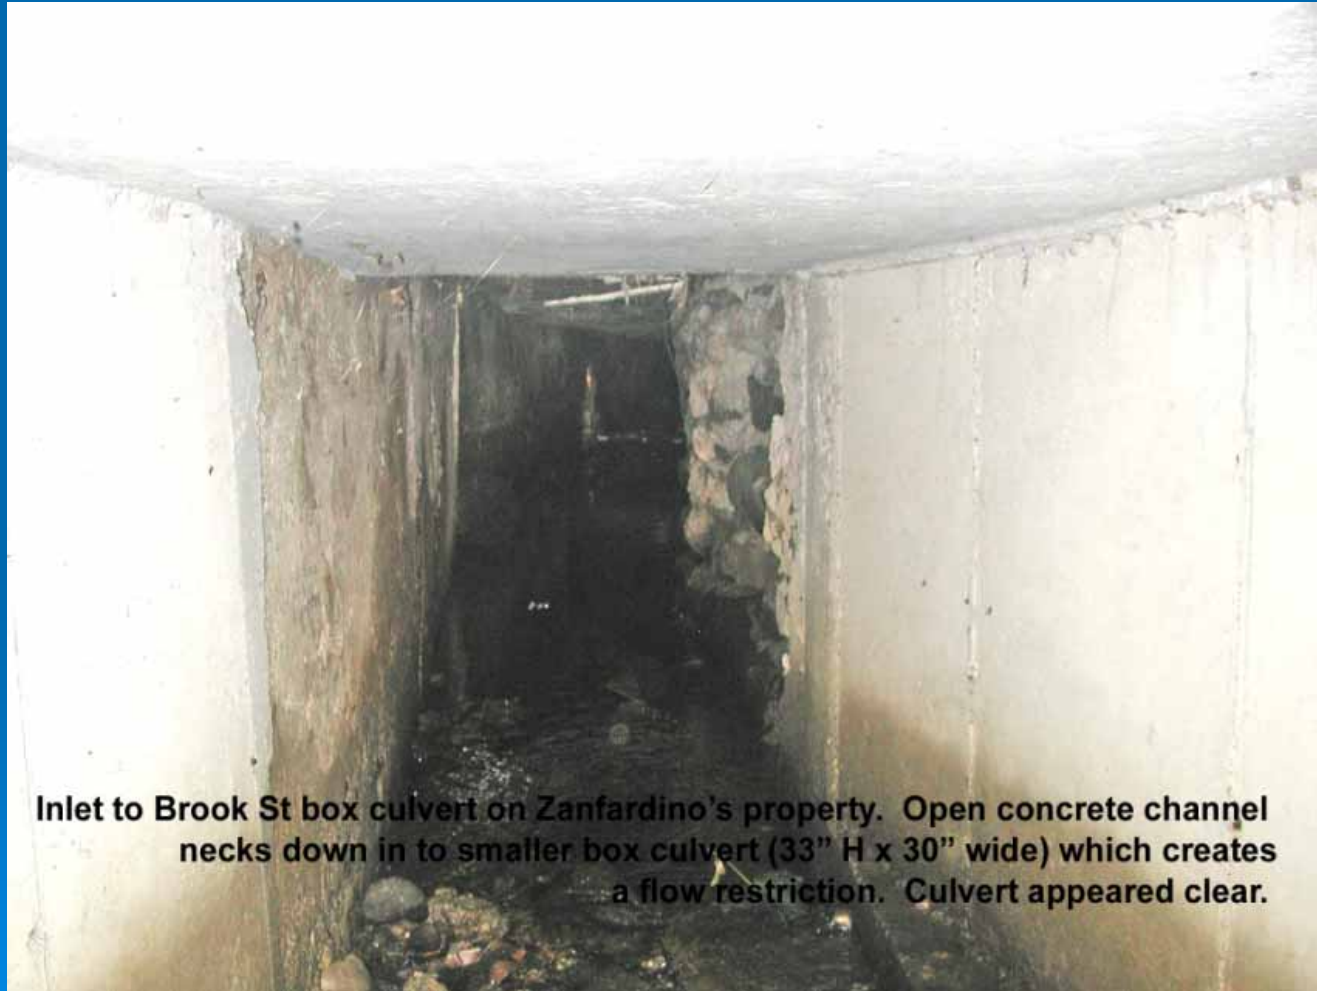
# Entrance to box culvert below garage

**Inlet to Brook St box culvert on Zanfardino's property. Open concrete channel necks down in to smaller box culvert (33" H x 30" wide) which creates a flow restriction. Culvert appeared clear.**

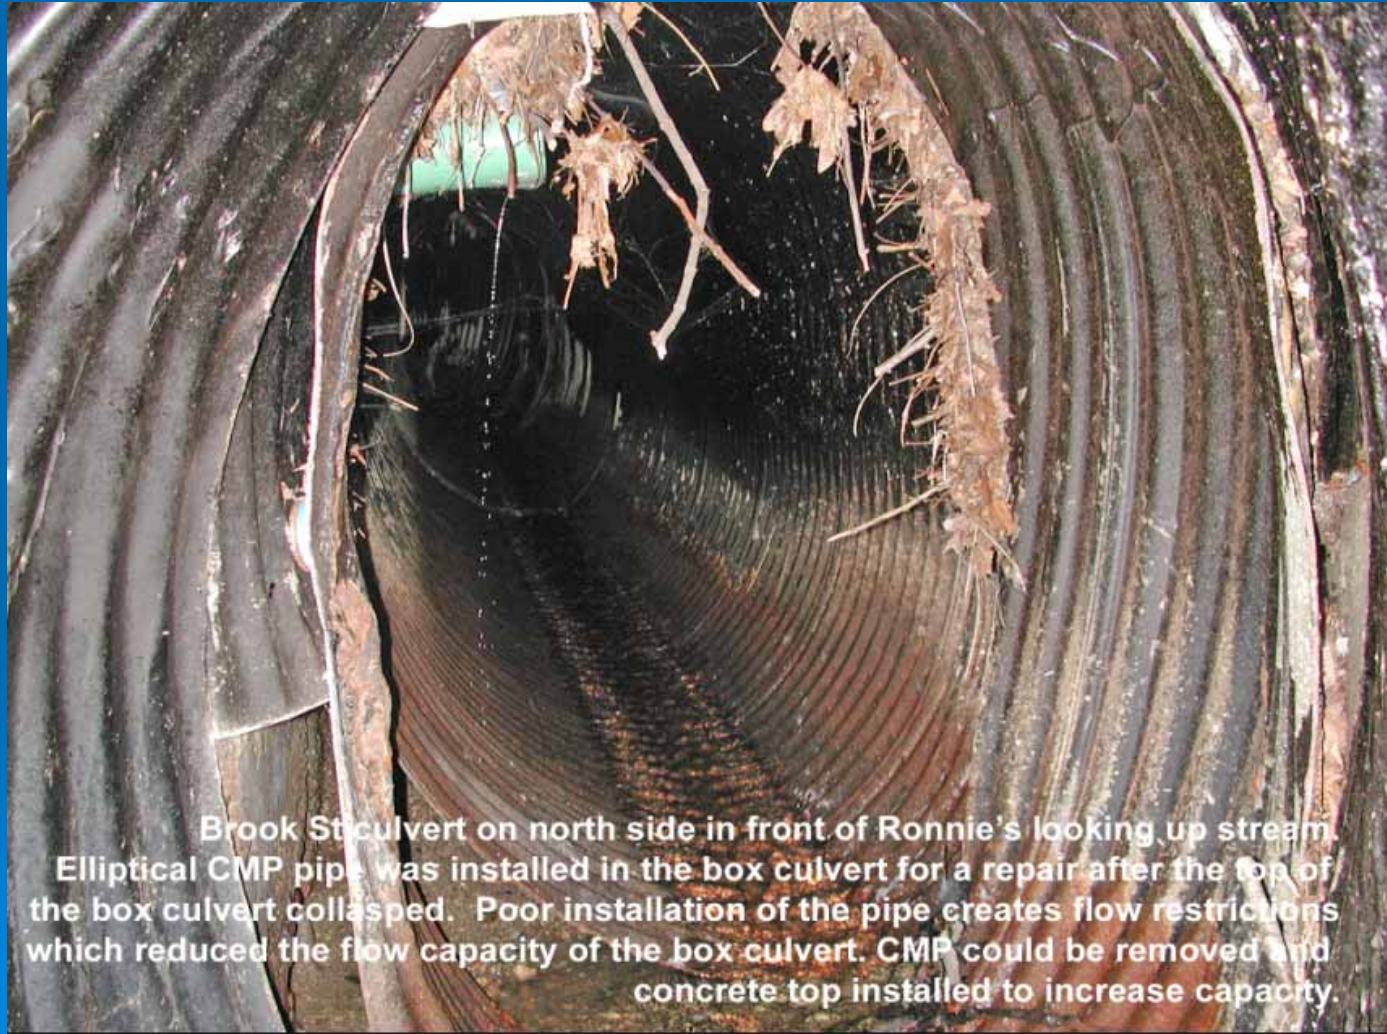
# Storm Pipe on Brook Street

Brook St culvert on north side in front of Ronnie's looking up stream. Elliptical CMP pipe was installed in the box culvert for a repair after the top of the box culvert collapsed. Poor installation of the pipe creates flow restrictions which reduced the flow capacity of the box culvert. CMP could be removed and concrete top installed to increase capacity.

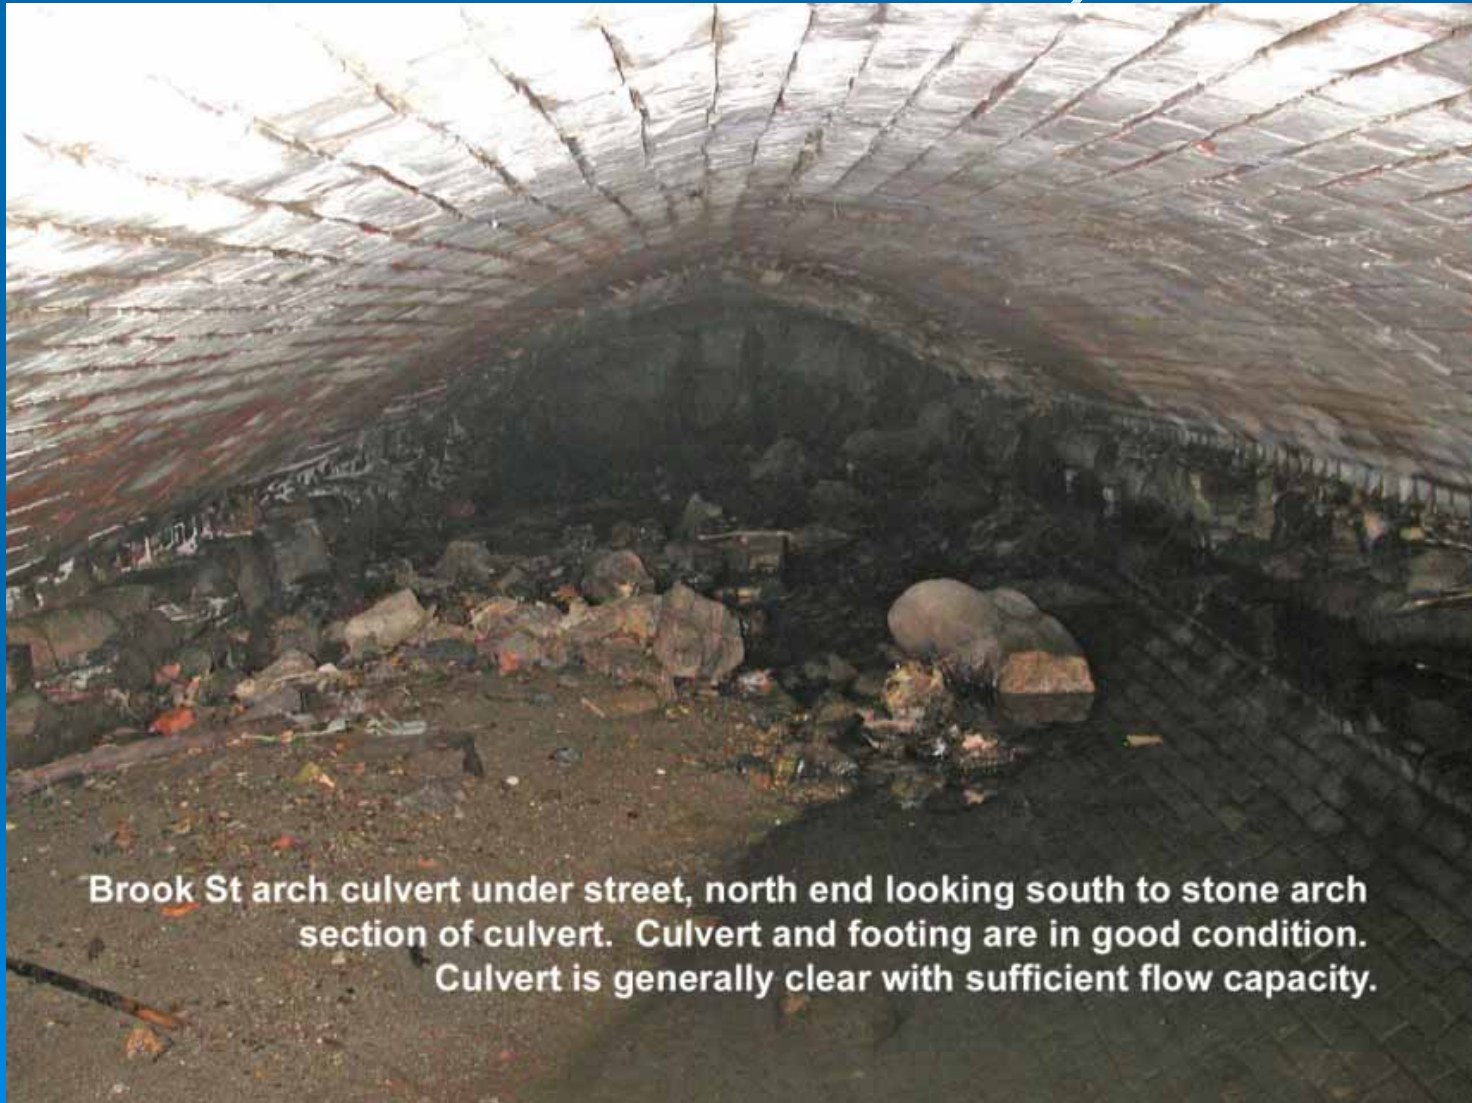
# Culvert under Brook Street (arch: brick and stone)

Brook St arch culvert under street, north end looking south to stone arch section of culvert. Culvert and footing are in good condition. Culvert is generally clear with sufficient flow capacity.

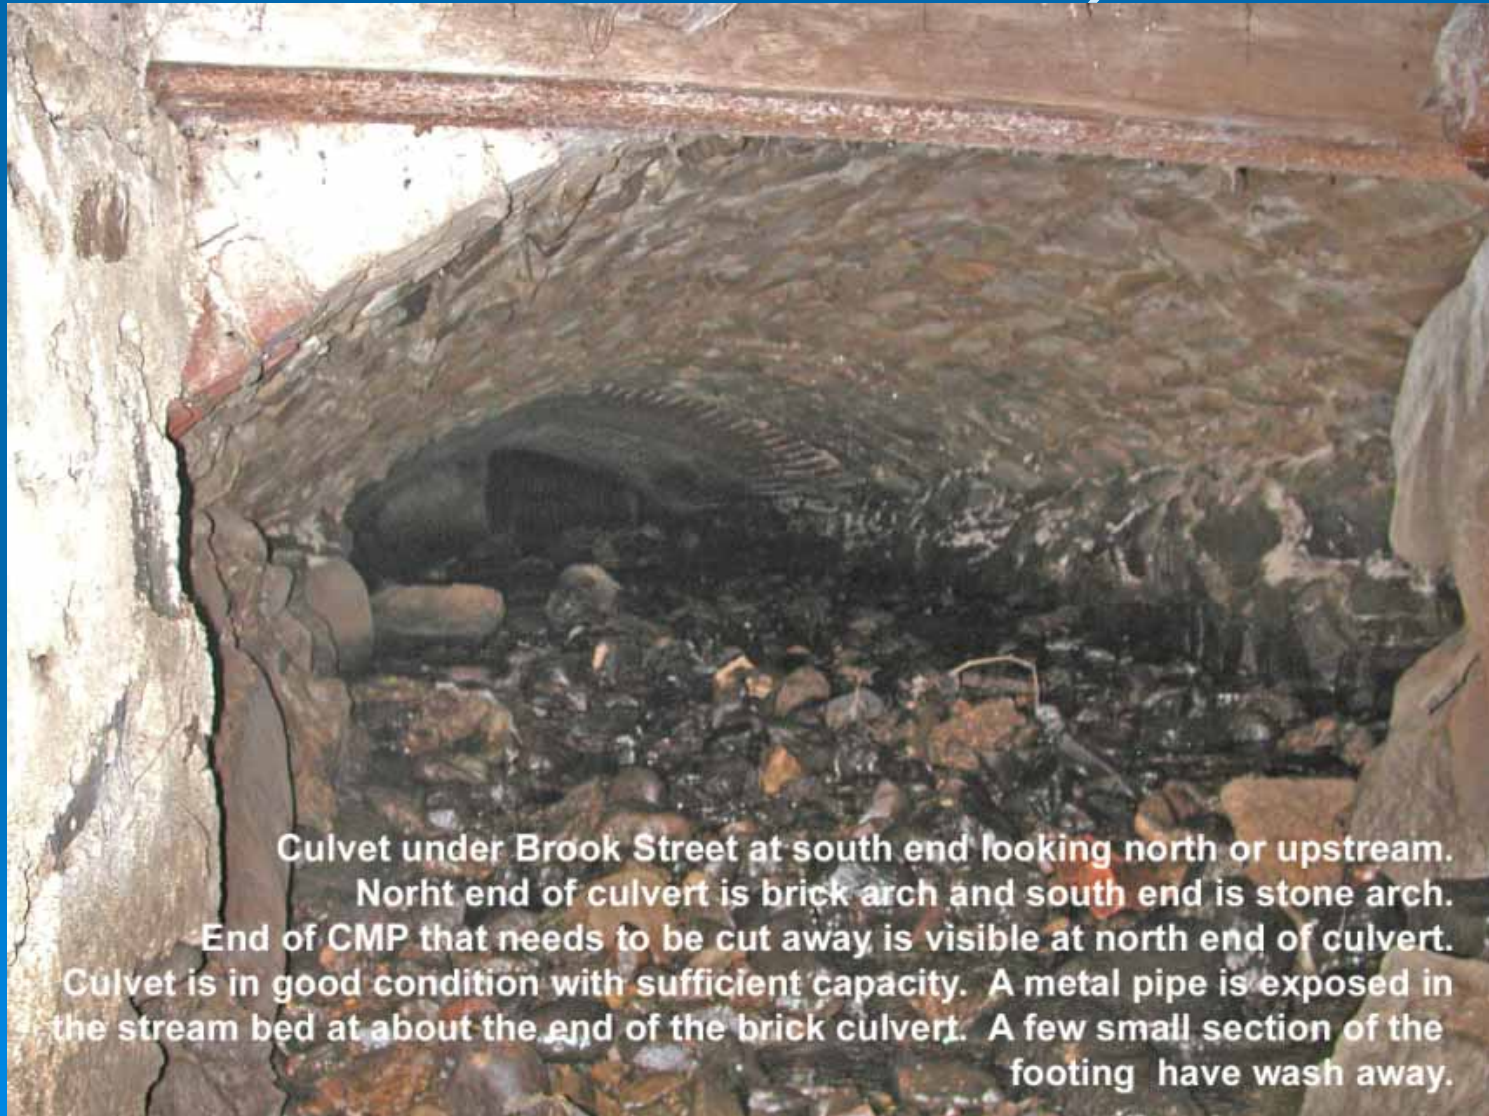
# Culvert under Brook Street (arch: brick and stone)

Culvert under Brook Street at south end looking north or upstream.

North end of culvert is brick arch and south end is stone arch.

End of CMP that needs to be cut away is visible at north end of culvert.

Culvert is in good condition with sufficient capacity. A metal pipe is exposed in the stream bed at about the end of the brick culvert. A few small sections of the footing have washed away.

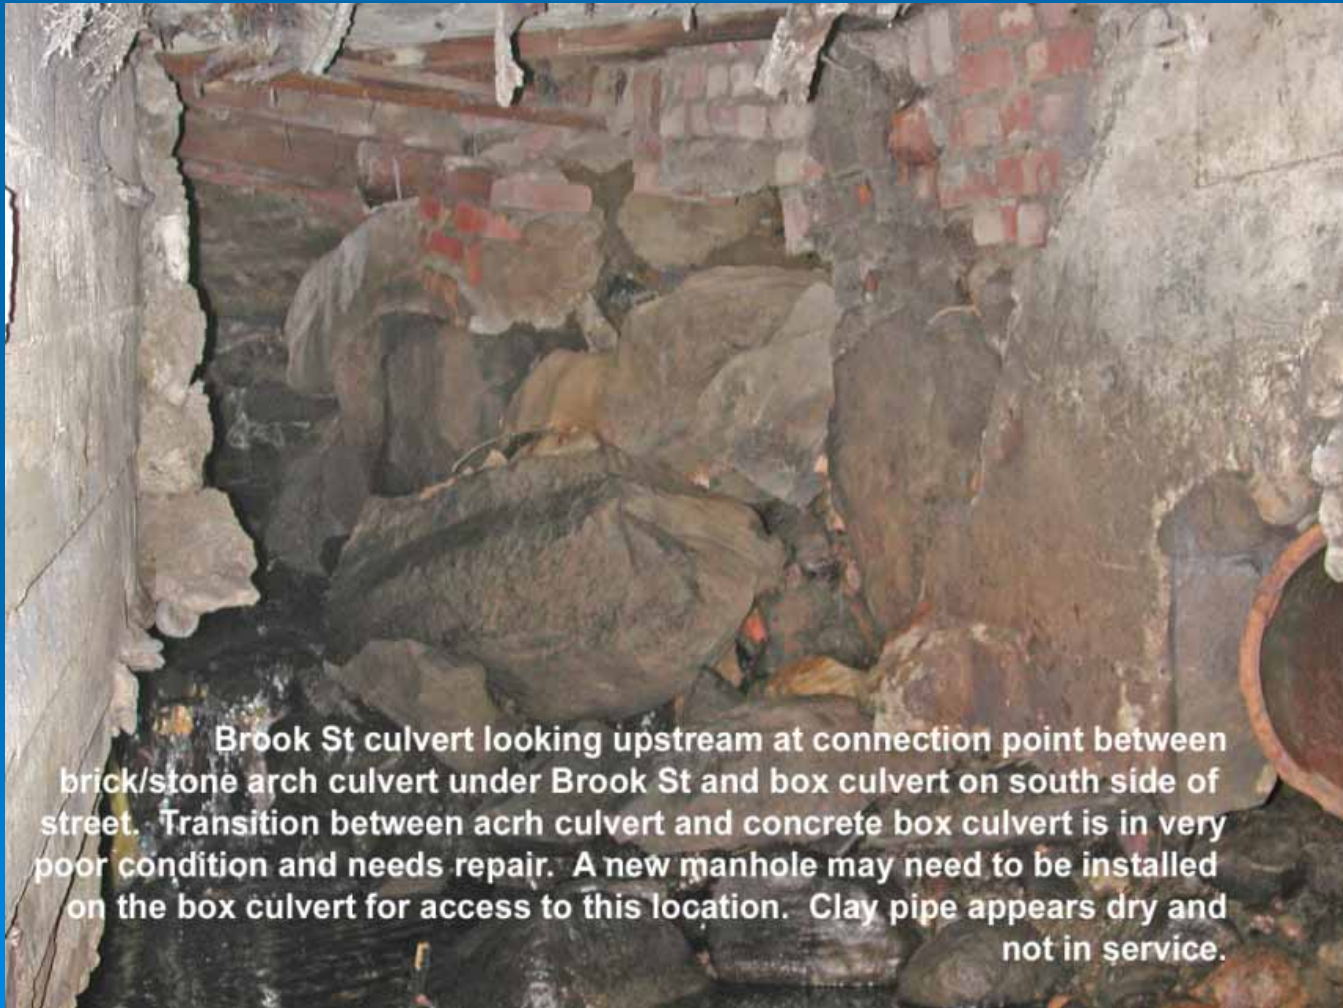
# Culvert under Brook Street connection to box culvert south side of Brook St

Brook St culvert looking upstream at connection point between brick/stone arch culvert under Brook St and box culvert on south side of street. Transition between arch culvert and concrete box culvert is in very poor condition and needs repair. A new manhole may need to be installed on the box culvert for access to this location. Clay pipe appears dry and not in service.

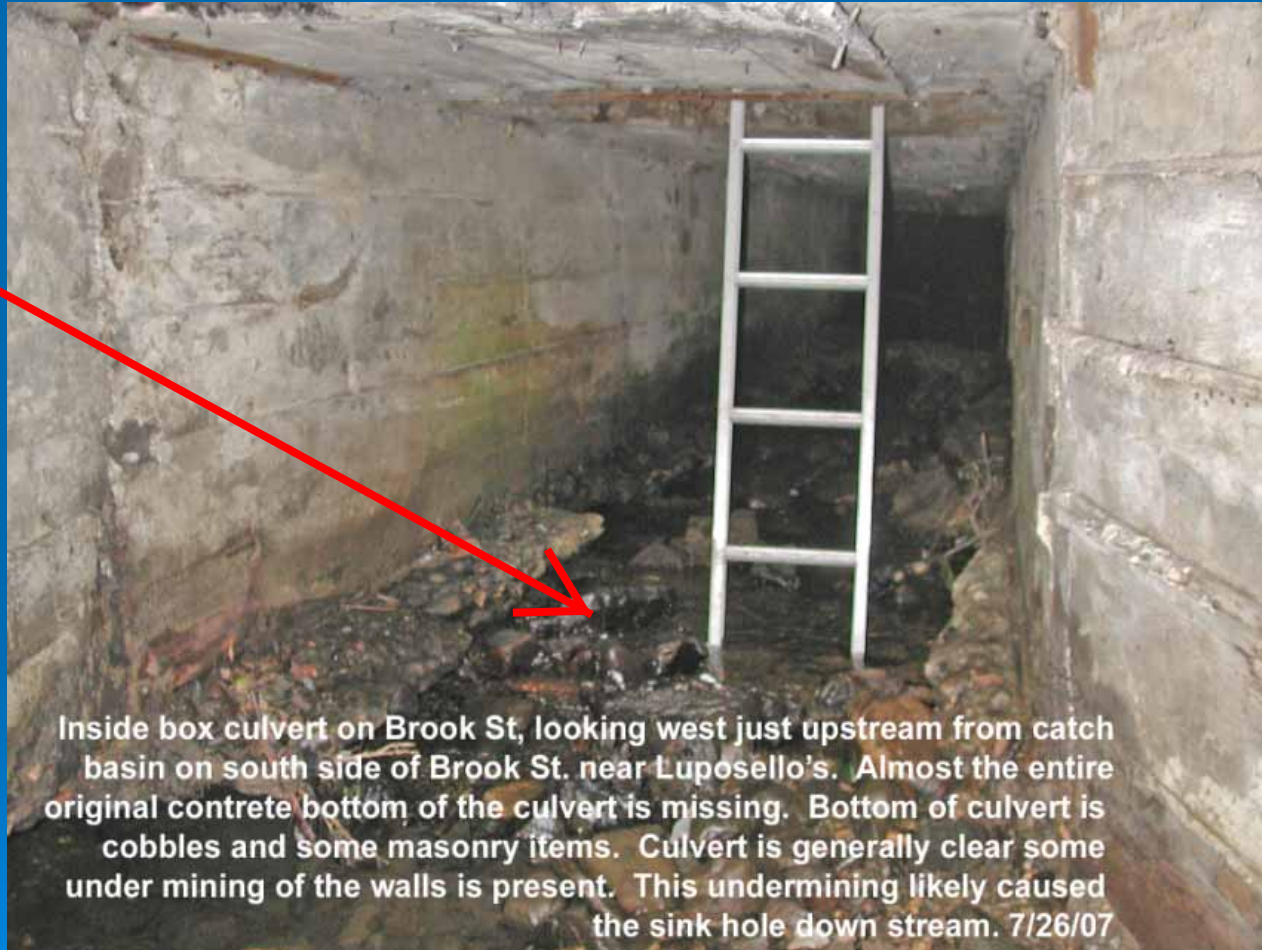
# Start of box culvert on south side of Brook Street

Inside box culvert on Brook St, looking west just upstream from catch basin on south side of Brook St. near Luposello's. Almost the entire original concrete bottom of the culvert is missing. Bottom of culvert is cobbles and some masonry items. Culvert is generally clear some undermining of the walls is present. This undermining likely caused the sink hole down stream. 7/26/07

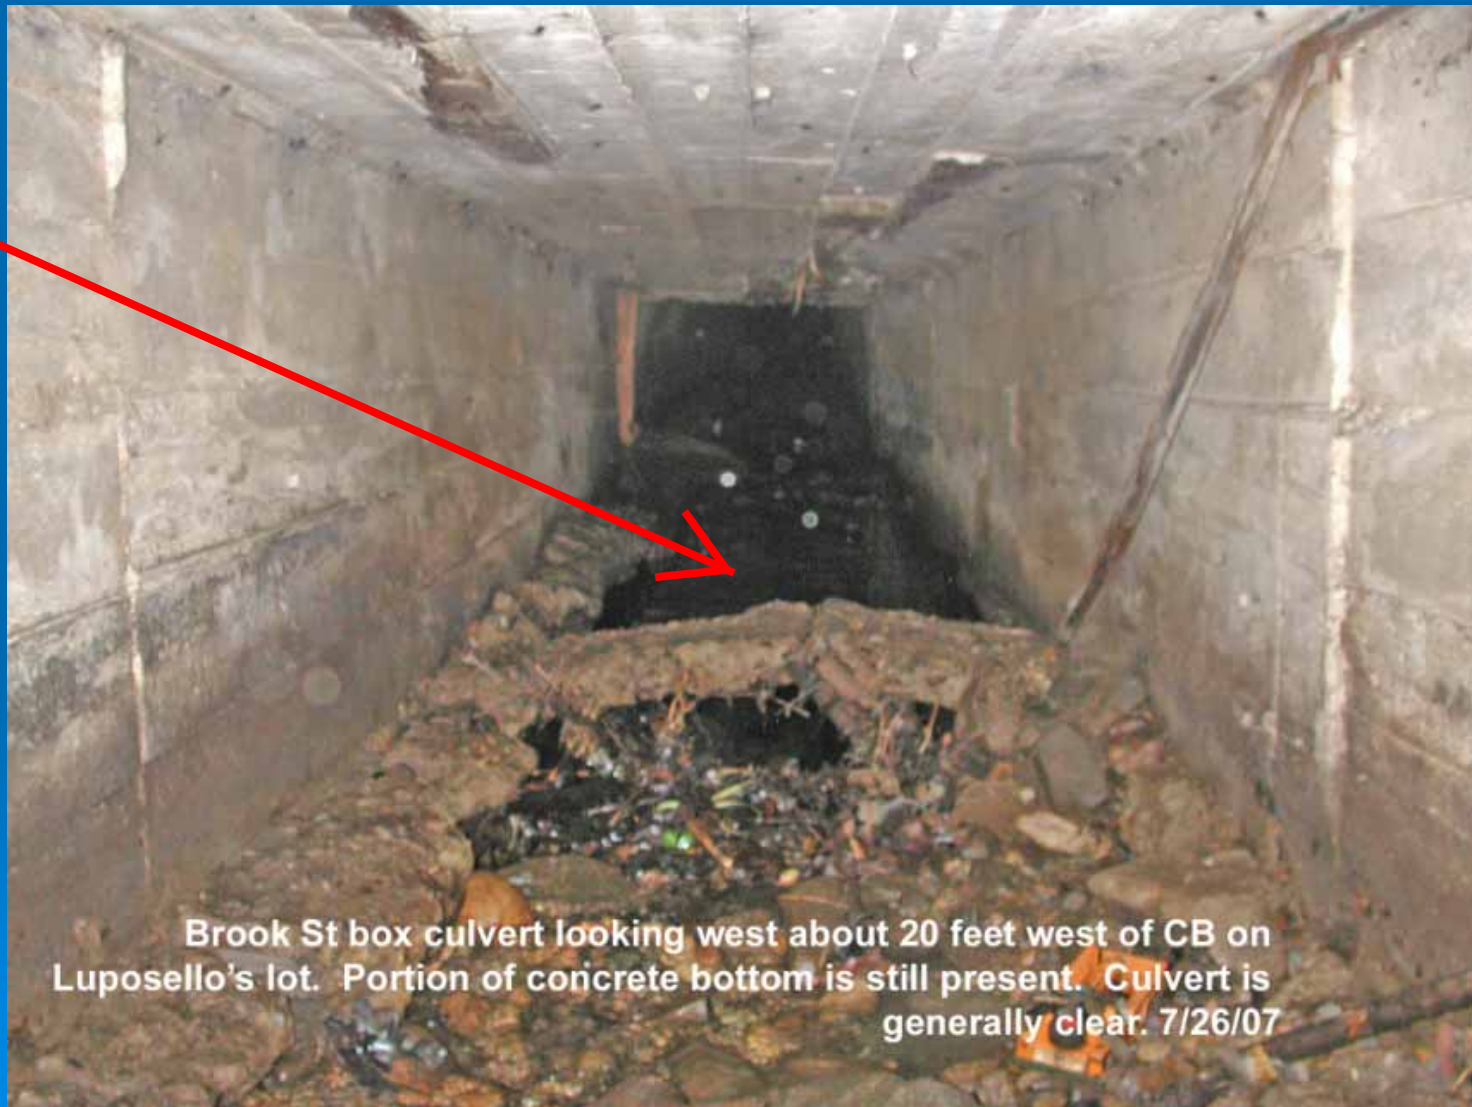
# Box culvert on south side of Brook Street

Brook St box culvert looking west about 20 feet west of CB on Luposello's lot. Portion of concrete bottom is still present. Culvert is generally clear. 7/26/07
