Memorandum

Re: Croton-Harmon Train Station Parking Lot – Shoreline Resiliency and Flood Mitigation

**CROTON-HARMON TRAIN STATION PARKING LOT
SHORELINE RESILIENCY AND FLOOD MITIGATION STUDY**

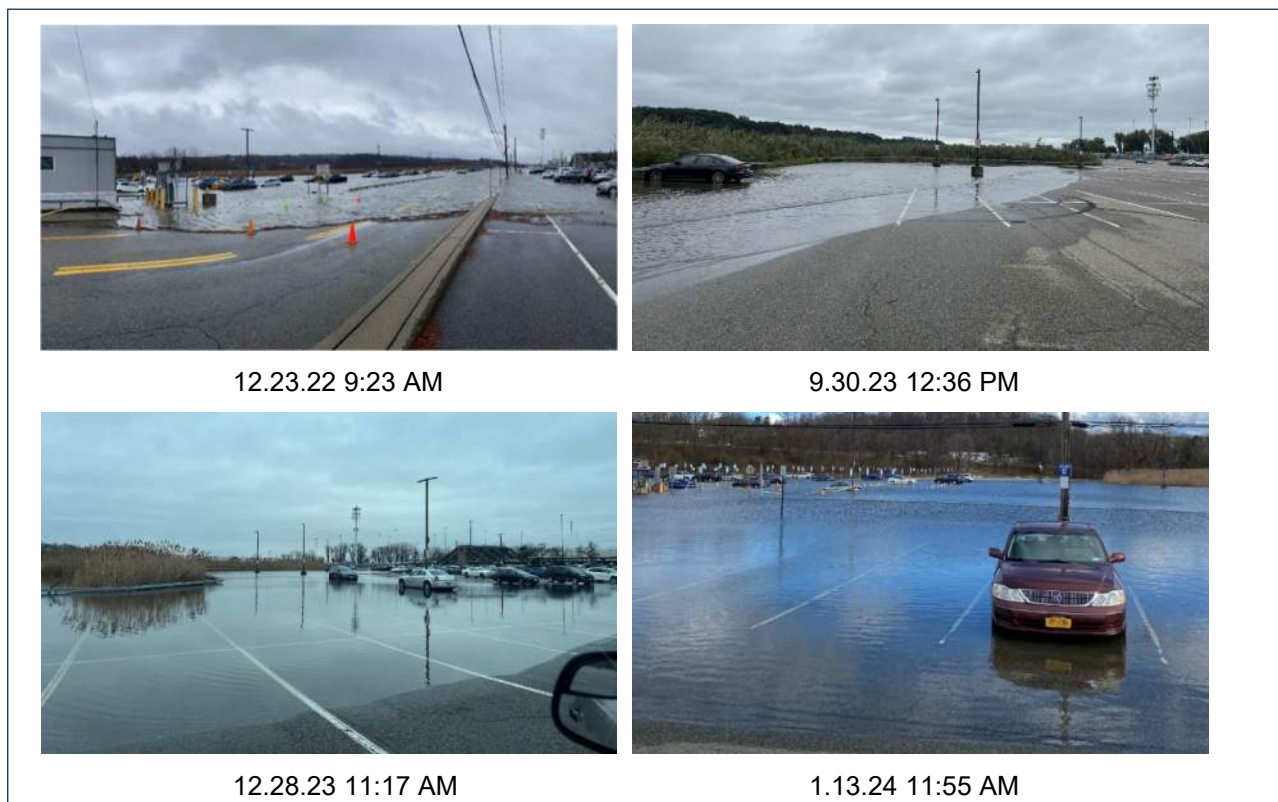
Date	Est. Flood Depth (based on photos)	Hudson Water Level (Piermont Station) – FT NAVD88	Max Flood Time (Piermont Station)	Last Rain Amount (in)	Days from Last Rain Event	Days to/from Full/New Moon
12/23/2022 ¹	24-30"	5.68	9:12	0.84	0	0
9/30/2023 ¹	6"	4.01	10:42	1.77	1	1
12/28/2023 ¹	6-10"	4.10	11:00	1.80	0	2
1/13/2024 ¹	30-40"	5.58	11:42	2.38	3	2
9/20/2024 ²	4-8"	3.73	11:30	0.35	11	3

1) Photos from these events were provided by the Village and included in Figure 1.

Figure 1. Photos taken during historical flooding events.

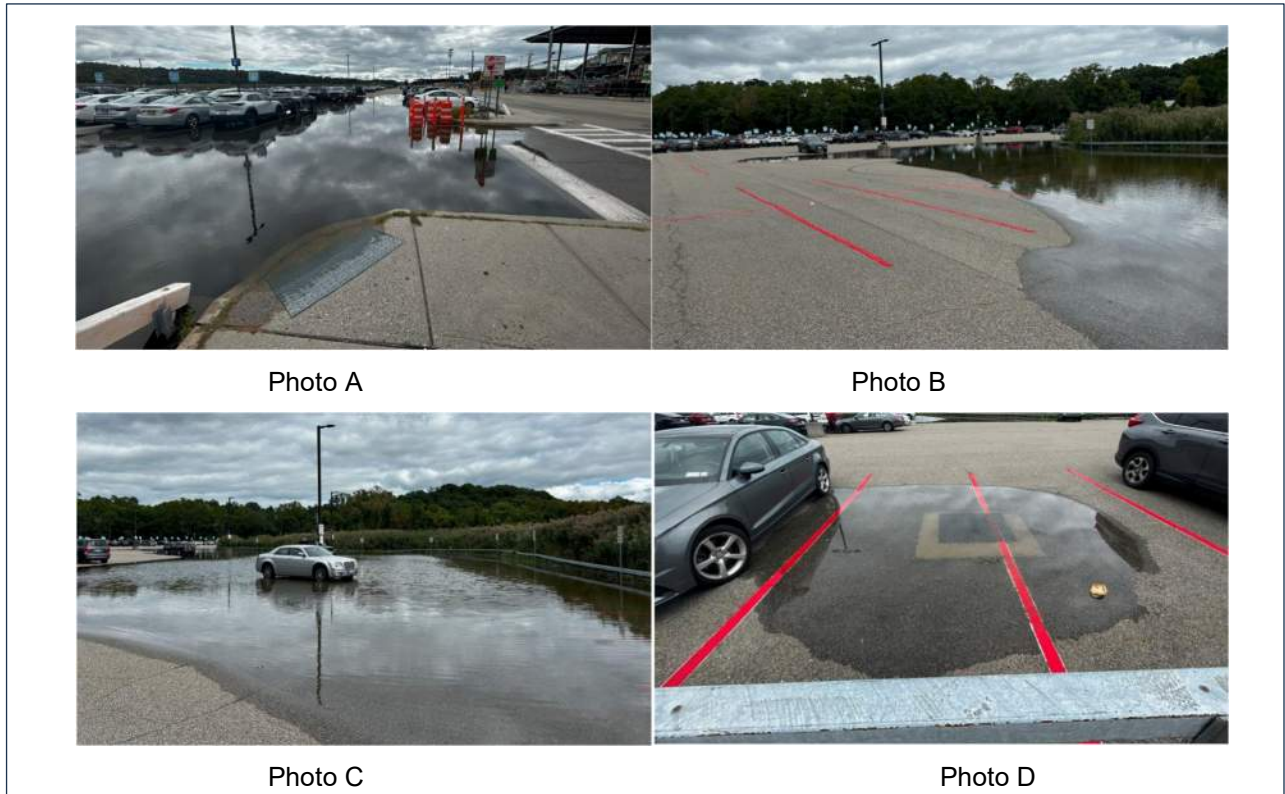
AKRF performed a site visit on 9/20/2024. The peak high tide was observed around 12:30 pm which coincides with the photo time stamps. Only 4-8 inches of flooding was observed. This flooding is described as “nuisance flooding” and would not cause damage to personal property and vehicles. Based on observations, the water entered the site from the marsh on the eastern side of the parking lot. It was observed that water entered the parking lot through the existing drainage system as seen in Photo D, in

Figure 2. The original site plans for the 2009 upgrade included duck bill tide gates; however, based on discussions with the Village, it was understood that these tide gates were not installed. The missing tide gates allow tidal water to back up through the storm sewer system causing the surcharging inlets as observed. The amount of flooding during this event was higher than expected based on site elevations, and AKRF calculated that settling had occurred which is described in the next section.

Figure 2. Photos taken during site visit on 9/20/2024 by AKRF.

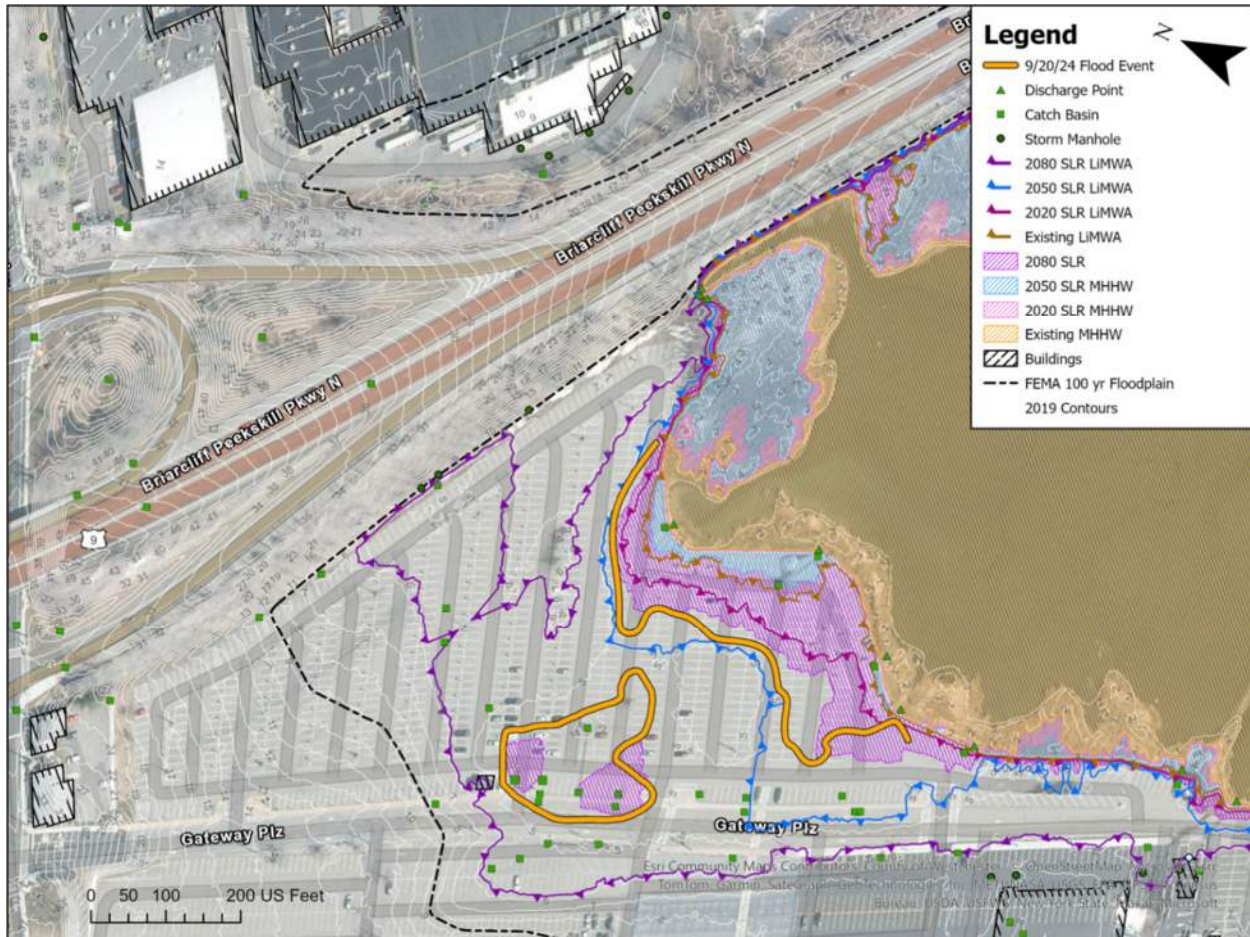
To determine the impact of projected sea level rise on flooding of the parking lot, AKRF applied sea level rise adjustment factors from the New York City Panel on Climate Change to the LiMWA and MHHW elevations. Table 2 shows the elevations and impacts to the site on parking and structures for MHHW and LiMWA for existing, projected 2020, 2050, and 2080 Sea Level Rise (SLR) conditions. Figure 3 graphically shows these existing and projected elevations on the site map with present day elevations (no further settlement). The observed flooding event on 9/20/24 and historical flood elevations were all above the existing MHHW and MHHW with SLR. The LiMWA elevations consider wave action due to storms. AKRF utilized the historical flood information with the predicted amount of parking spaces lost, and discussions with the Village to set the DFE at the projected 2080 LiMWA elevation of 5.9 ft (NAVD88).

Figure 3: MHHW and LiMWA for existing conditions and 2020, 2050, & 2080 SLR
