Town Landing Resiliency Study

Falmouth, Maine

GEI Consultants, Inc.
5 Milk Street
Portland, ME 04101
207-347-2370

July 14 2023
Project 2200496

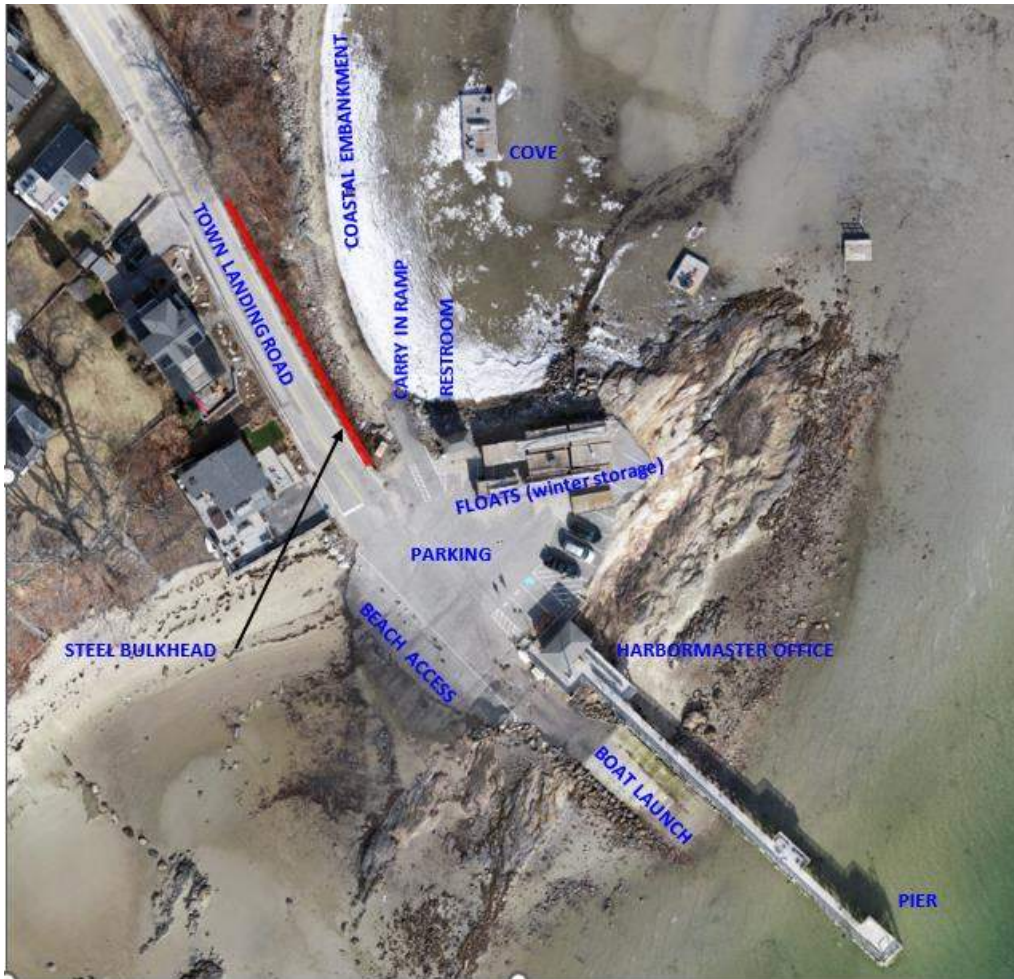
Fig. 2. Falmouth Town Landing Facilities- GEI Drone Photo Composite (2022)

The existing site is located in Falmouth Foreside and is accessed from Town Landing Road which extends from Route 88 to Casco Bay. The site is depicted in Figure 2 below. The site was developed on a natural ledge outcrop which has served as a public access point to Casco Bay for over 100 years. Features currently located at the site include a pile-supported timber pier with seasonal floating docks and gangways, a Harbormaster’s office, a year-round boat launch, parking, a seasonal restroom, a small carry-in ramp, a beach access area, and a coastal embankment that follows the east side of Town Landing Road.

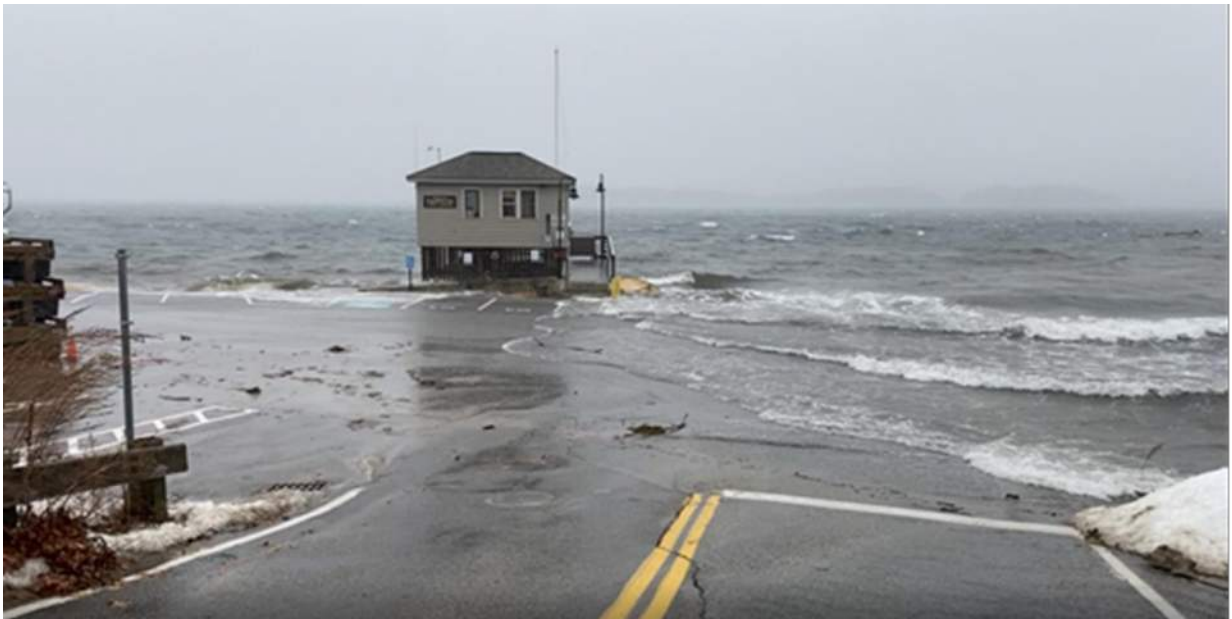
Fig. 9. Falmouth Town Landing Pier 12.23.2022

The figure below provides an image of the conditions at the Falmouth Town Landing within an hour of the 23 December 23, 2022 storm peak. The image shows that the water overtopped the parking lot and reached the elevation of the pier.

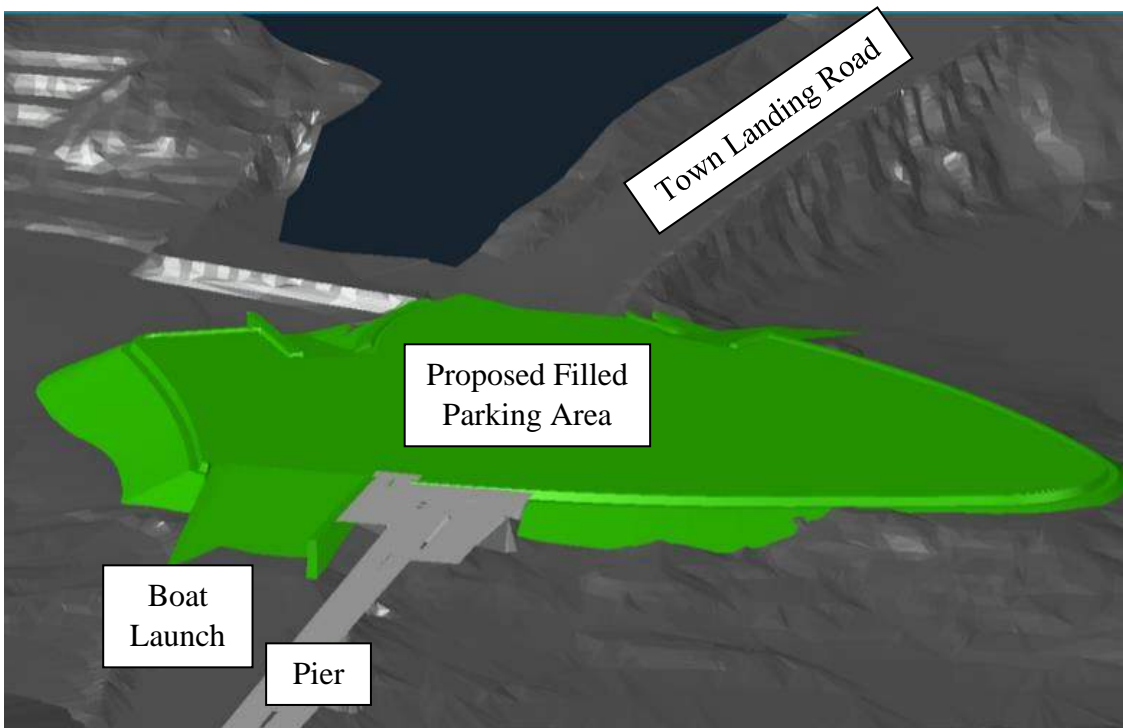
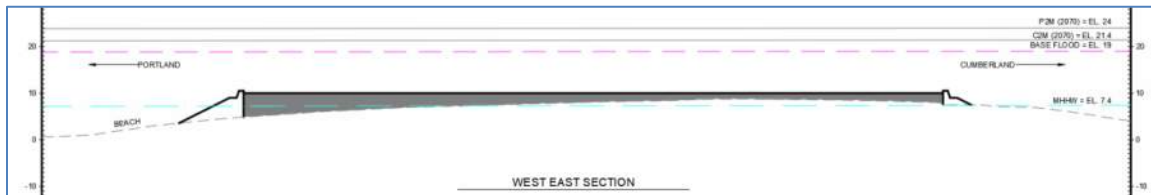
Fig. 10. Isometric and Section of Raised Parking Area

Elevate the site area to secure operational parking and circulation until at least 2100. Refer to the Figures below that contain and elevate the site within a perimeter seawall.

- Refer to the previous section on flood inundation. An elevation of 10.0 ft NAVD88 will interface with the driveway elevation of the abutting property and accommodates waterfront access with no change in parking capacity.
- A seawall has been selected directly fastened to the ledge below.
- The site grade is raised from 1 to 3-ft and accommodates ramp and beach access.
- It would be possible to increase site resilience by raising the seawall above the parking grade, but the design will need to consider the number of openings to accommodate ramps and beach access.

Recommendation- This minimizes impact to abutting properties with the installation of new resiliency measures. Increase elevation of site area by filling interior and installing a perimeter seawall that will be anchored to the existing ledge so that it can resist the overtopping and wave action associated with significant storm events.
