Via Coconut Road

Village of Estero

Landscape Site Analysis

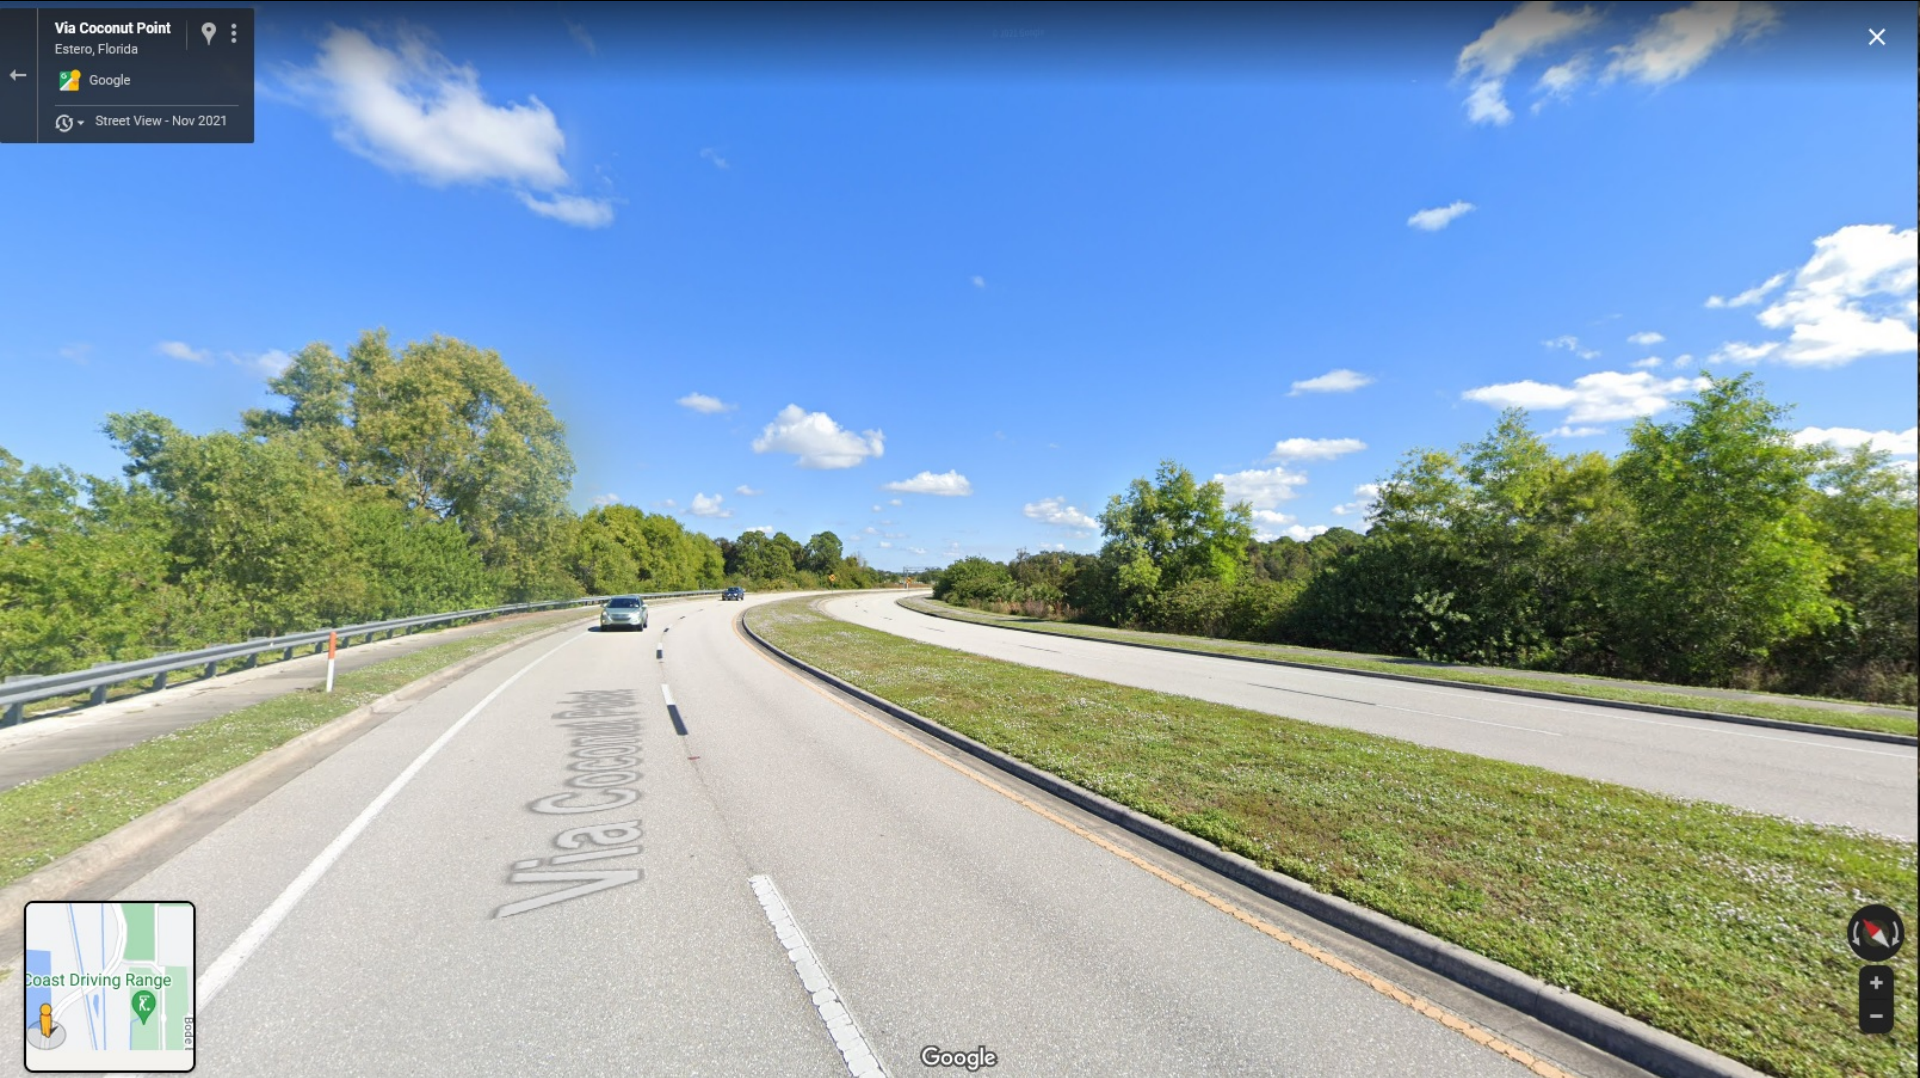
Typical – 600 ft north of Williams Rd, facing North

The sidewalk is at a uniform distance from back/ curb, creating a very sterile look. Guardrails occur at numerous locations.

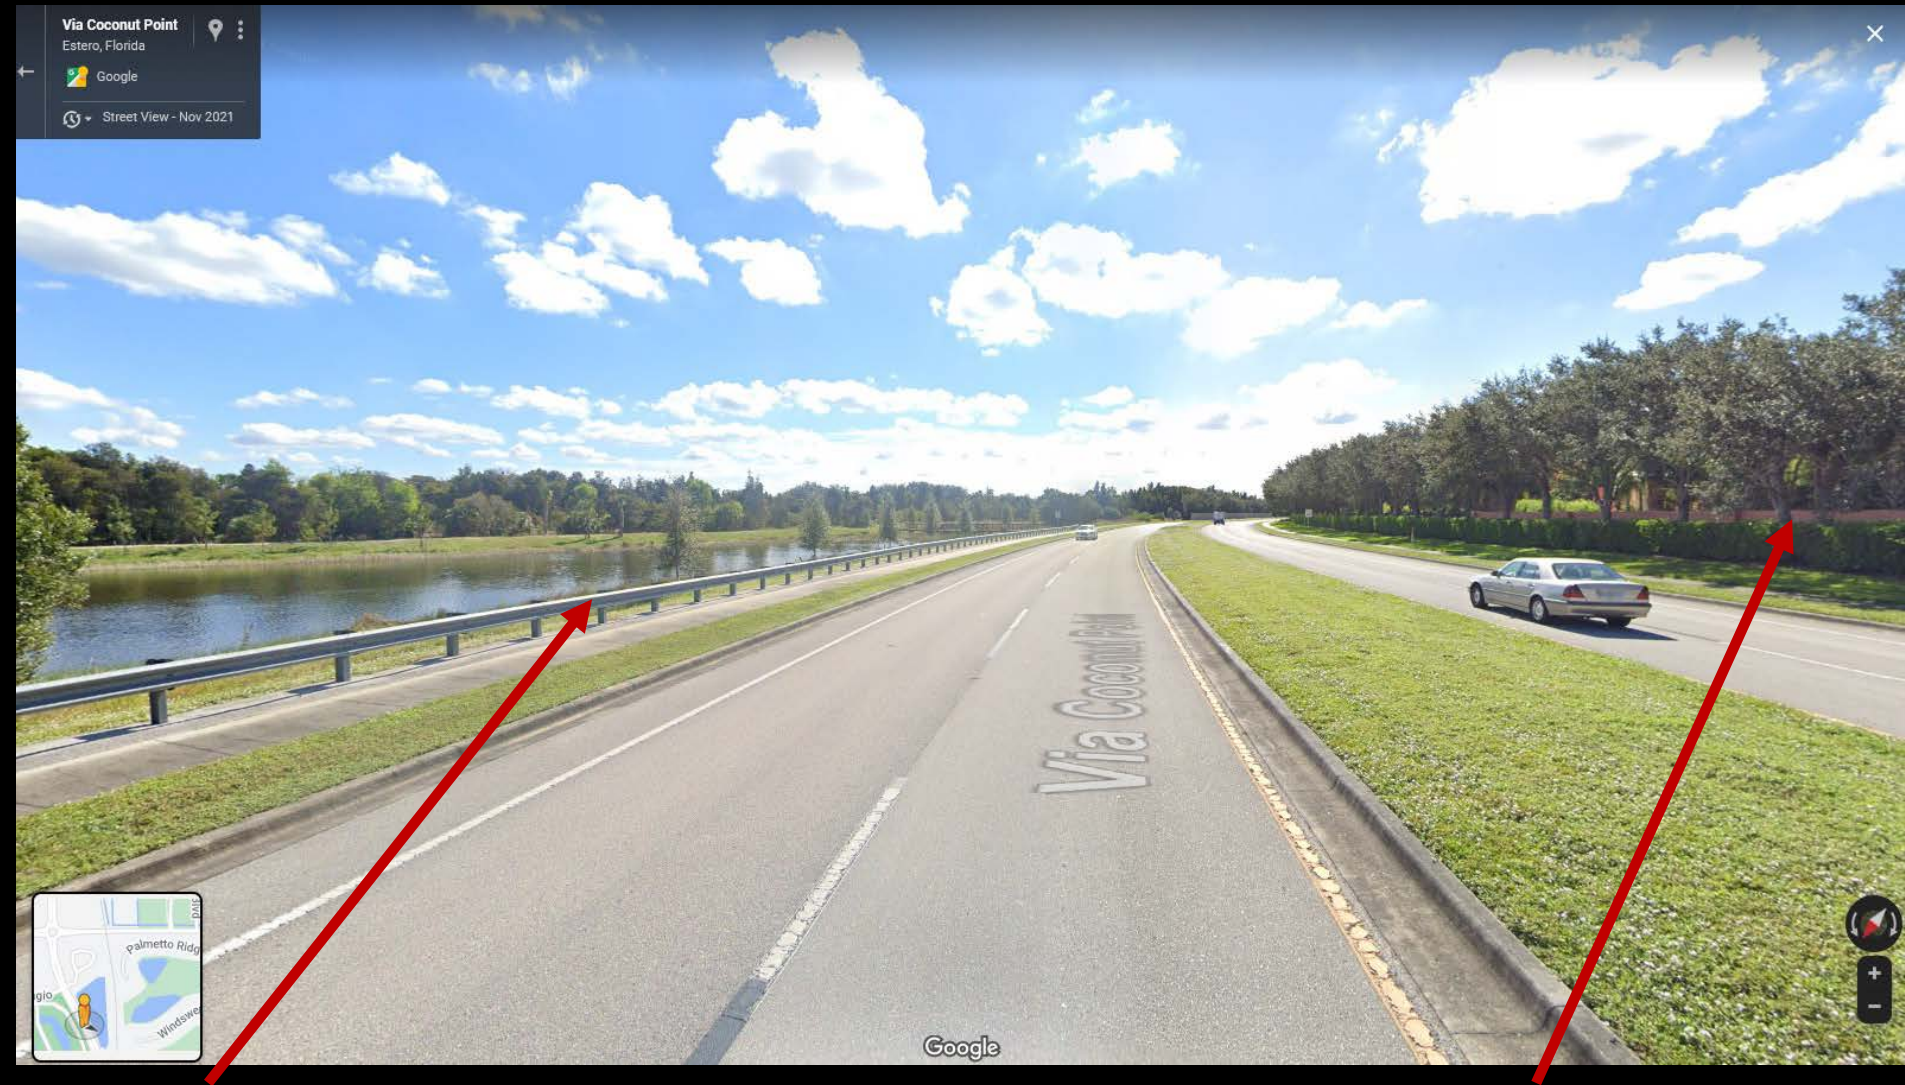
Typical - 1 000 ft south of Williams Rd, facing South

Guardrail along pond

Perimeter wall and buffer landscaping along Rapallo

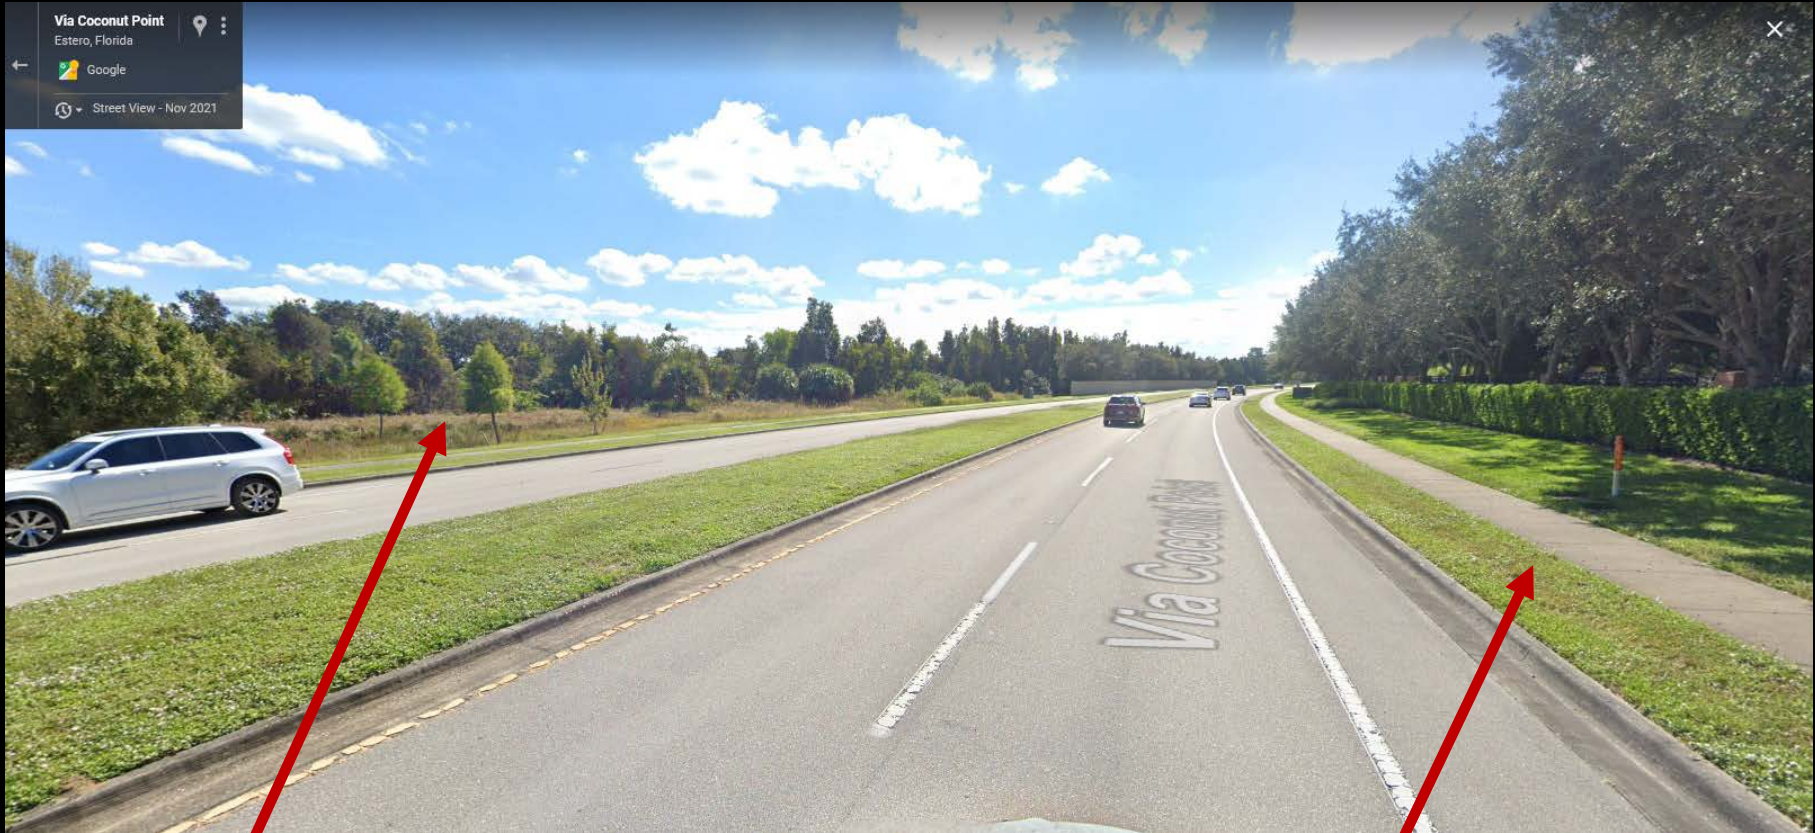
Typical – 1,550 ft south of Williams Rd, facing South

Pond and wetland along Rd

**Uniform spacing of sidewalk from
back of curb**

**Work with property owner
to enhance landscaping
and views**

**Work with Property Owner to obtain
an easement to meander sidewalk
and add varied landscaping.**

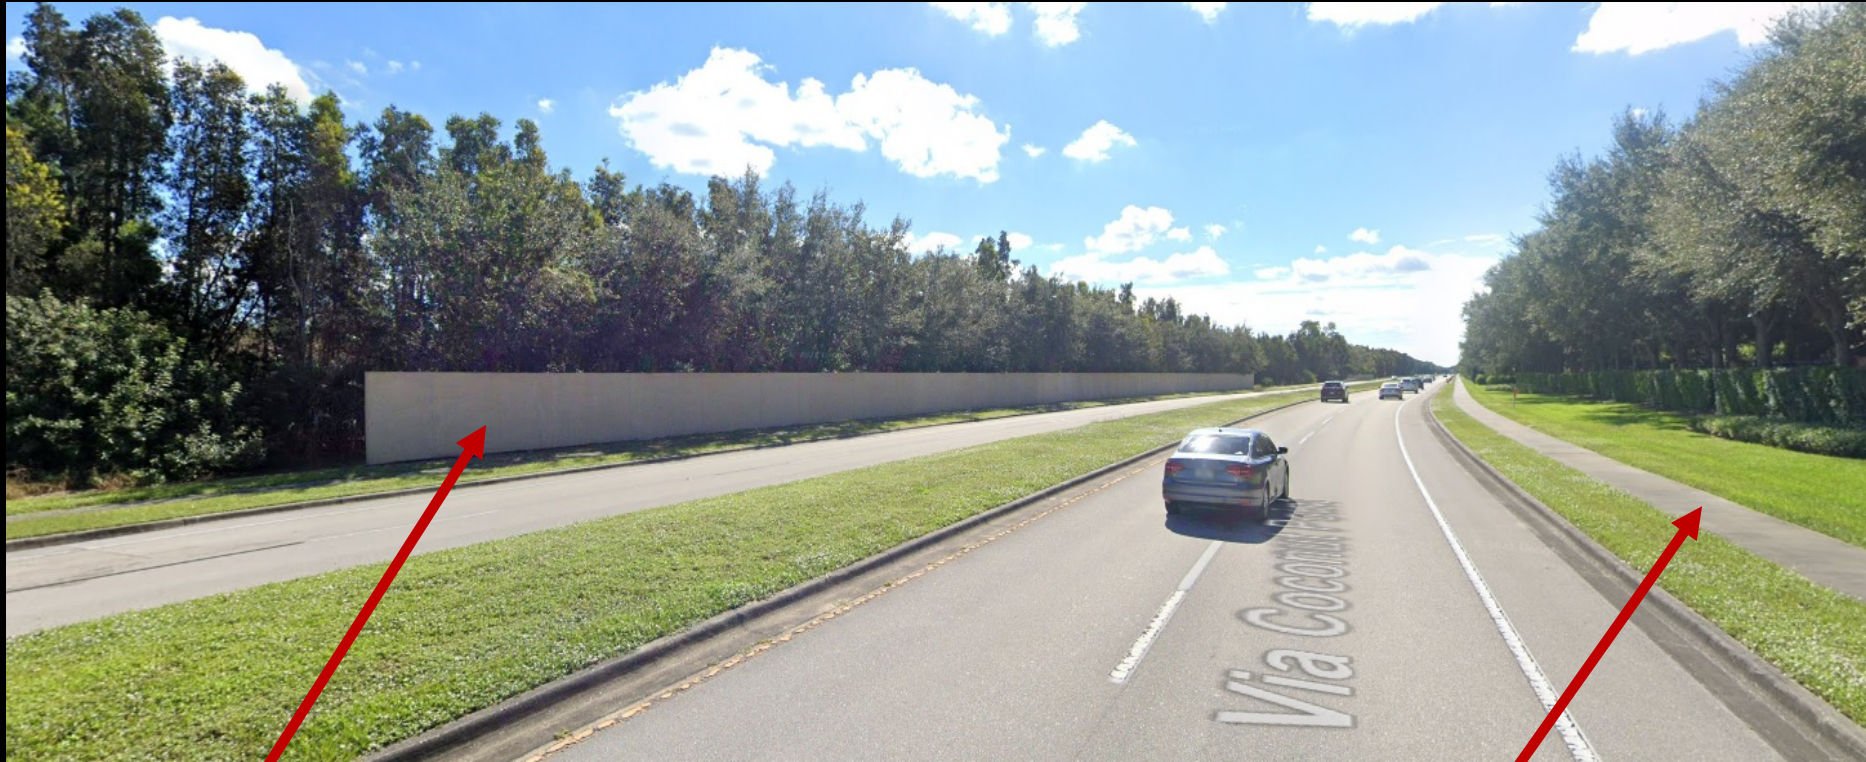
Typical – 2,000 ft south of Williams Rd, facing South
Between Brooks and Rapallo

Existing wall to buffer adjacent homes, may no longer be needed with mature landscaping

Uniform spacing of sidewalk from back of curb

Work with development to remove

Work with Property Owner to obtain an easement to meander sidewalk and add varied landscaping.

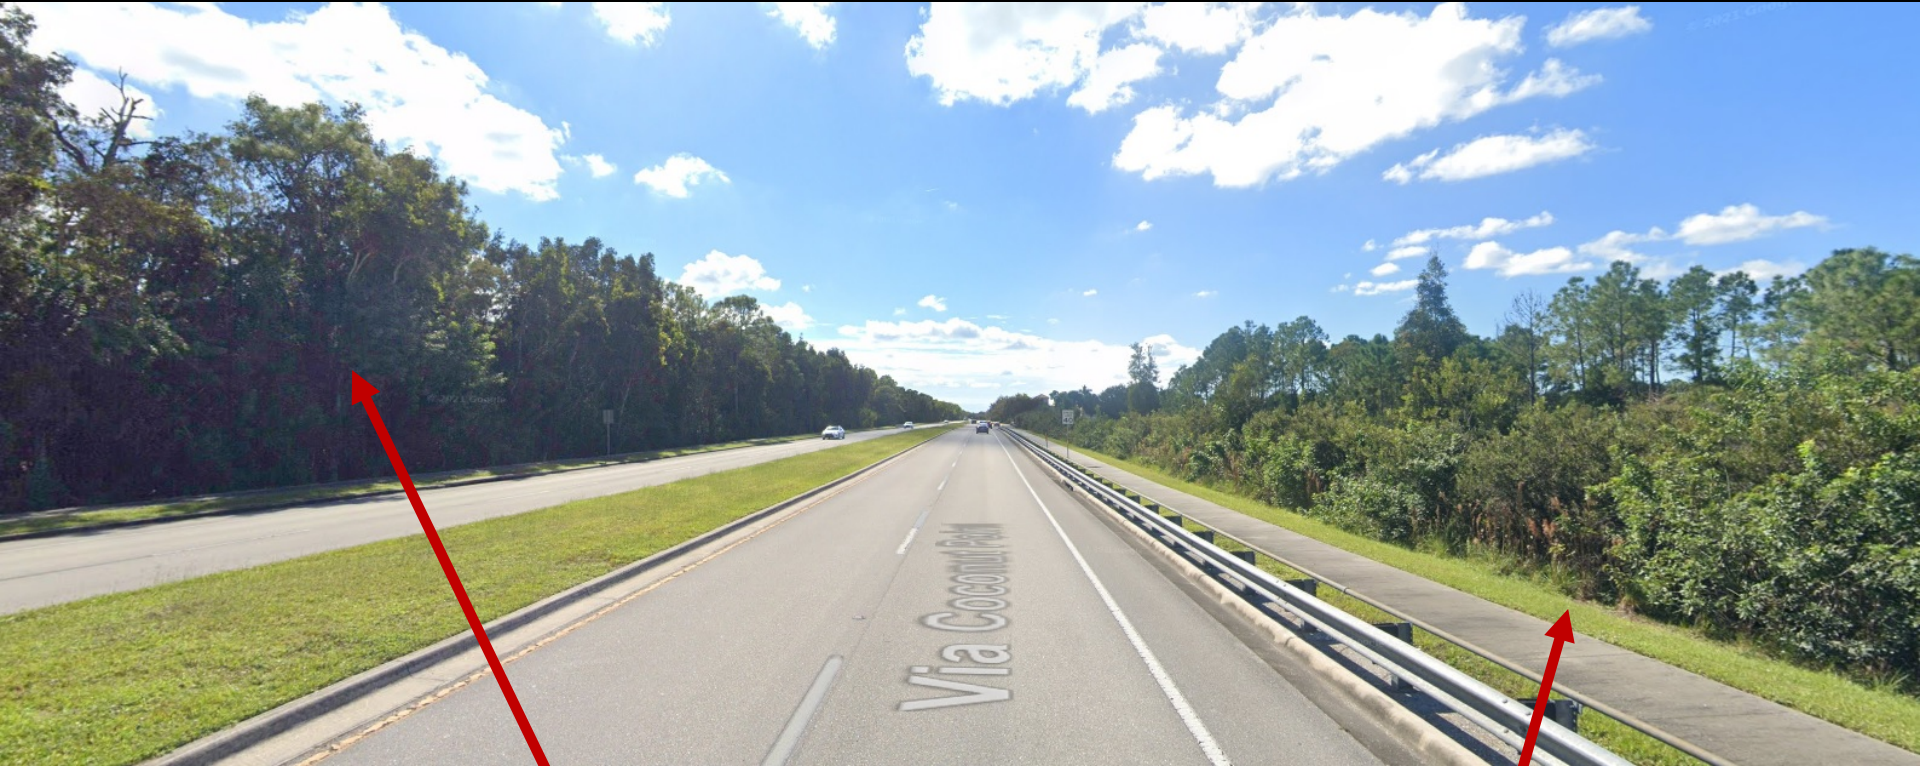
Typical – 3,200 ft south of Williams Rd, facing south

Exotic vegetation along east side of road

Grade difference prevents meandering sidewalk

Existing guard rail, canal and trees prevent meandering sidewalk

Work with property owners to remove exotic vegetation

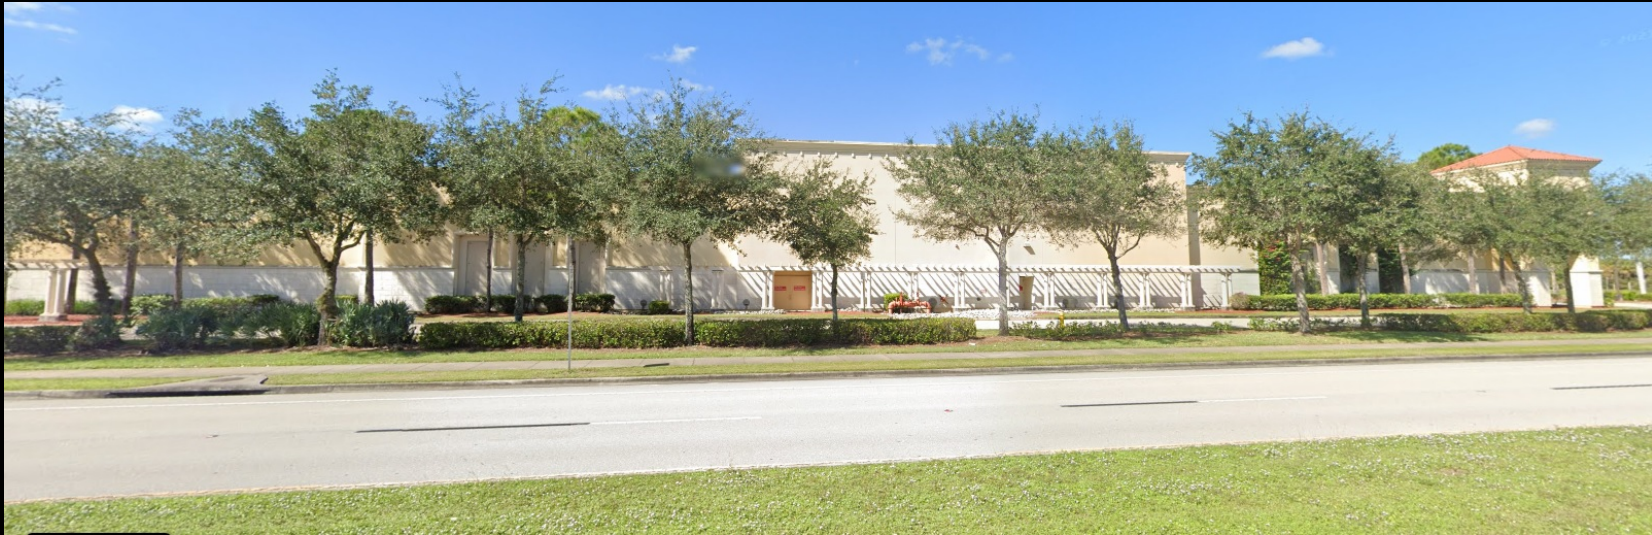
Coconut Point Mall has limited buffering and no wall – work to better buffer service areas and parking lot.

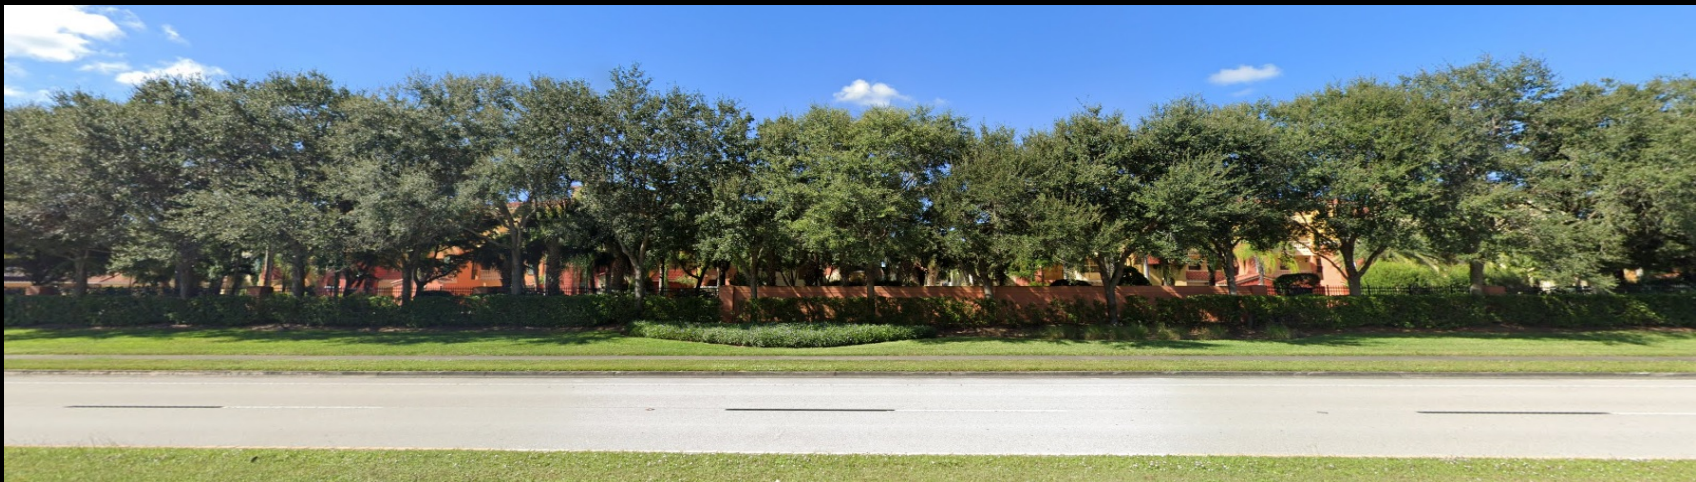
Residential developments have attractive landscaping and wall – only need minimal landscape enhancements.

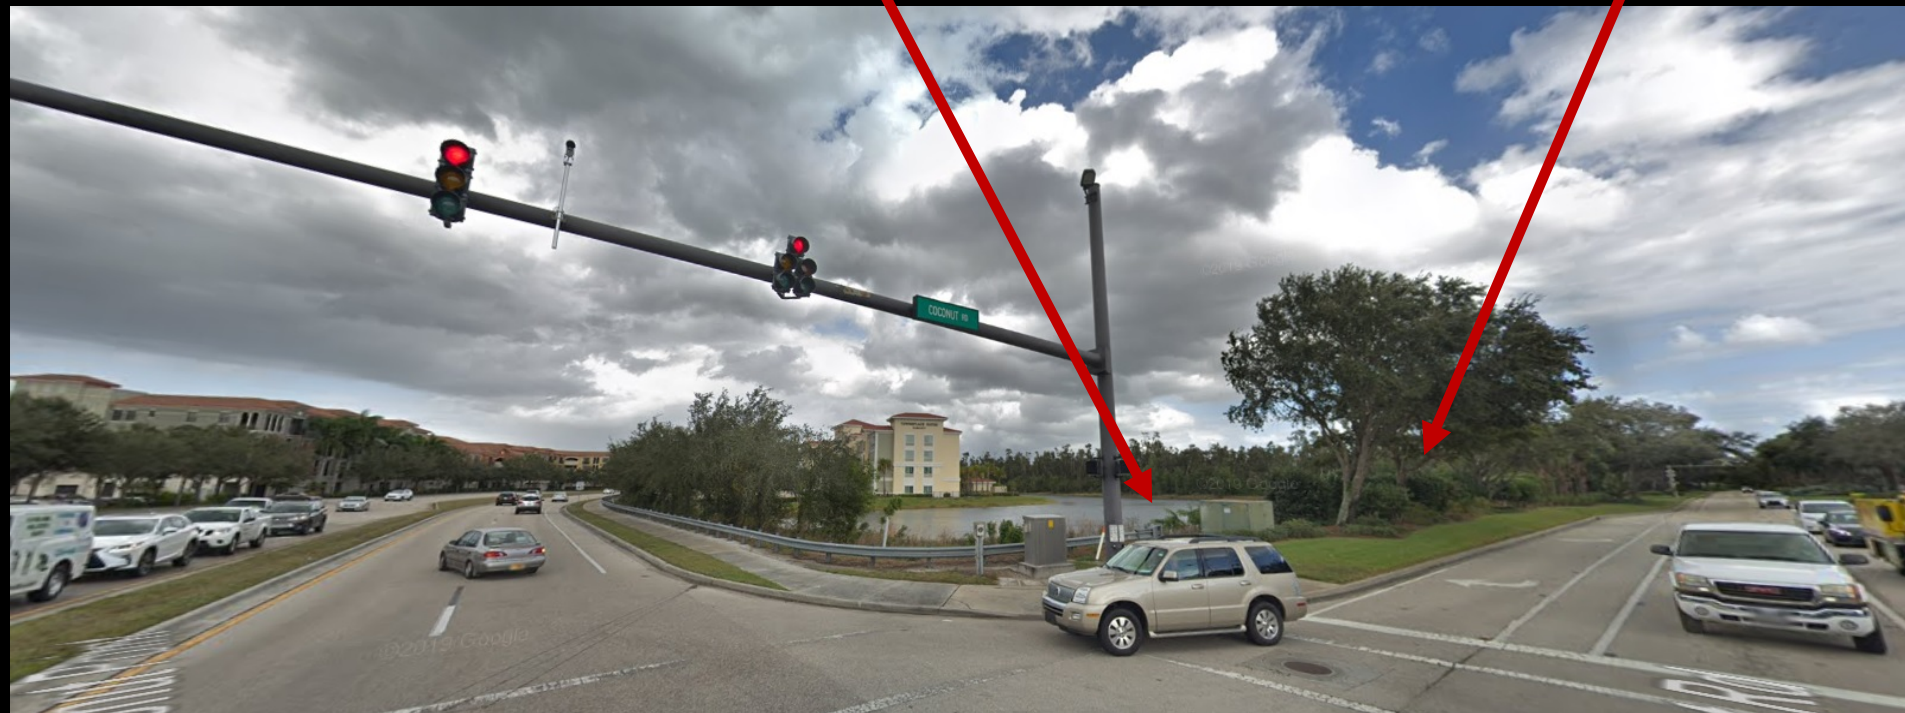
Typical – South of Coconut Road

Residential buffer and hedge.

Narrow median limited planning opportunity

Uniform spacing of sidewalk from back of curb

Compliment with low plantings to improve pedestrian experience

Work with Property Owner to obtain an easement to meander sidewalk and add varied landscaping.

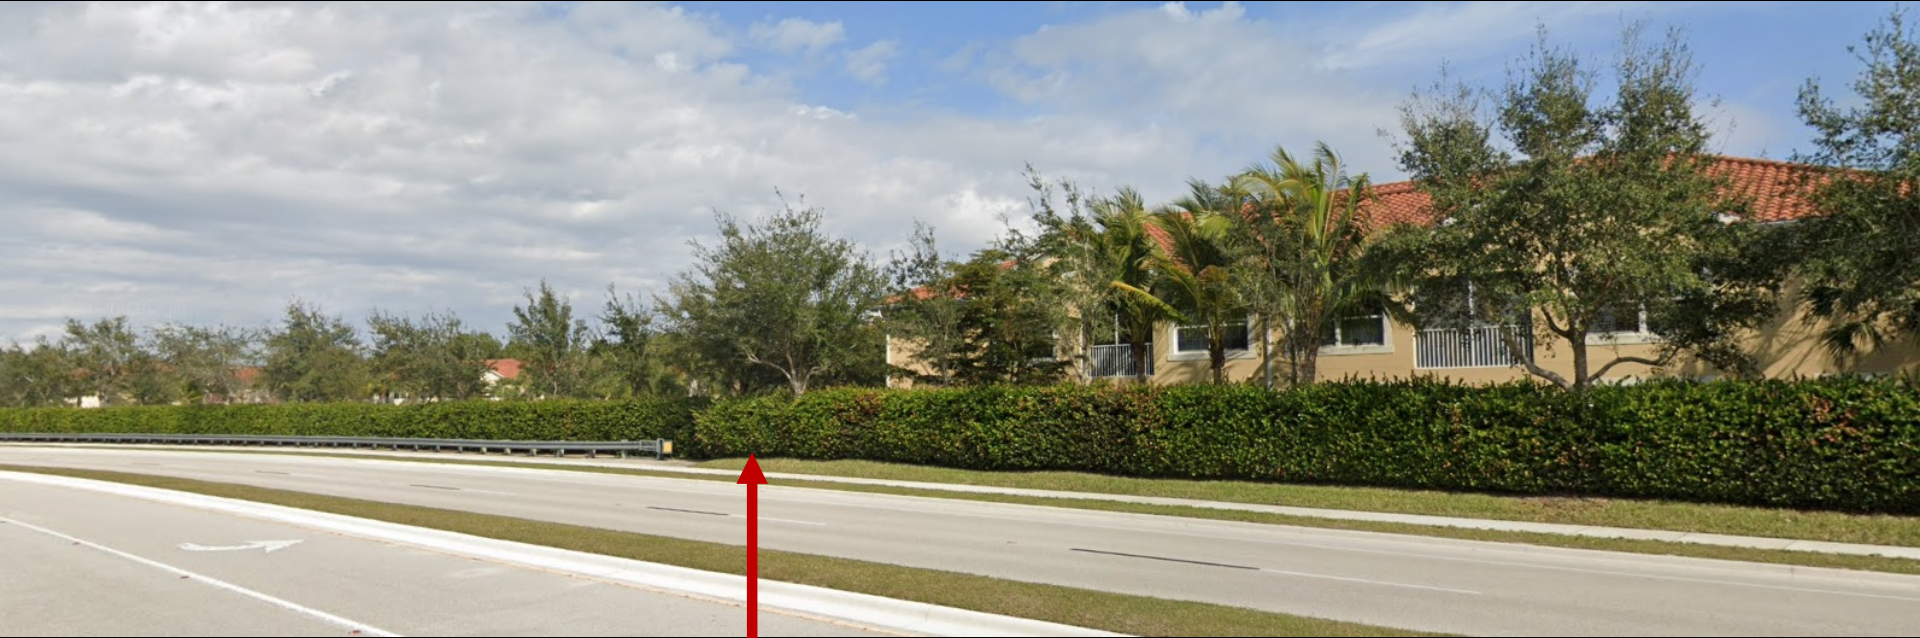
Existing guardrail and buffer limit ability to meander sidewalk

Add shrubs and ground covers to enhance pedestrian experience

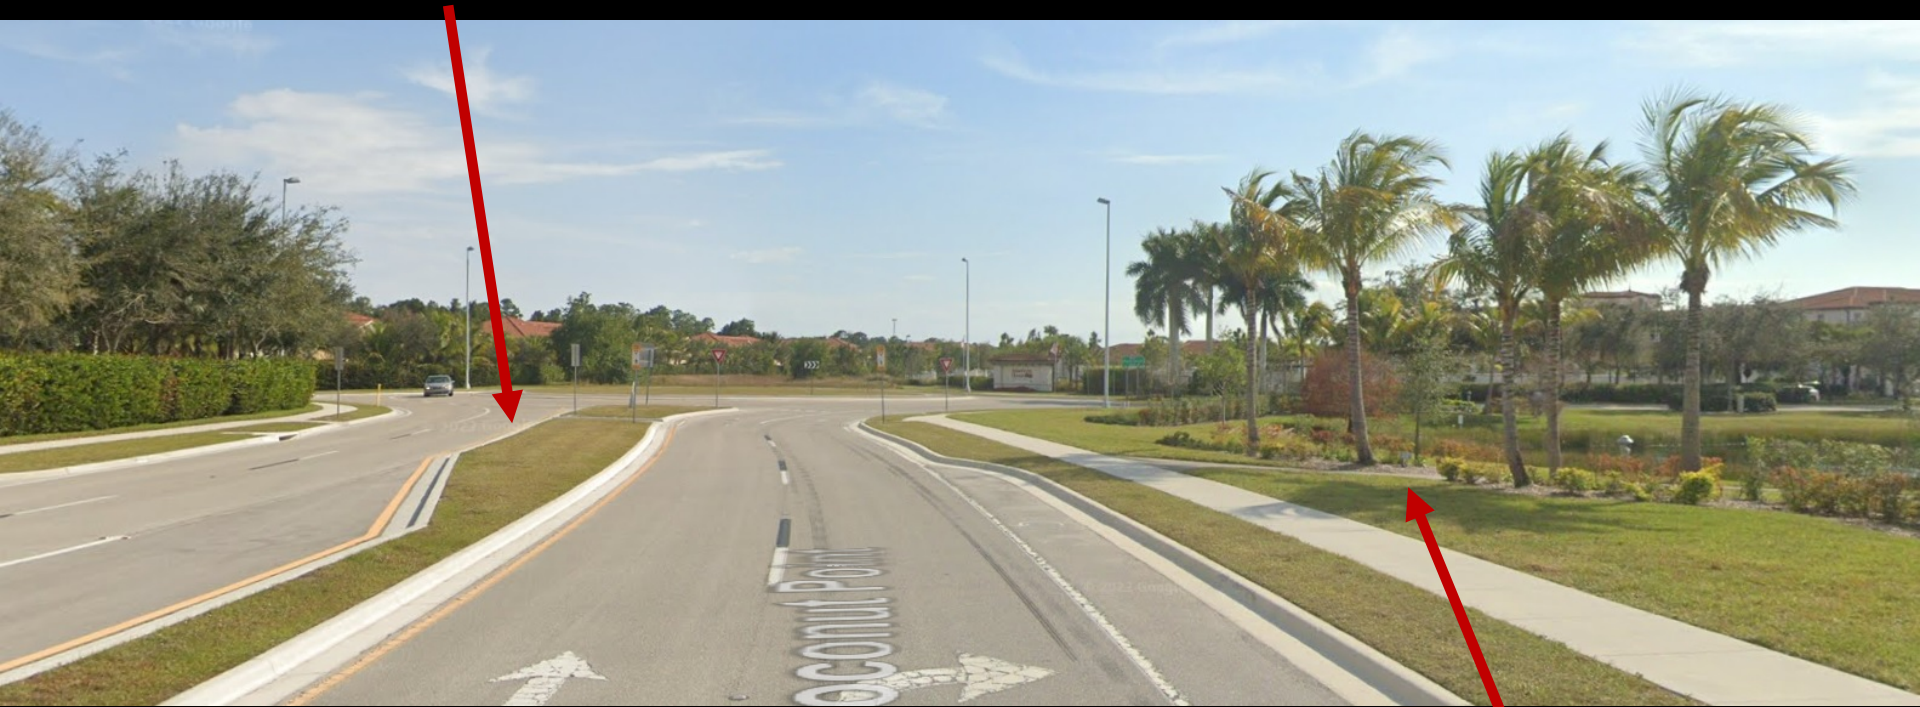
Typical – North of Pelican Colony Blvd, facing south

Narrow median with utilities

Uniform spacing of sidewalk from back of curb

Add trees where possible, could be limited to shrubs and groundcover

Work with Property Owner to obtain an easement to meander sidewalk and add varied landscaping.
