**CITY OF BELLE MEADE  
BOARD OF BUILDING CODES APPEALS  
REGULAR MEETING AGENDA PACKET  
JUNE 9, 2026, 04:00 PM**

**AGENDA BOARD OF BUILDING CODES APPEALS  
REGULAR MEETING  
JUNE 9, 2026, 04:00 PM  
BELLE MEADE CITY HALL, 4705 HARDING PIKE**

Re: Risk assessment of walnut tree near club house

TRAQ Report

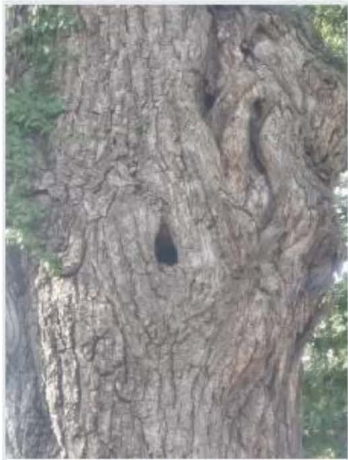
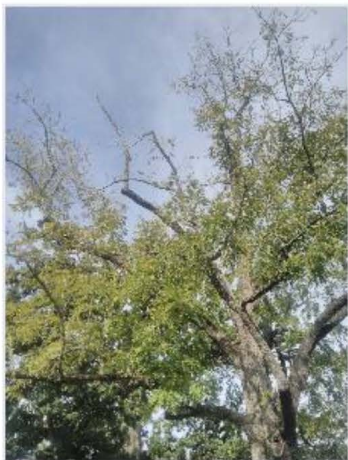
17613182429875570798335389623846.jpg  
10/24/2025

| <b>Black walnut Tree ID #5383</b><br>815 Belle Meade Boulevard | |
|---|---|
| Condition: | Poor |
| Health Issues: | Fungal infection, decay, low vigor |
| Crown/Branch Issues: | Large Deadwood (>10in), Broken/Hangers, Weak Attachments, Cavities/Decay, Visible Cracks |
| Likelihood of Failure - Branches: | Imminent |

| Trunk Issues: | Cavities/Decay - Minor, Cavities/Decay - Moderate, Cavities/Decay - Extensive, Heartwood Decay Suspected |
| Main Issue - Trunk: | Cavities/Decay - Extensive |
| Likelihood of Failure - Trunk: | Probable |

Trees are given a risk rating on a scale ranging between low, moderate, high, and extreme using the TRAQ criteria. My inspection of the roots did not uncover any reasons for concern. However, it is my professional opinion that the crown and branches of the tree pose a high risk of impact. The largest factor in this being the large deadwood in the crown could fall even under fair weather conditions, possibly without warning. The trunk and major leads also pose a high risk of failure and impact; the extensive decay makes it probable that a major failure could occur during normal weather. In both of these cases, the likelihood of impact from the tree failing is high. The consequences of large deadwood falling would be significant, and the consequences of impact from the trunk or a major lead would be severe. Therefore, in my professional opinion, there is a high risk of failure and impact from the subject tree within the next year. While pruning is an option to mitigate the risk from falling deadwood, the extensive decay in the trunk would mean that the residual risk of the tree would remain high and removal is the only option available to remove the risk.

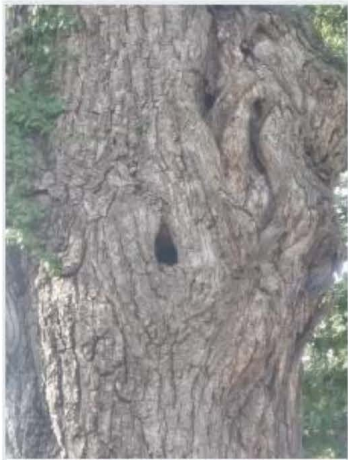
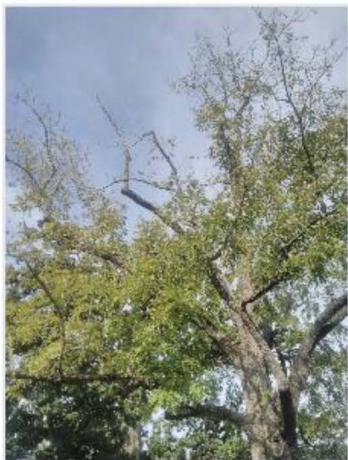
| <b>Black walnut Tree ID #5383</b><br>815 Belle Meade Boulevard | |
|---|---|
| <b>Photos</b><br><br>17613182429875570798335389623846.jpg<br>10/24/2025<br> | |

| <b>Black walnut Tree ID #5383</b><br>815 Belle Meade Boulevard | |
|---|---|
| Condition: | Poor |
| Health Issues: | Fungal infection, decay, low vigor |
| Crown/Branch Issues: | Large Deadwood (>10in), Broken/Hangers, Weak Attachments, Cavities/Decay, Visible Cracks |
| Likelihood of Failure - Branches: | Imminent |

| Trunk Issues: | Cavities/Decay - Minor, Cavities/Decay - Moderate, Cavities/Decay - Extensive, Heartwood Decay Suspected |
| Main Issue - Trunk: | Cavities/Decay - Extensive |
| Likelihood of Failure - Trunk: | Probable |

Trees are given a risk rating on a scale ranging between low, moderate, high, and extreme using the TRAQ criteria. My inspection of the roots did not uncover any reasons for concern. However, it is my professional opinion that the crown and branches of the tree pose a high risk of impact. The largest factor in this being the large deadwood in the crown could fall even under fair weather conditions, possibly without warning. The trunk and major leads also pose a high risk of failure and impact; the extensive decay makes it probable that a major failure could occur during normal weather. In both of these cases, the likelihood of impact from the tree failing is high. The consequences of large deadwood falling would be significant, and the consequences of impact from the trunk or a major lead would be severe. Therefore, in my professional opinion, there is a high risk of failure and impact from the subject tree within the next year. While pruning is an option to mitigate the risk from falling deadwood, the extensive decay in the trunk would mean that the residual risk of the tree would remain high and removal is the only option available to remove the risk.
