# POTABLE WATER Distribution System Analysis

-----  
Croton-on-Hudson (V)  
Westchester County, NY

February 2007

The Dutchess County Office  
The Chazen Companies  
21 Fox Street  
Poughkeepsie, New York 12601  
(845) 454-3980

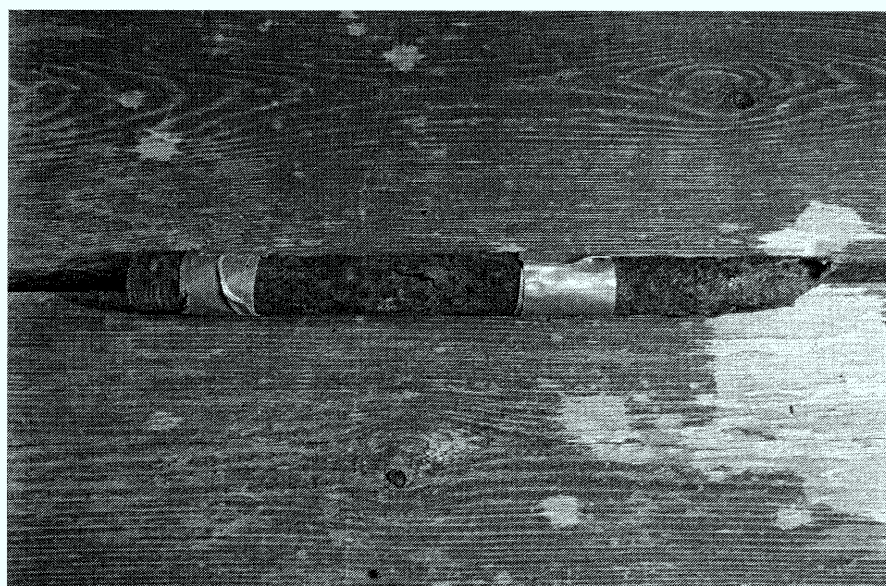
**Figure 3 – Galvanized steel water service pipe with corrosion hole in center of picture, encountered during the Harmon Water Main Replacement Project area in the Village, 2005**

Some water quality issues are a result of the type of service piping used by individual customers. Corrosion inhibitors will aid in the reduction of metals leaching from customer service connections.
