# Croton Yacht Club, Croton-on-the-Hudson, NY

## Design Protocol Report - Rev. 4

September 2011

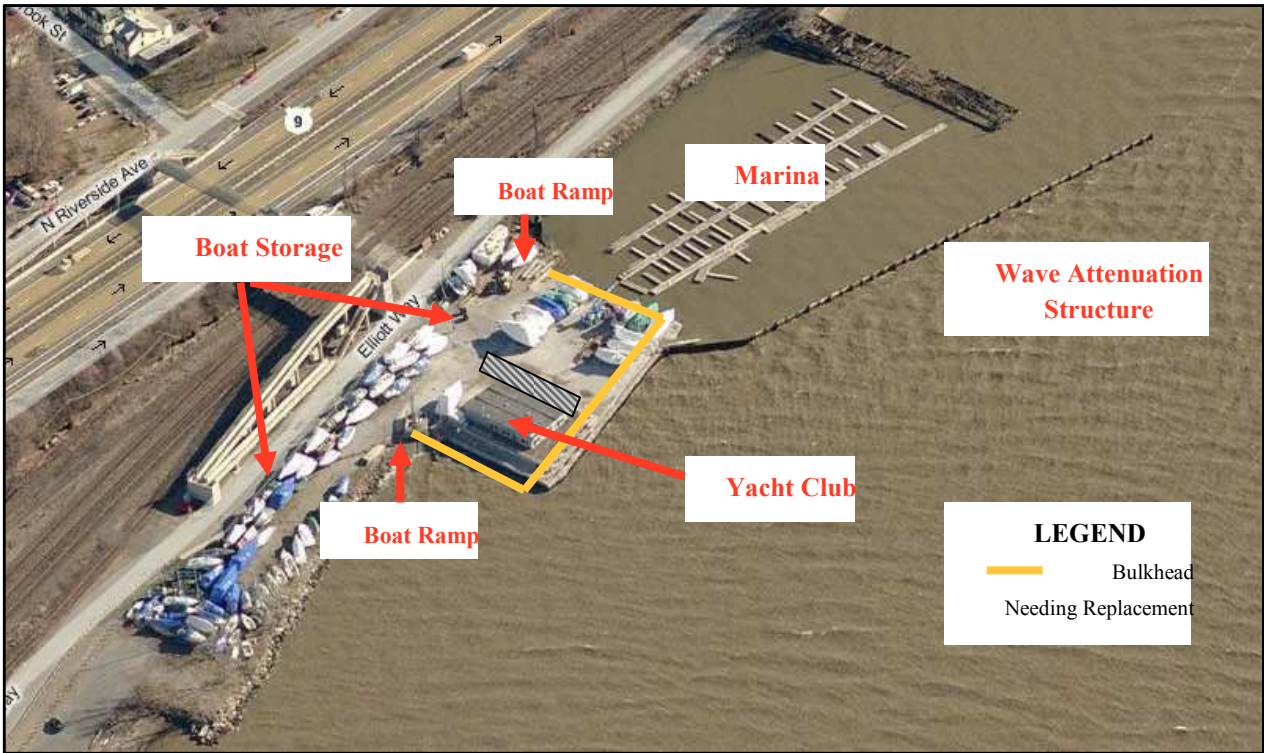
Figure 1- Project Components

Ocean and Coastal Consultants (OCC) is providing the Village of Croton with engineering design services for the replacement of approximately 433 feet of the 500 feet of existing steel sheet pile bulkhead at the site.

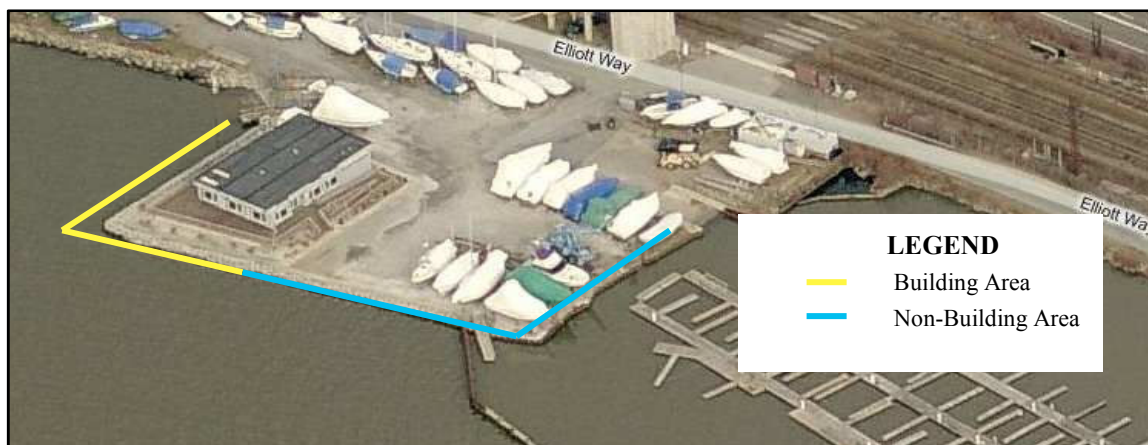
Figure 3- Design Surcharge Load Map

The design surcharge loads for the bulkhead are identified by the two areas as depicted on Figure 3 and include the following:

- Building Area (North and part of Southwest Bulkhead): 100 PSF
- Non-Building Area (South Bulkhead and part of Southwest Bulkhead): 200 PSF

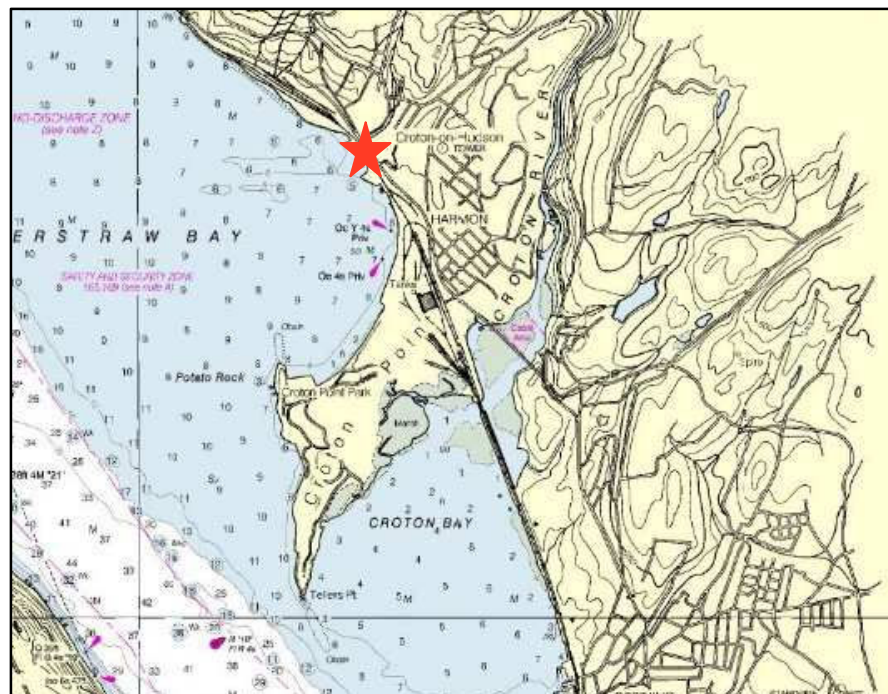
Figure 5- NOAA Chart 12343

The Croton Yacht Club is located adjacent the Hudson River in the Village of Croton on Hudson, Westchester County, New York (Figure 4) and is in NOAA Chart 12343 from New York to Wappinger Creek (Figure 5).

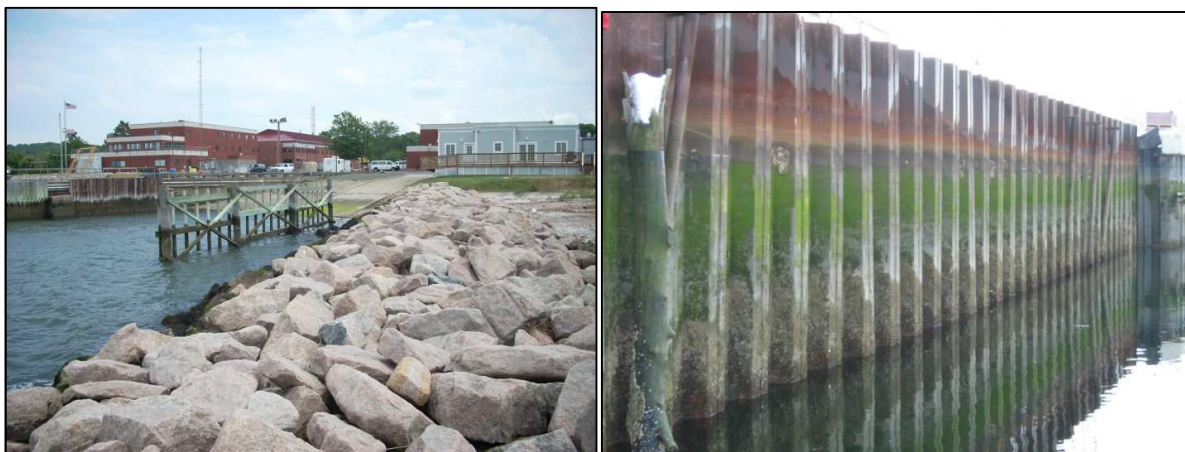
*Photo 5 - Stone Revetment (left) and Cantilever Bulkhead (right)*

**Stone revetment:** This method of stabilization includes the placement of stone rocks at a 1V:1.5H slope along the shoreline (Photo 5). A stone revetment was ruled out as a possibility for the Croton Yacht Club site due to the usage of the upland area adjacent to the shoreline, regulatory concerns, and navigational limitations. Permitting such a structure requires limited encroachment into the water area past the existing bulkhead. In order to maintain the proper slope and the encroachment limitations, the bottom of the revetment would have to be in line with the current bulkhead and the top of the revetment would fall very close to the yacht club building. This would decrease the usable land area for yacht storage, reduce or eliminate the public access area, and limit the ability to launch boats.

**Cantilever Bulkhead:** This shoreline stabilization method consists of the placement of vertical steel sheet pile (Photo 5). This option was not a possibility for the site due to the soil conditions and the surcharge loads along the upland adjacent the shoreline.

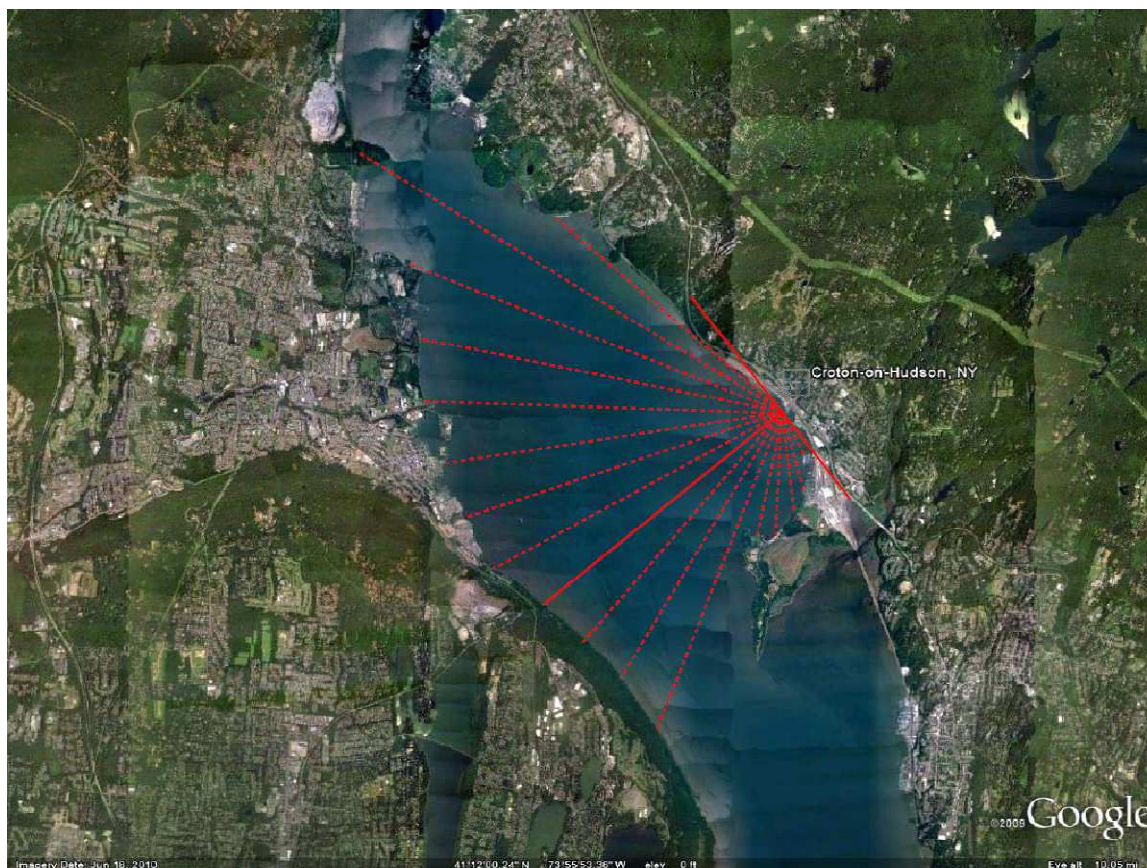
Figure B1: Google earth view with wind fetch directions located.

The ACES module was utilized using "shallow restricted" option to determine the common probabilistic storm parameters significant wave height and peak period. The significant wave height ( $H_s$ ) is the average of the one third (1/3) highest waves in the wave field. The peak period ( $T_p$ ) has the highest energy in the wave field. The blowing wind direction iteratively changed until the maximum significant wave was obtained. The most critical significant wave was found to be caused by wind blowing from the direction of 300° from the North. The average depths were obtained from NOAA Chart 12343. The average depth for the selected fetch, which was used in ACES was estimated to be 15.6 feet at MHW.

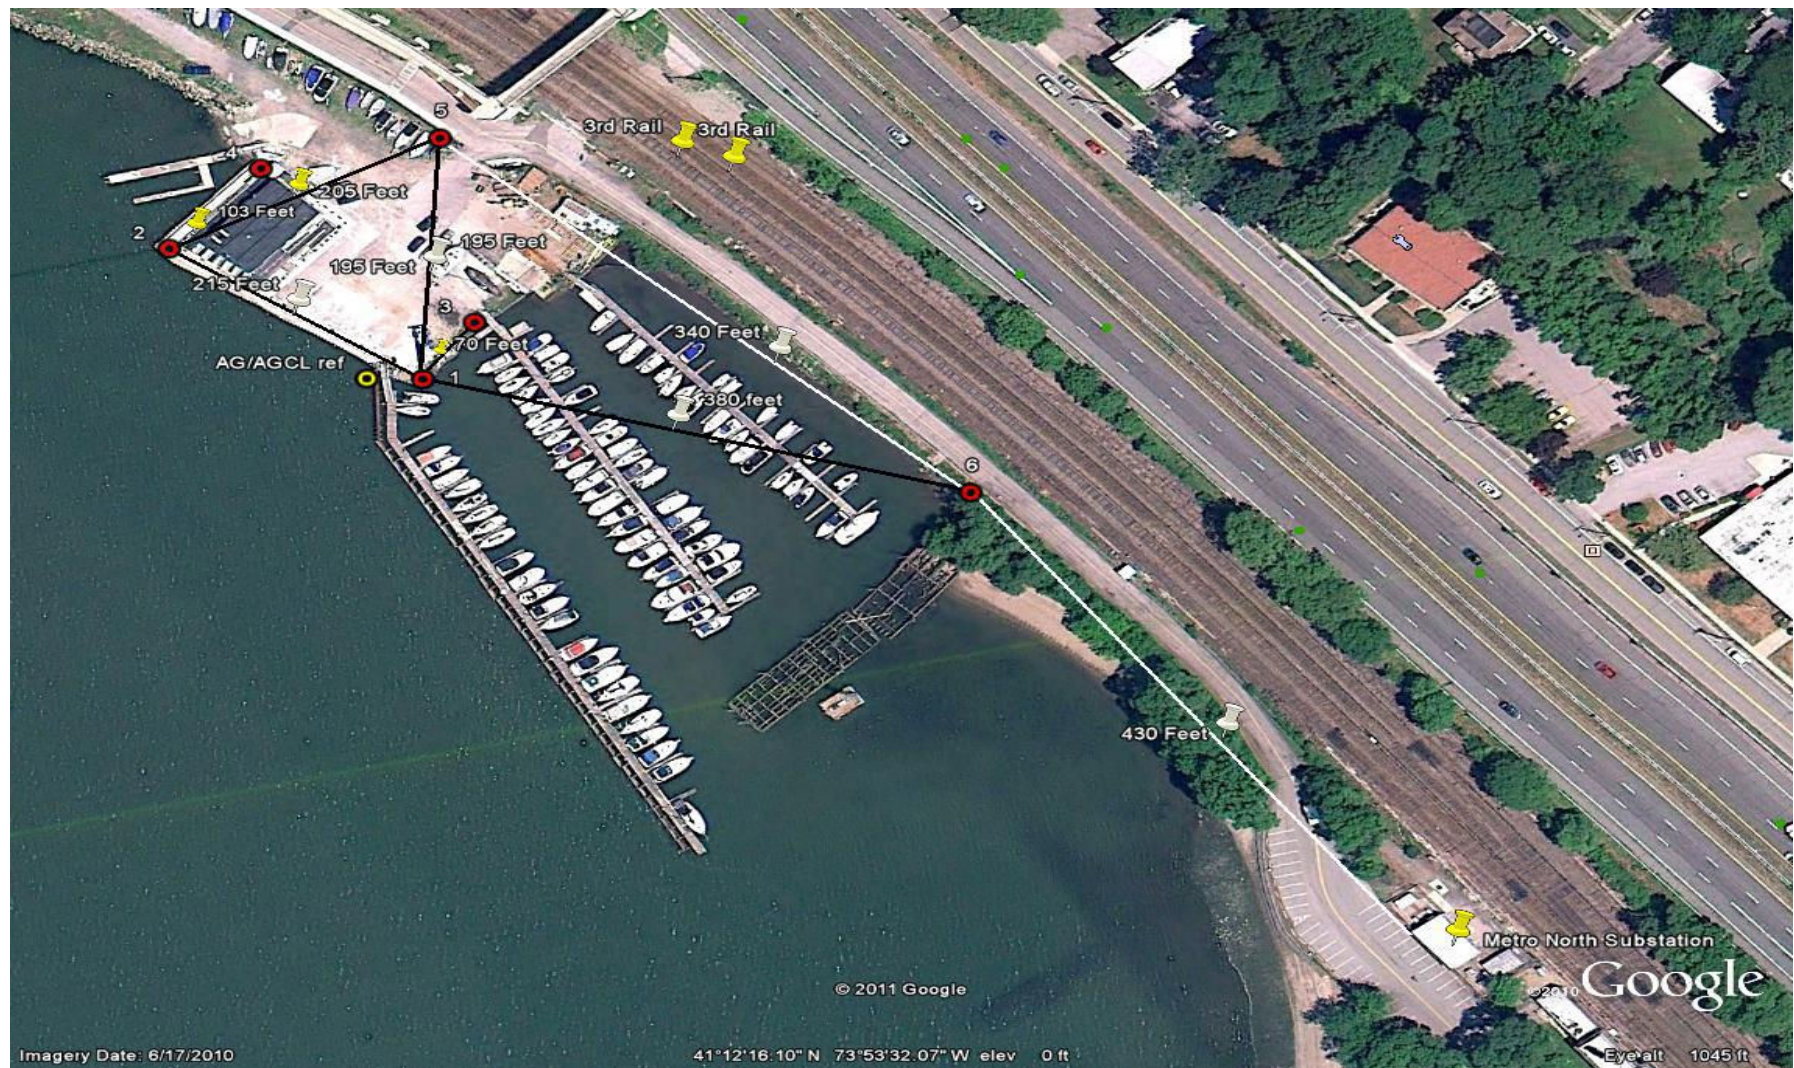
Figure 2 – General Test Plan with Reference Locations

bulkheads and oriented so that the polarity of paired electrodes would indicate a direction of current flow (Voltage Gradient). The location of each electrode is shown in Figure 2. A seventh reference electrode was installed on the northernmost H-pile on the wave screen. This electrode was a Silver/SilverChloride (AG/AGCL) and is the standard electrode for testing in brackish water or seawater. The AG/AGCL electrode monitored the potential of the H-pile for the same period to see if the voltage changes in the area caused any effects on in place steel structures. In this case, the potential changes on the H-pile correlated with activity in the ground.
