**Village of Croton-on-Hudson  
Feasibility Study for the Space Analysis, Renovation and Energy Improvements  
for the Stanley H. Kellerhouse Municipal Building**

## DRAFT REPORT

RE: STUDY FOR  
RENOVATION OF CROTON-ON-HUDSON MUNICIPAL BUILDING  
CROTON-ON-HUDSON, NY 10520

PREPARED BY: CHRIS ANASTOS P.E.  
ANASTOS ENGINEERING ASSOCIATES

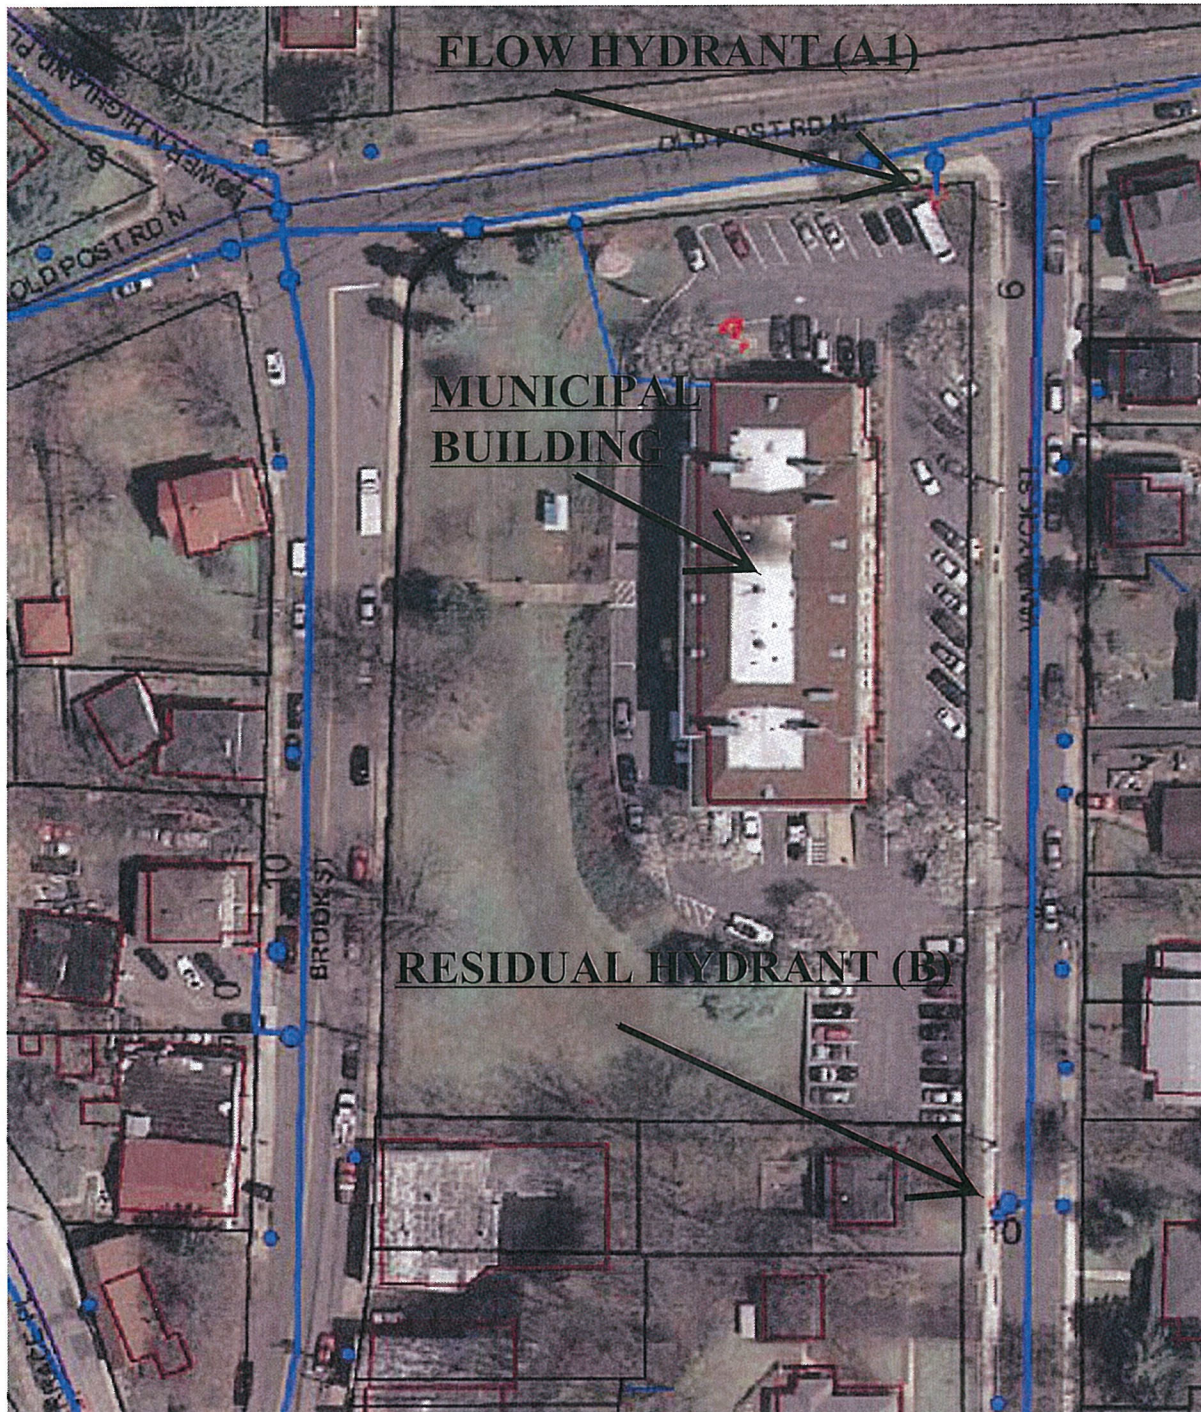
Location of flow and residual hydrants

A hydrant flow test was requested and performed by the Village. We determined from the data collected that there is adequate pressure under flow conditions to serve a sprinkler system in the building without the need for a fire pump. A new fire water service, anticipated to be 4" in size, would need to be provided for the building. It would run parallel to the new domestic water service. A double check backflow prevention device will be provided for this service. The piping will extend to a sprinkler riser up the building. Each floor will be provided with a floor control assembly connected to the riser consisting of a flow switch, tamper monitored valve, and an inspector's test port, to serve the sprinklers on that level. A Siamese fire department connection will also be provided on the front façade of the building.

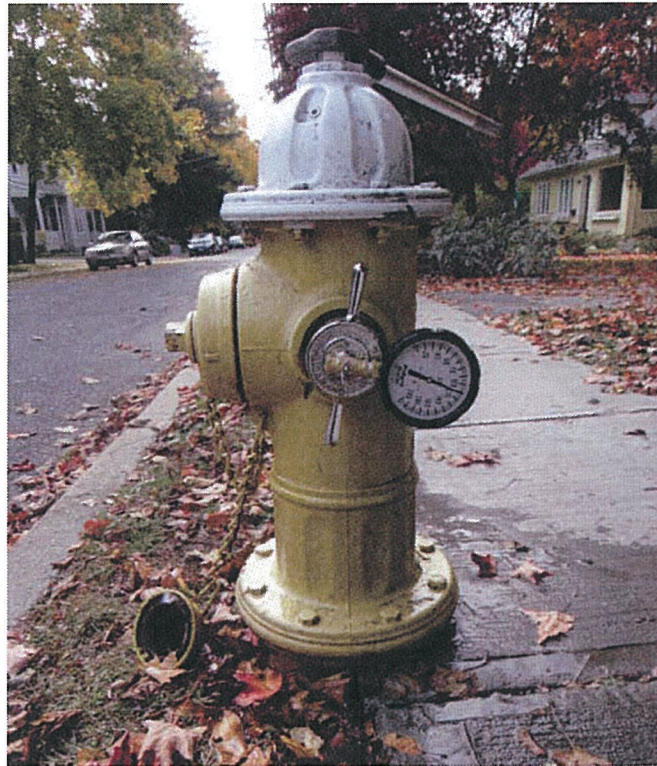
Residual hydrant: static pressure reading

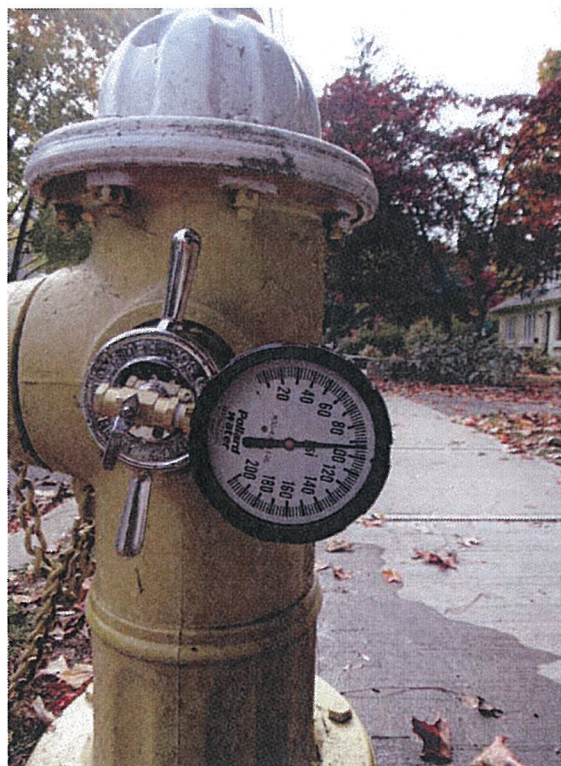
Residual hydrant: residual pressure reading

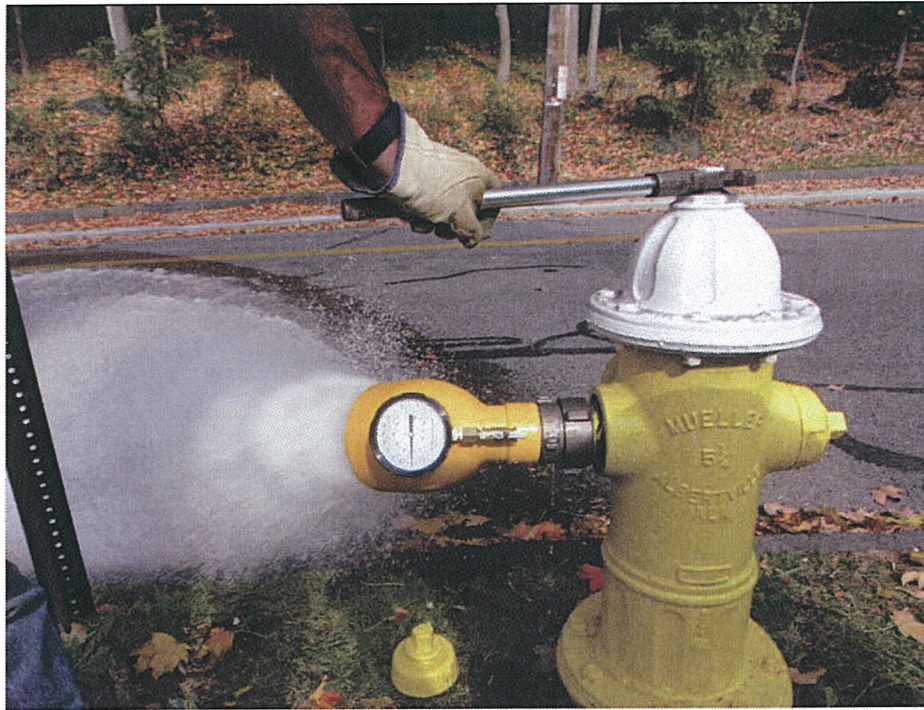
Flow hydrant being opened up (reading was taken at fully open condition)

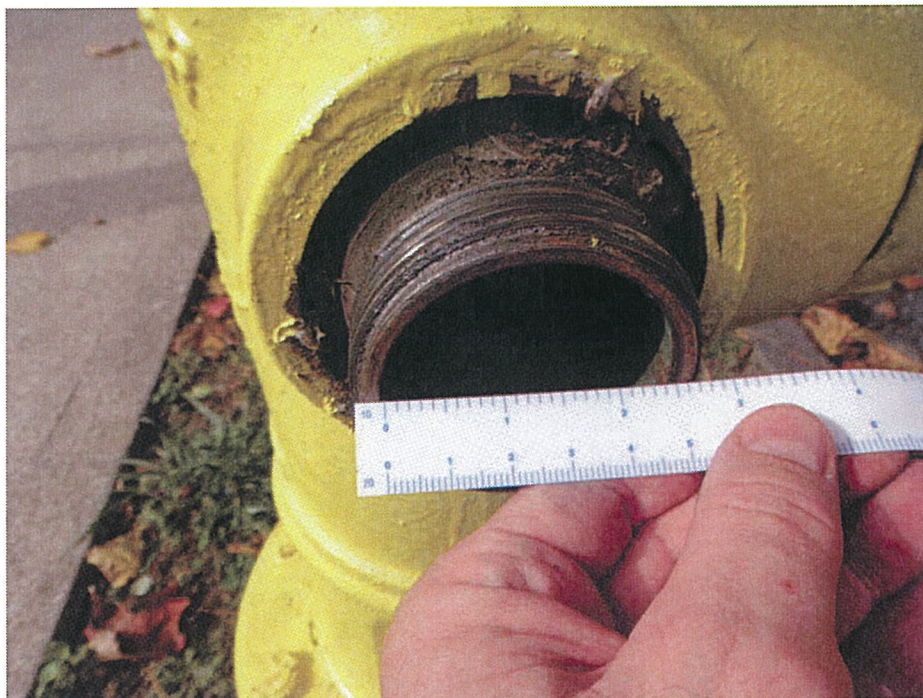
Flow hydrant nozzle measurement (2.5")
