# Croton River Hydrilla Control Project

2022 Update

Nicole White, CLM – Croton Hydrilla Control Project Manager  
New York State Department of Environmental Conservation

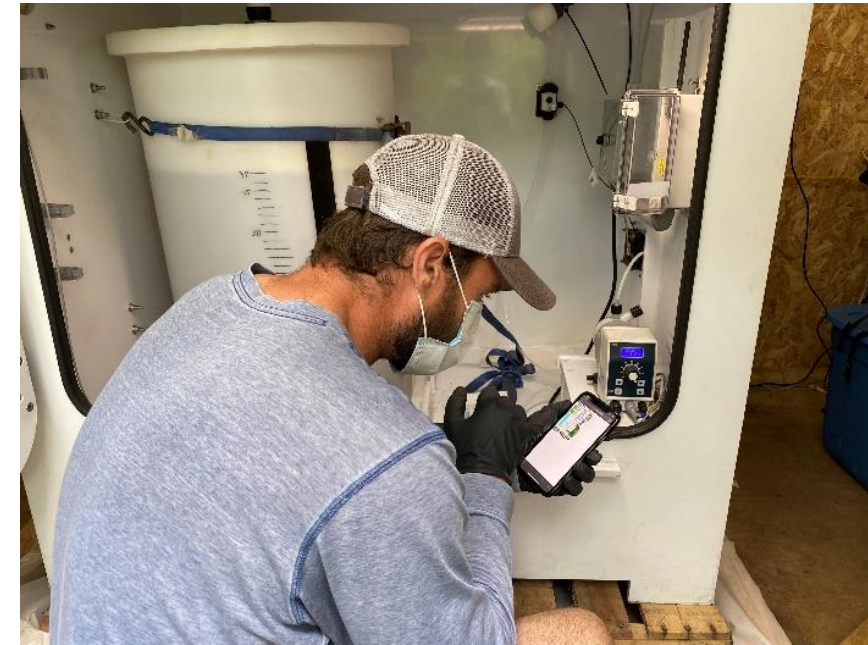
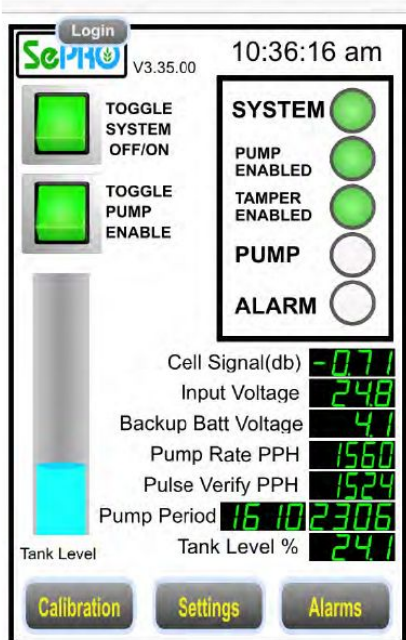
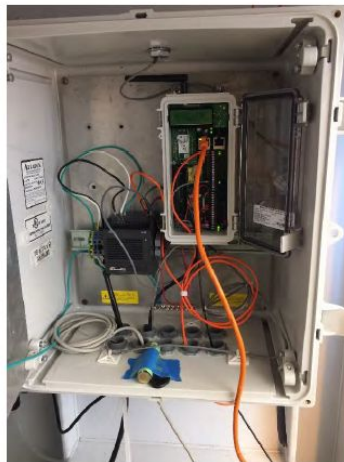
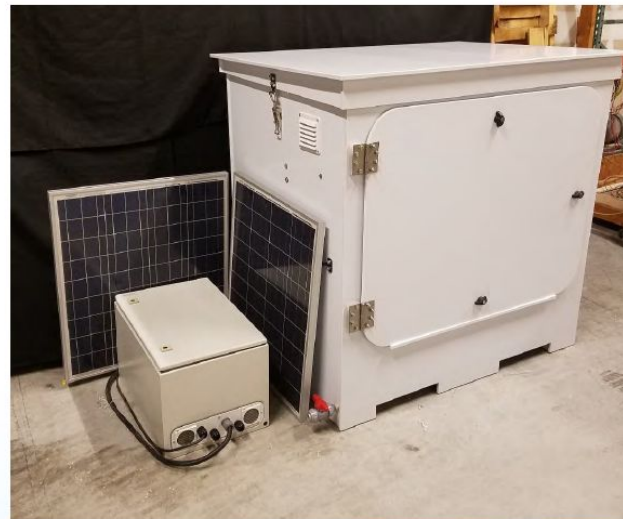
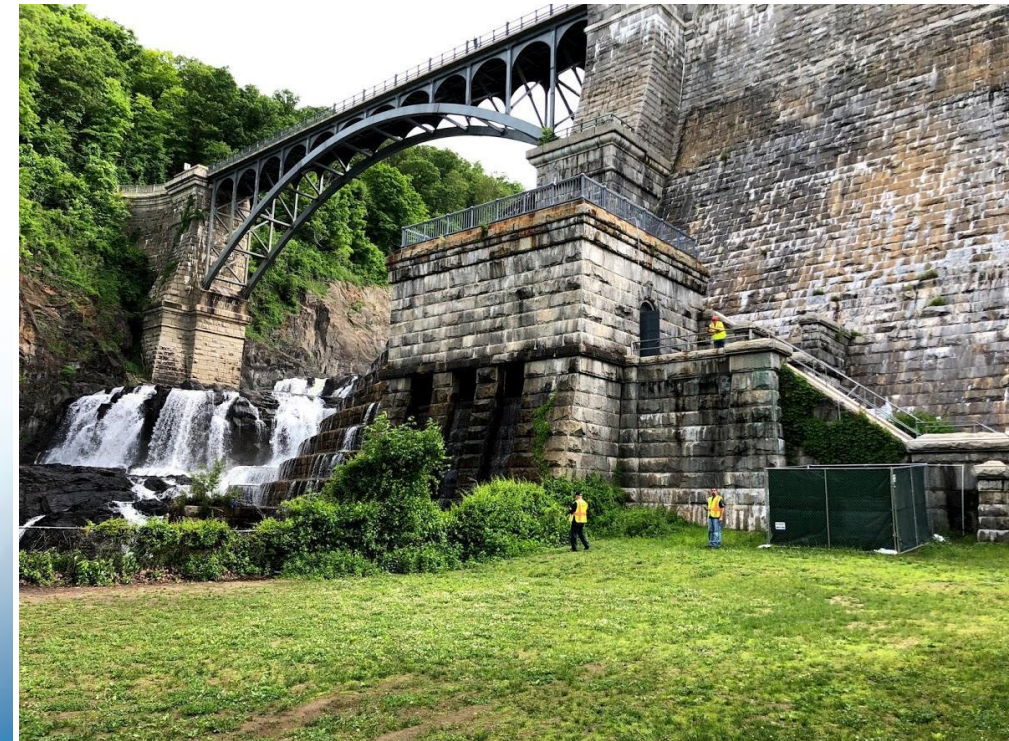
Cellular-controlled herbicide injection system designed by SePRO

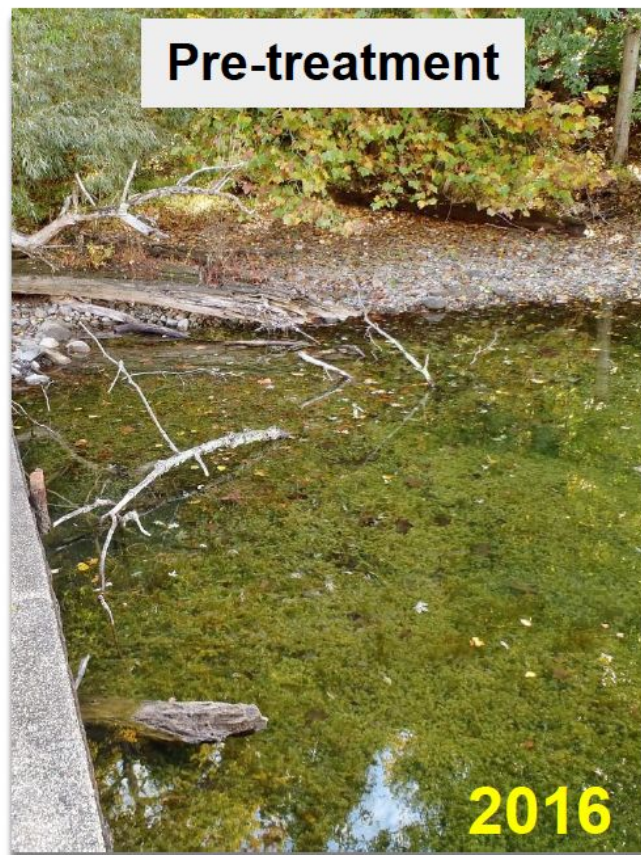
Prior to treatment (2016), thick mats of hydrilla grew to the surface of the water in dense and moderate abundance throughout the Croton River (top left).

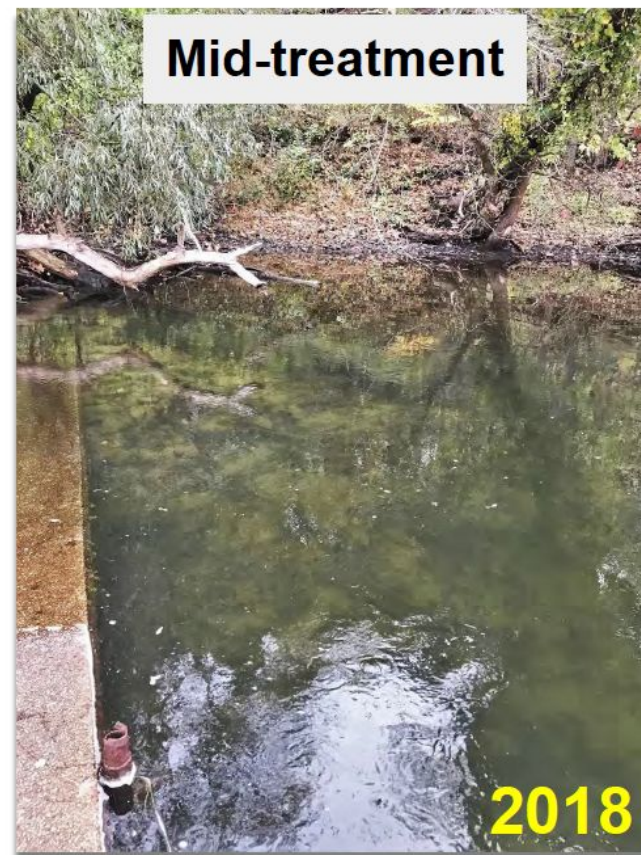
Following two seasons of treatment (2017 & 2018), hydrilla was reduced to sparse or trace abundance. No dense or moderate patches remained within the Croton River (top center)

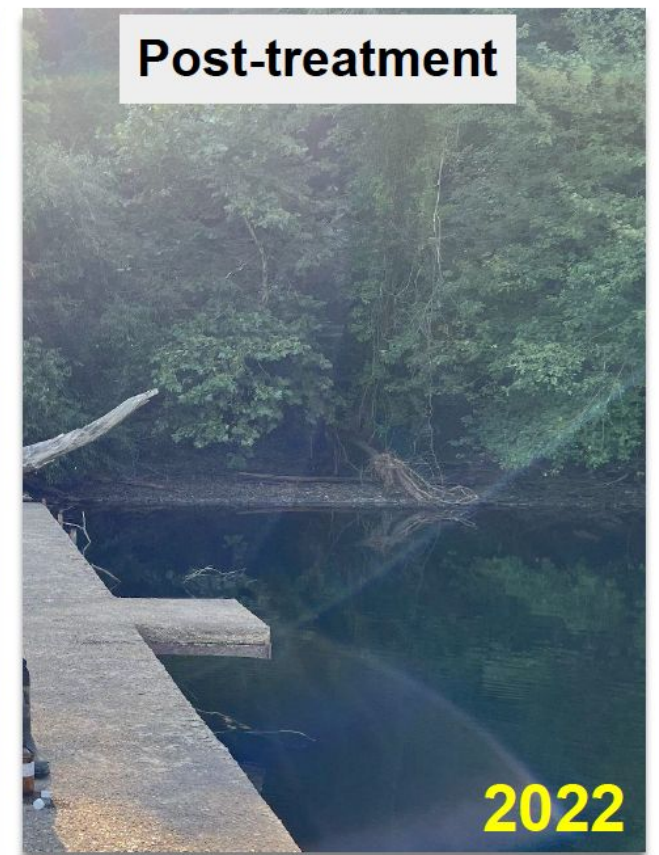
No hydrilla plants were observed in snorkel surveys or point intercept surveys following the sixth year of treatment in 2022 (top right).

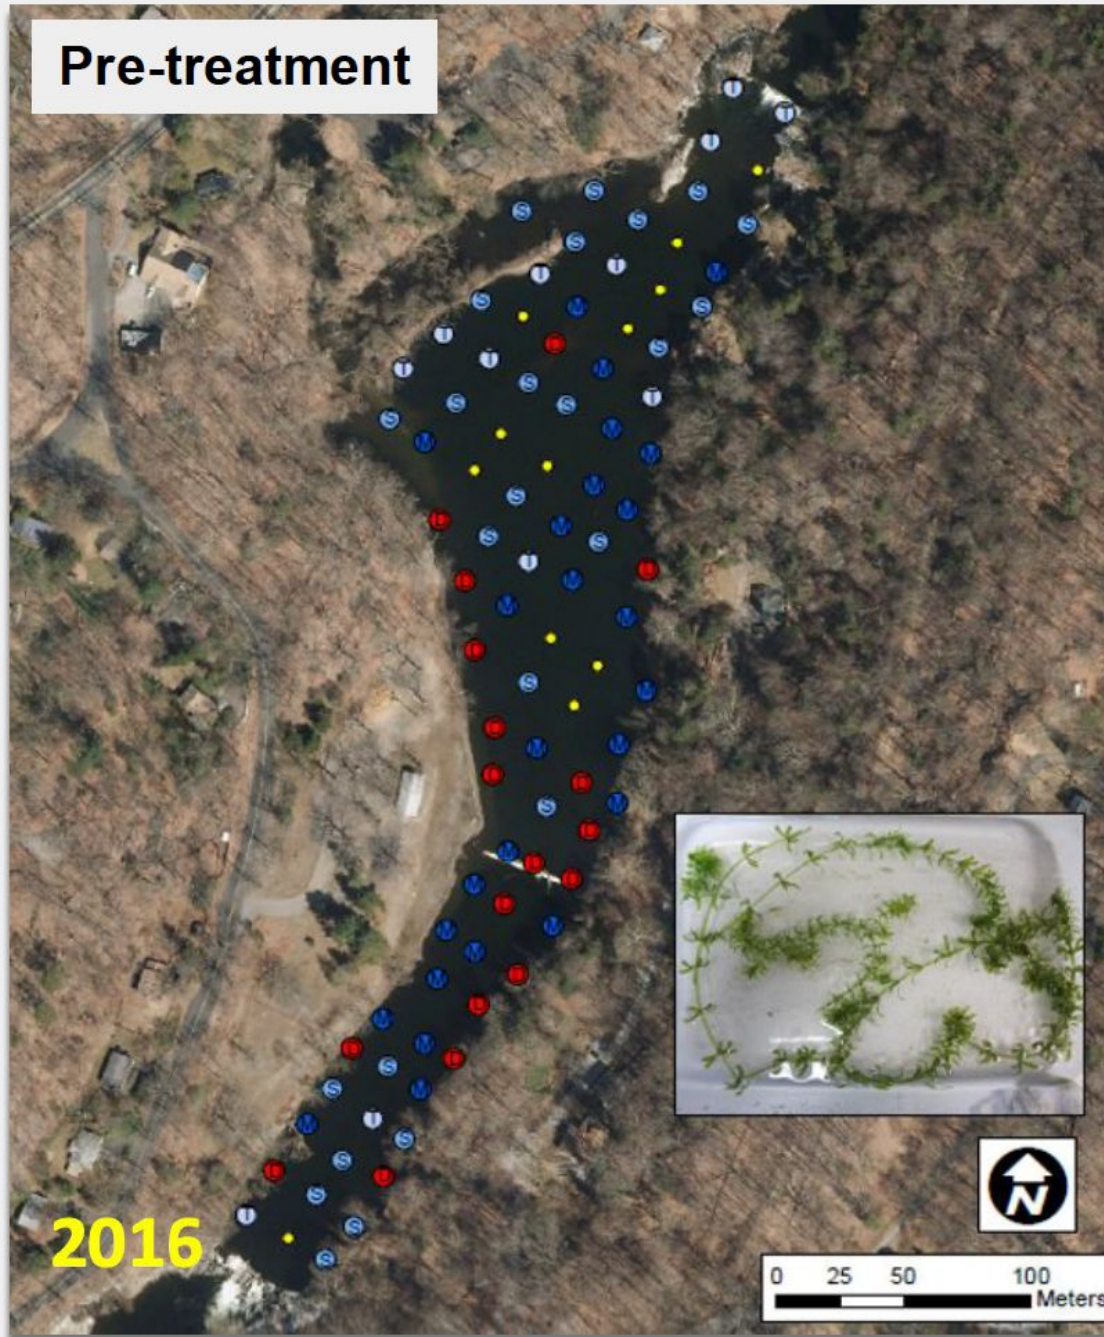
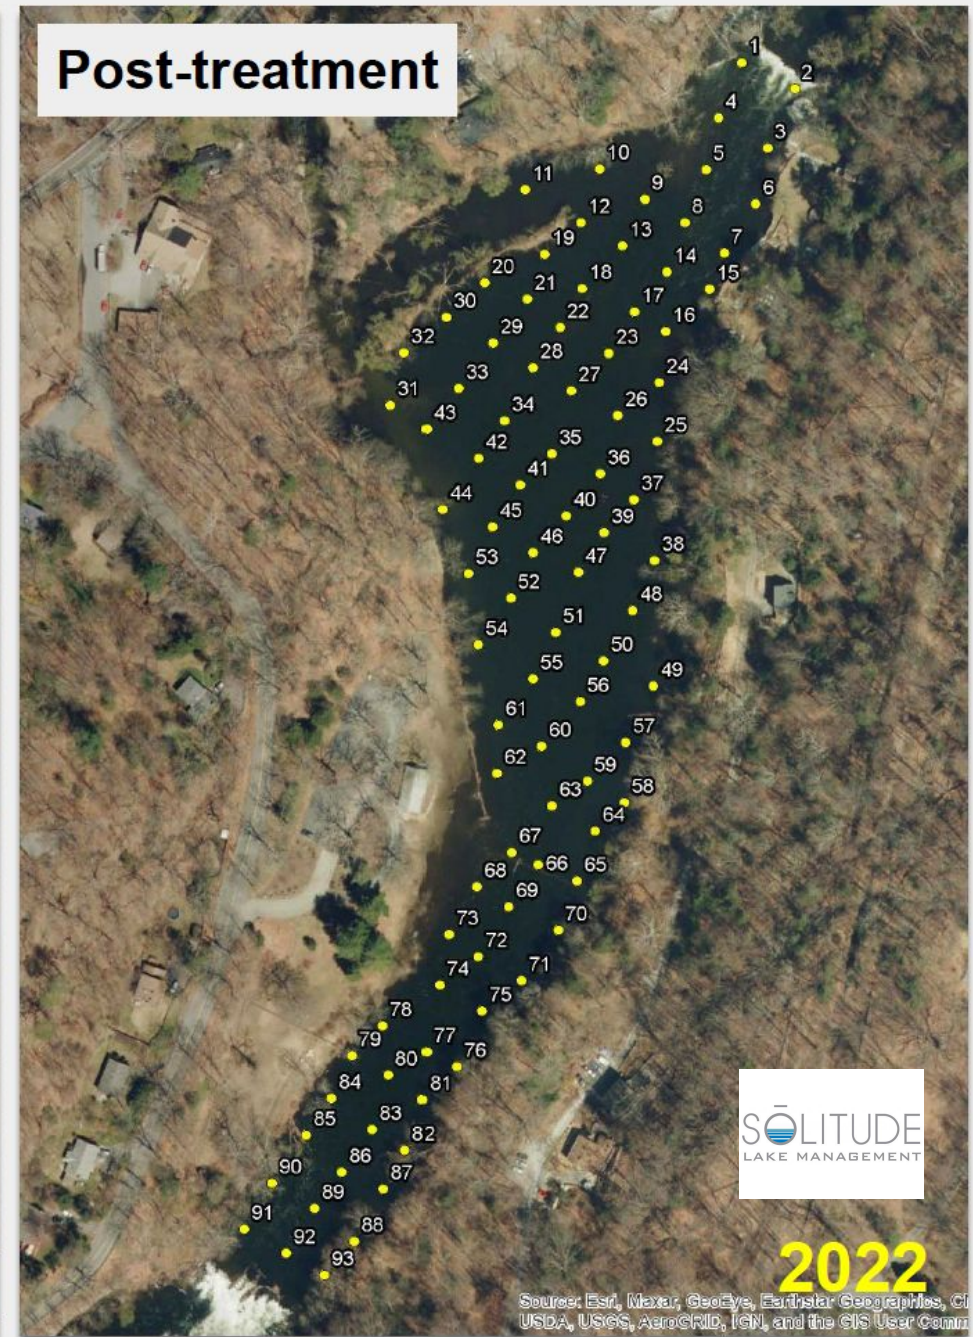
446 points surveyed annually in Croton River

43% infested with hydrilla in 2016

2022: no hydrilla was present (6<sup>th</sup> season of treatment)

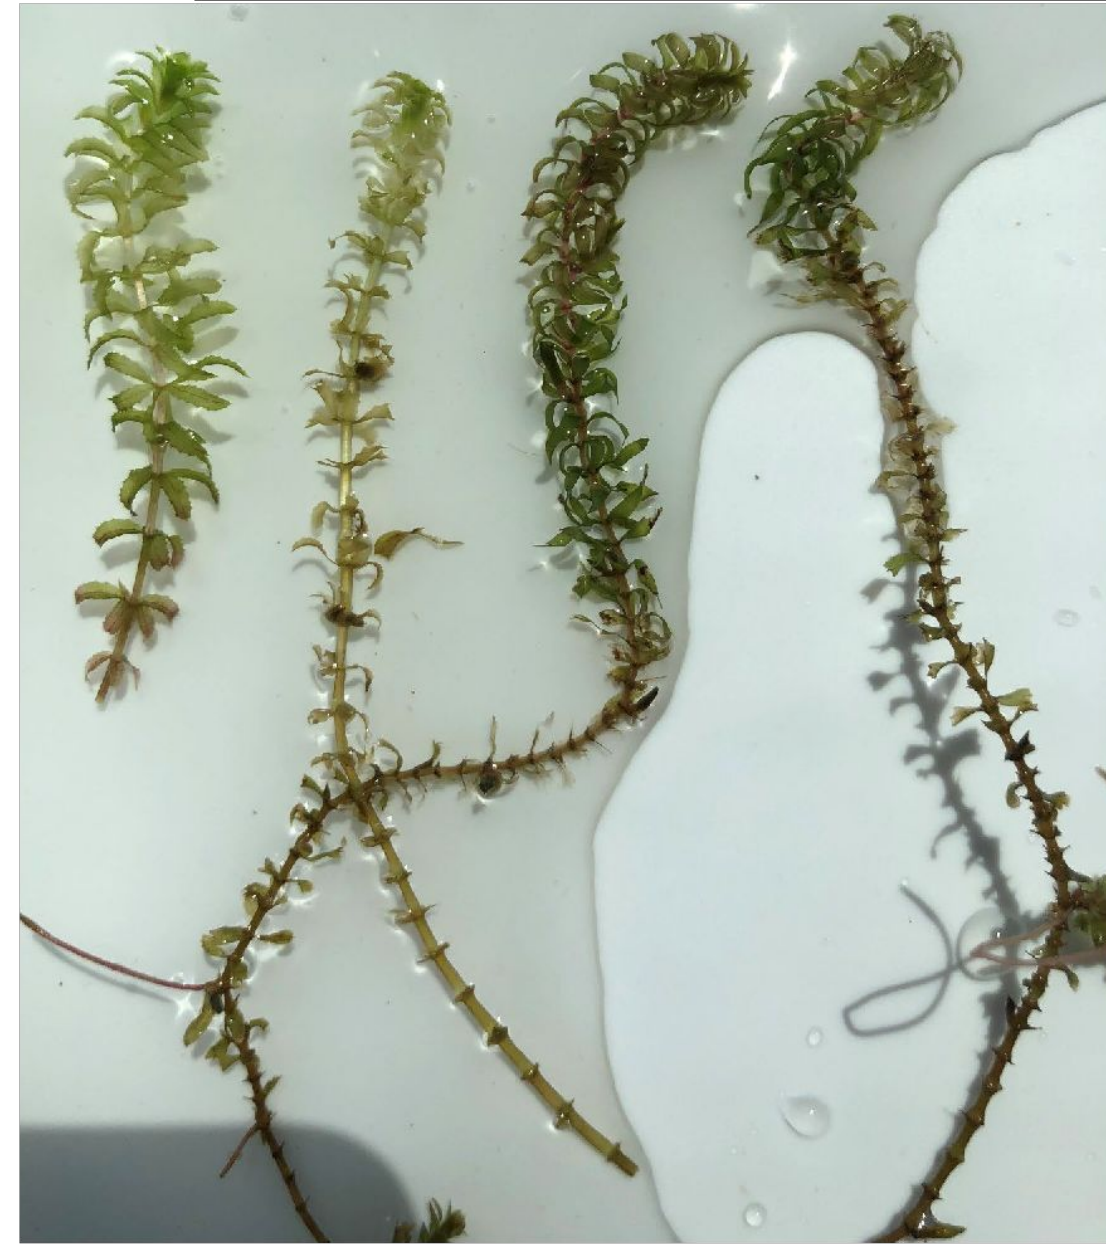
- Plants collected same day from same treatment site within Croton River
- Both plants show defoliation of lower leaves
- 2 hydrilla plants (left) show more chlorosis than 2 native elodea plants (right) 44 days into 3<sup>rd</sup> treatment season

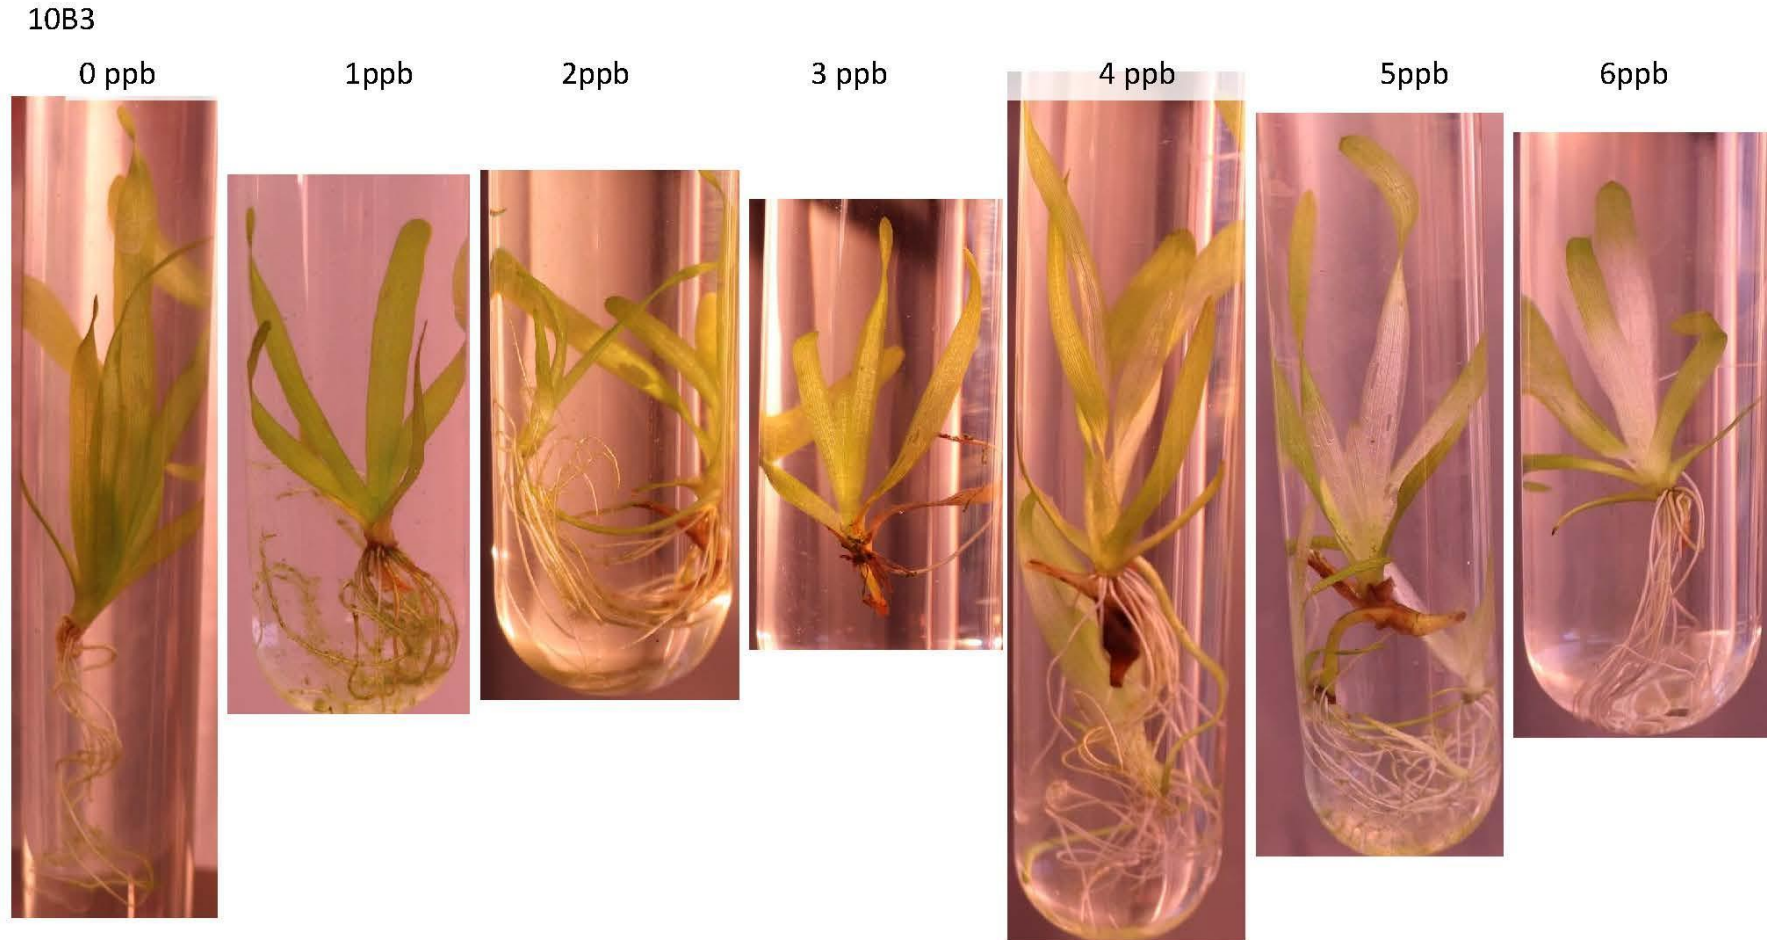
- subjected the genotypes to 7 levels of fluridone and replicated each genotype x herbicide combo 10 times.
- leaves bleaching at 5 and 6ppb.
- chlorophyll analyses on leaf samples in combo with photo imagery.
- None of the herbicide levels appear to be lethal but the herbicide appears to be stressing the plants even at these low herbicide concentrations.
