Falmouth Study Streams Stressor Report

Individual Watershed Reports

January 2022

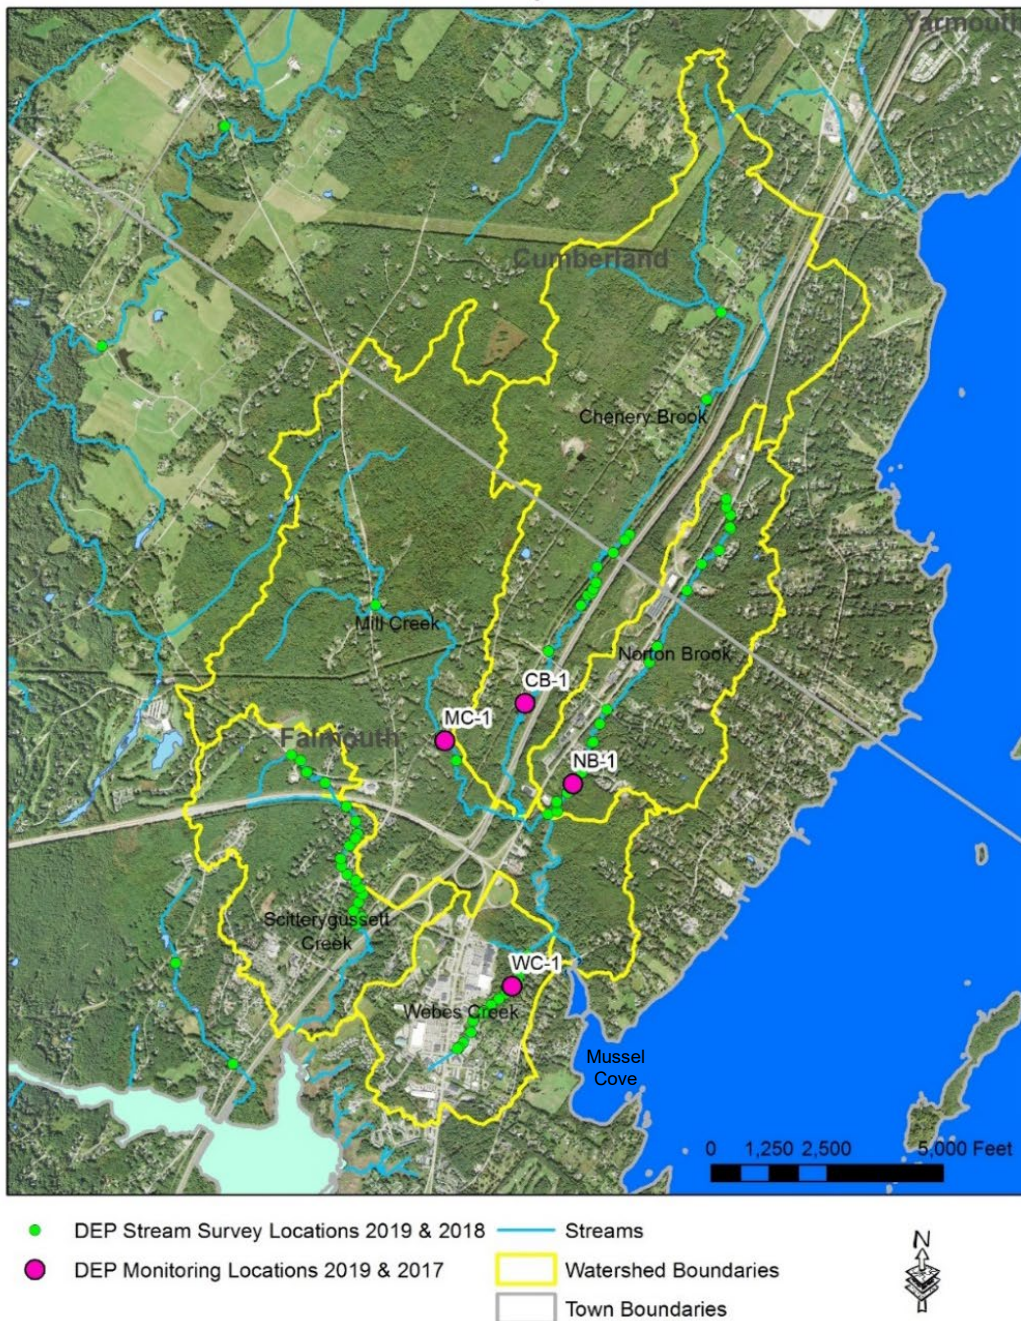
Figure 1. Coastal Area Study Stream Map: Watersheds and Surveying and Monitoring Locations.

Survey and Monitoring Locations Falmouth Study Watersheds

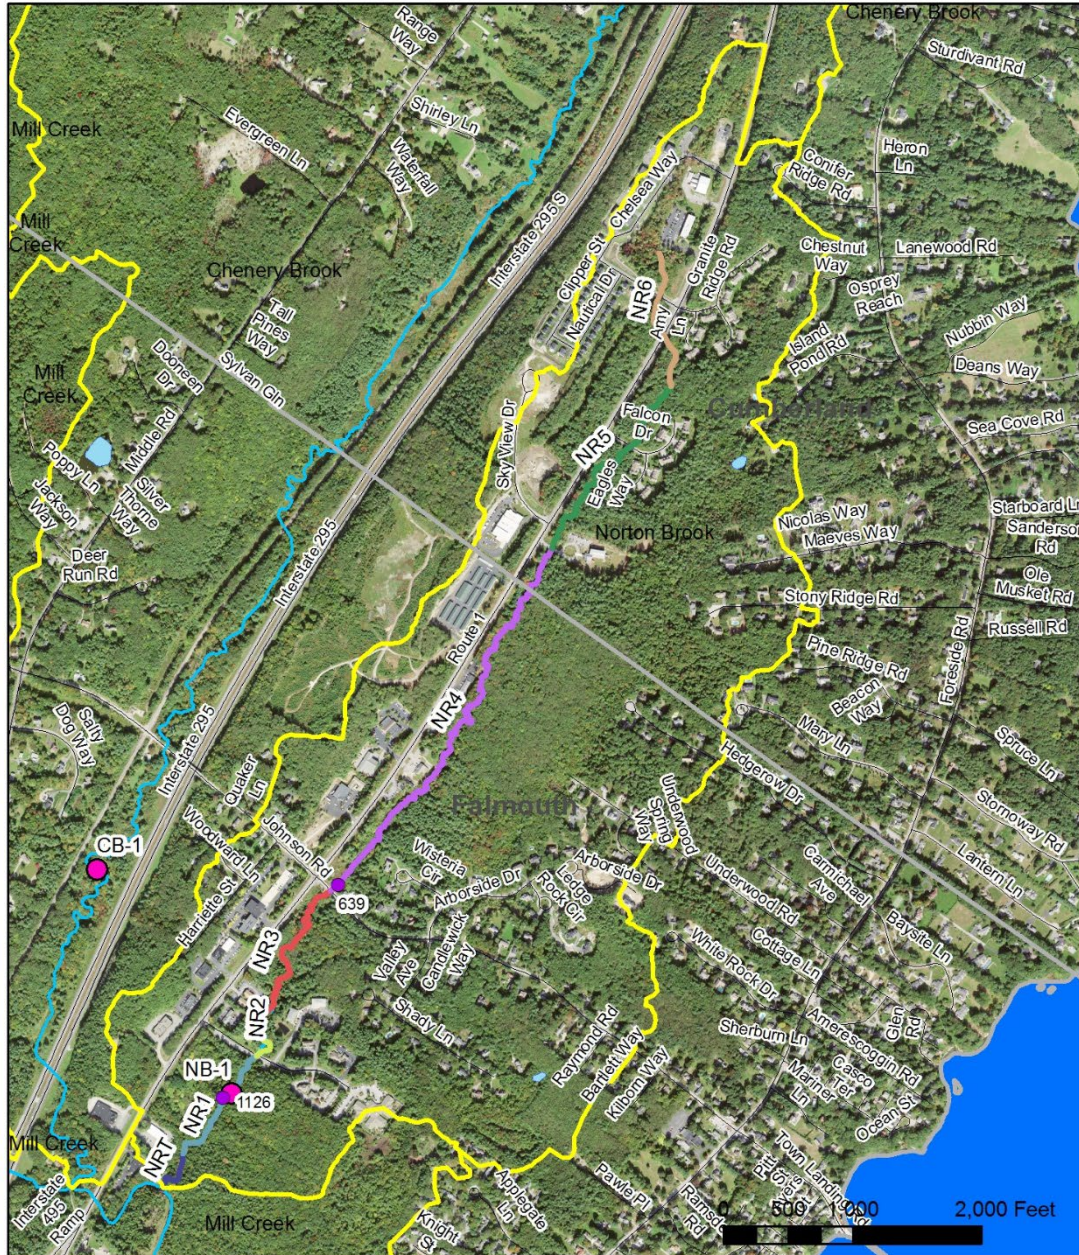
Study Watershed Reach Names Norton Brook

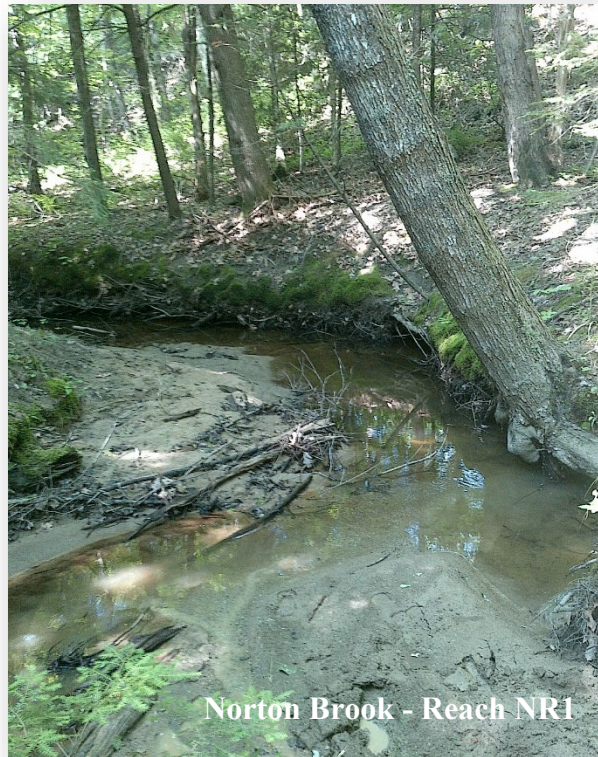
Norton Brook - Reach NR1

Reach NR1. This low gradient reach extends from head of tide about 1000 feet upstream to Northbrook Drive. The substrate is sand or silty sand with many meander bars and sand deltas at the outlets of two intermittent tributaries that drain gullies on the east side of the watershed. There is a large debris dam near the lower end of the reach which provides some habitat complexity both in substrate and velocity. In the stretch between the two tributaries a large abandoned culvert that provided the stream crossing for a discontinued road lies parallel to the stream in the stream channel. This restriction and the likely heavy stormflows from the upstream tributaries that drain most of the Northbrook Business Park has resulted in severe erosion of the western bank of Norton Brook, thus contributing more sand to the downstream deltas and bars. The DEP macroinvertebrate monitoring station is located just downstream of this tributary. It is apparent that the sand substrate in this reach is not stable and is likely altered during large runoff events.

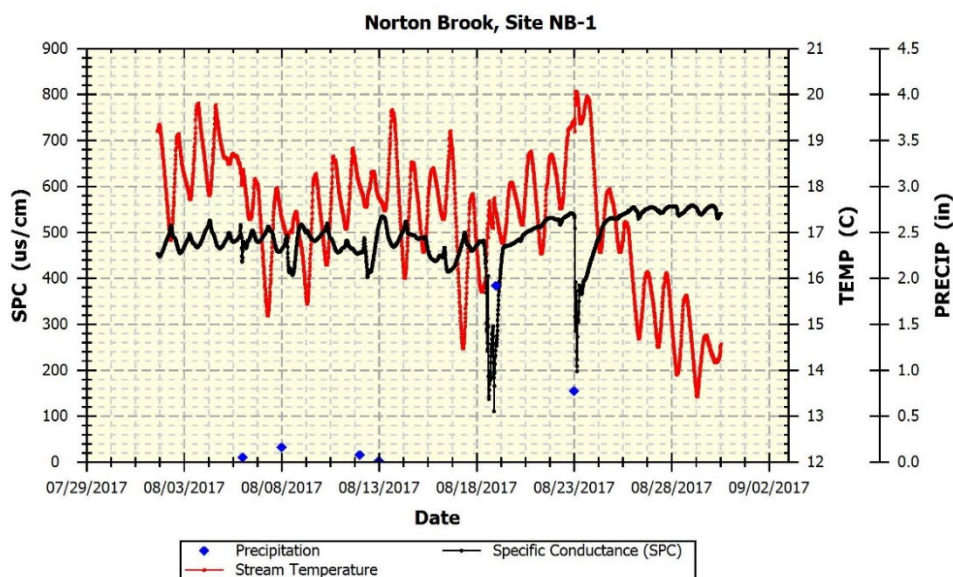
Specific Conductance. Specific conductance (SPC) was measured at Site NB-1 with a continuous data logger at the 2017 biomonitoring station August 1, 2017 to August 30, 2017, coincident with the period of deployment rock bag artificial substrates to monitor the macroinvertebrate community. The logger took measurements every 15 minutes. During this period SPC ranged from 110 μ s to 558 μ s, with an average of 486 μ s and a median value of 488 μ s. During this period, there was very little precipitation and the stream was at low baseflow most of the time. Nearly all of the lowest readings (<300 μ s) occurred during and shortly after a half inch rain event on August 18. This pattern of higher conductivity during baseflow than during storms indicates that many of the ions contributing to the conductivity are in the groundwater. In urban and urbanizing streams, the most likely culprit is chloride because of the high amounts of deicing salts that are applied in the watershed and the fact that, unlike most other ions, chloride is not attenuated in the soil.

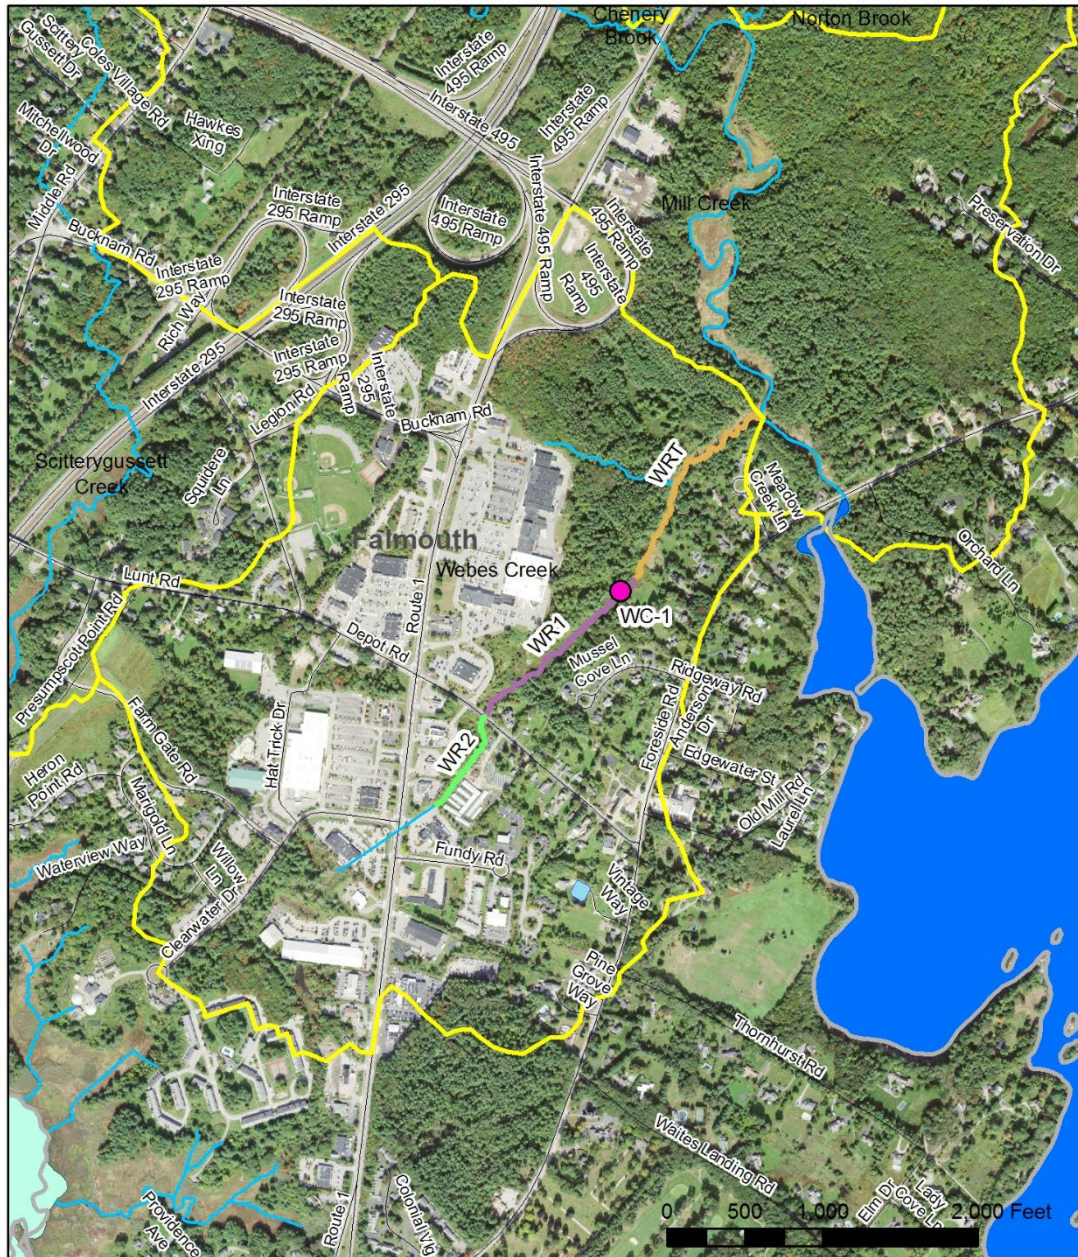
Study Watershed Reach Names Webes Creek

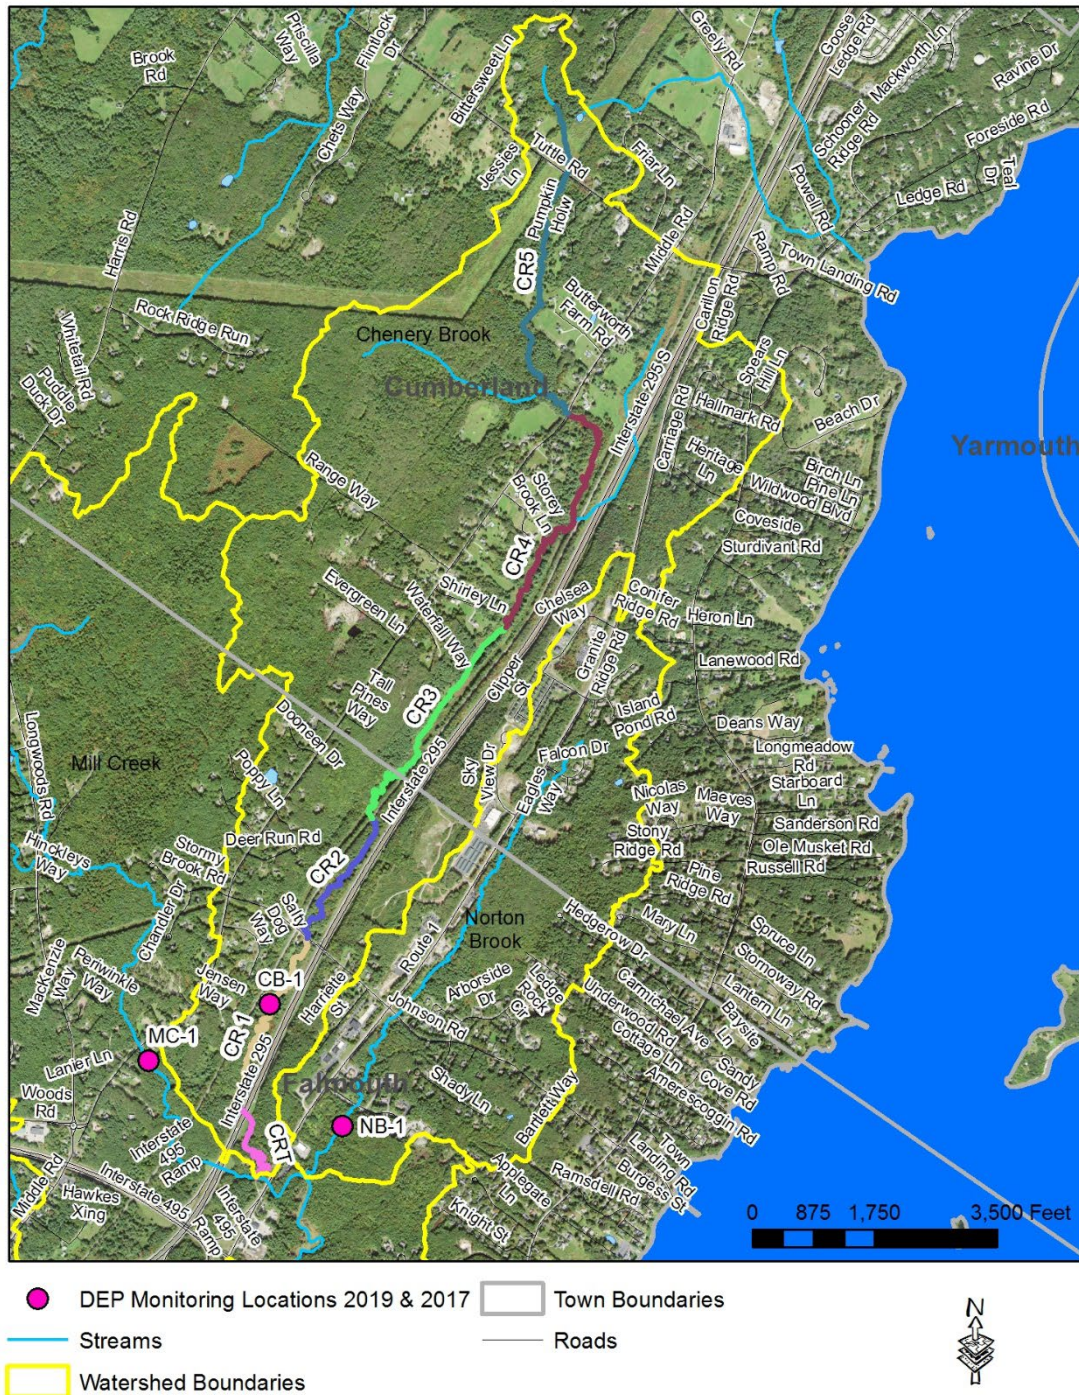
Figure 5. Chenery Brook Watershed and Study Reaches.

Study Watershed Reach Names Chenery Brook

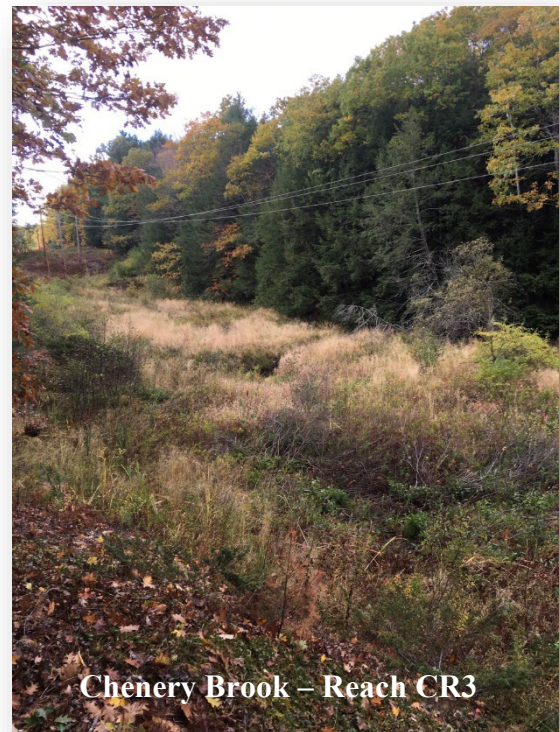
Chenery Brook – Reach CR3

All non-tidal reaches. Though the Chenery Brook watershed is not that small (about 2 square miles) observation of the stream during a very dry period in 2018 showed very little flow, particularly in the upper reaches. This limits both the velocity of flow and the availability of wetted substrate. These particularly low flows are likely due to the shallow to bedrock till and silty marine clay soils that

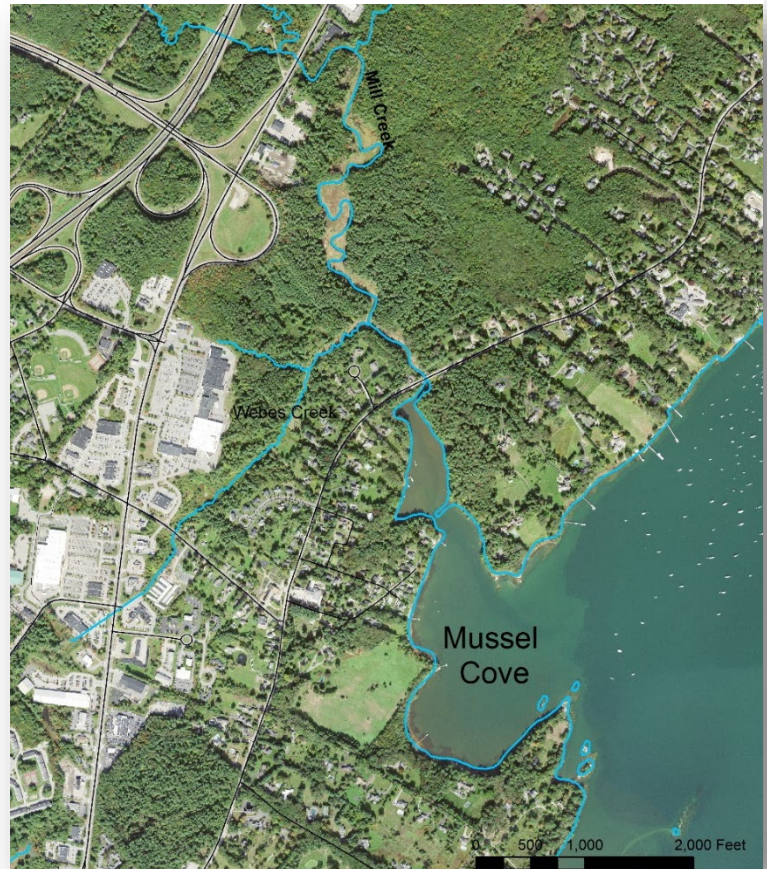
Figure 7. Mussel Cove Map.

Known studies of Mussel Cove water quality occurred during spring-summer 2006-2008¹ and on four dates in summer-fall 2013 (Maine DEP unpublished data). While a sparse data set and representative mostly of Mussel Cove mouth conditions, available information demonstrates a marine-dominated embayment with temperature and salinity ranging from approximately 6°C to 19°C, and 24 ppt to 31 ppt (April to November), respectively. Available observations indicate low turbidity (mean 2.49 NTU), low dissolved inorganic nitrogen (<0.01 mg/L to 0.12 mg/L) and phosphorus (<0.01 mg/L to 0.21 mg/L) concentrations, and the potential for bacterial and/or algal productivity to influence dissolved oxygen and pH conditions. Total nitrogen concentrations from the 2013 survey reflect levels typical for inner Casco Bay's marine-dominated embayments (0.15

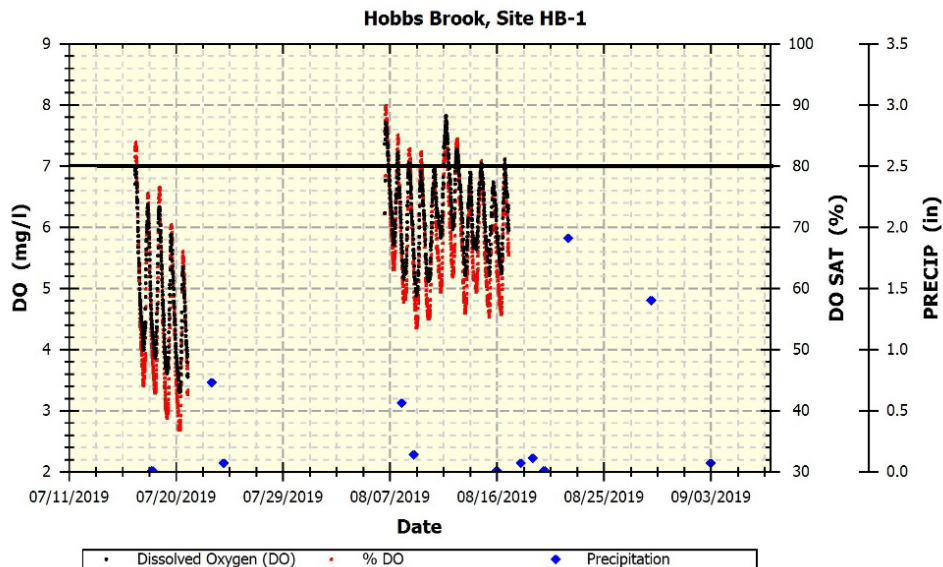
Dissolved Oxygen. The dissolved oxygen logger was partially buried in sediment when checked mid-deployment and at retrieval. Data was removed for the periods it appeared to have been buried. Dissolved oxygen was predominantly below the Class B standard of 7.0 ppm, with values from 3.3 ppm to 7.8 ppm, and a mean value of 5.8 ppm for the period recorded. The diurnal swing was regularly around 2 ppm, with a maximum of 3 ppm, indicating that the low nighttime dissolved oxygen was a result of periphytic algal respiration. This suggests that nutrient levels in the brook are high enough to support significant algal production under optimal conditions and that shade is insufficient to limit that production. The overall low dissolved oxygen levels indicate increased bacterial respiration as well.
