**CITY OF BELLE MEADE  
HISTORIC ZONING COMMISSION  
REGULAR MEETING AGENDA PACKET  
JANUARY 14, 2025, 03:00 PM**

**A. The application for a Certificate of Appropriateness, #A24-31, of Dan Viner, 436 Westview Avenue, for a demolition of a single family residence.**

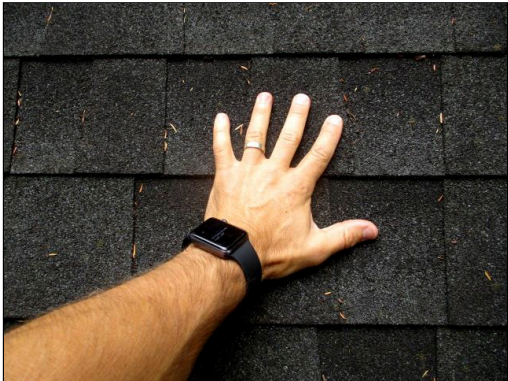
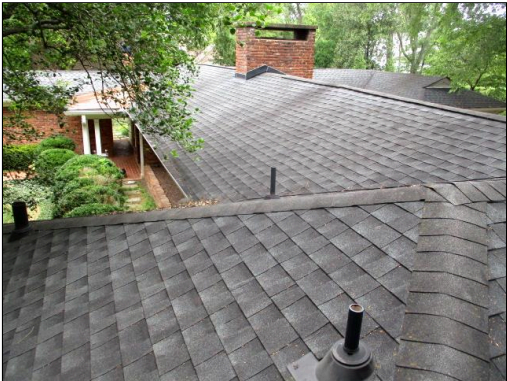
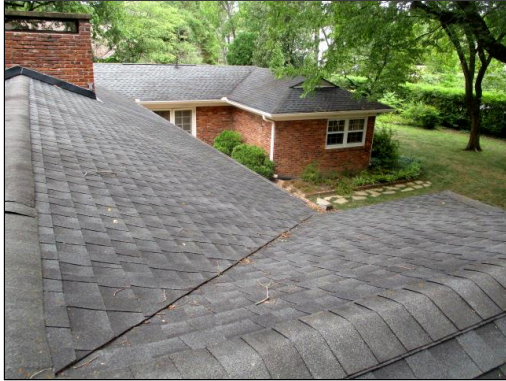
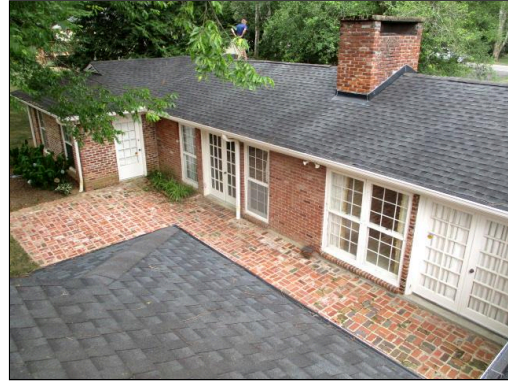
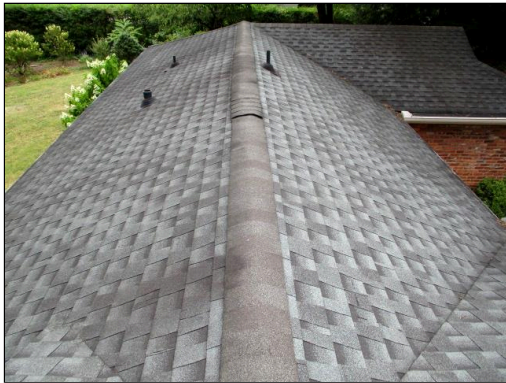
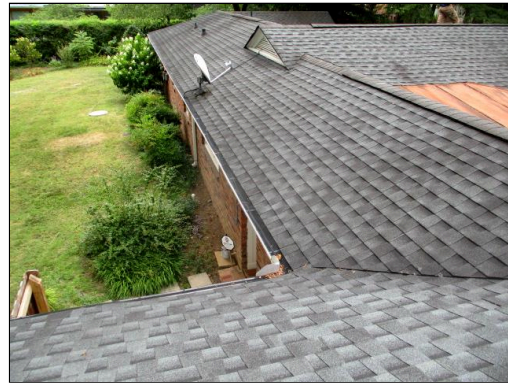
**1.0** (1) The roof was covered with laminated fiberglass composition asphalt shingles and appeared to be past the mid-point of its service life (estimated 10-15 years old)

**Recommend** referring to disclosure documents or asking for exact age of roof and any warranty literature available

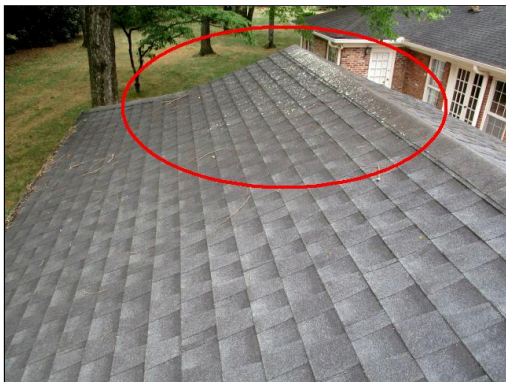
1.0 Item 11 (Picture)

**1.0 (2) Defects were observed on the roofing surface:**

- Physical damage with visible asphalt and fiberglass was observed in areas. This damage most likely occurred from storm damage.
  - Leaks can be expected if repairs are deferred
- The bottom of the valley was collecting debris. Debris shelters water accelerating the process

of deterioration creating a higher potential for future leaks.

- Moss growth was observed in areas. Moss growing on any roof surface will be more severe on roof sections that area shaded and exposed to periodically damp cool weather conditions. Because moss growing on a roof surface will hold moisture on the roof longer than other areas, these growths can reduce the service life of the roof covering, causing permanent damage if the growth is left unchecked

**Recommend** a qualified roofer complete repairs necessary

**Recommend** keeping the valley areas free of debris at all times

**Recommend** a professional clean these areas of the roof. Aggressive cleaning by a non-professional may produce a nice aesthetic result but at the expense of damaging the shingles

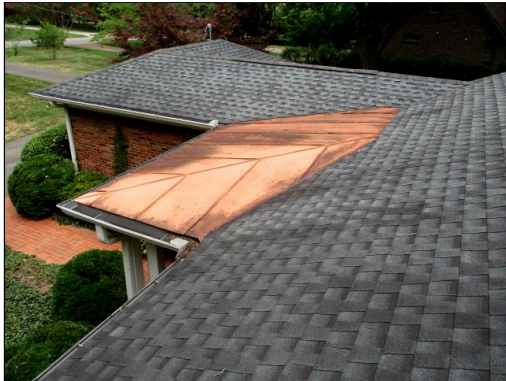
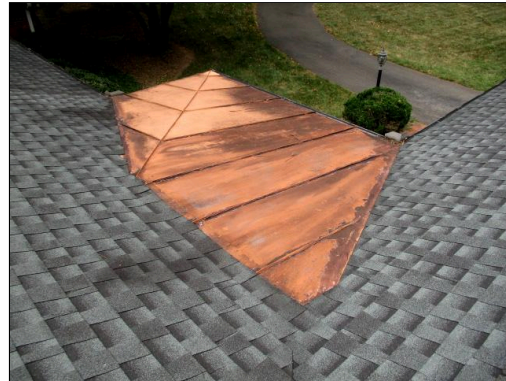
**1.0 (3)** Standing seam metal roofing was installed on the home

performing as expected

**Recommend** referring to disclosure documents or asking for exact age of roof and any warranty literature available

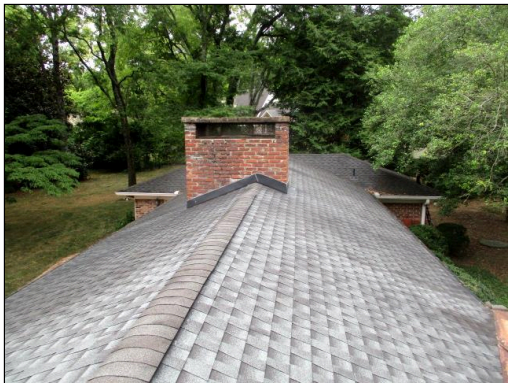
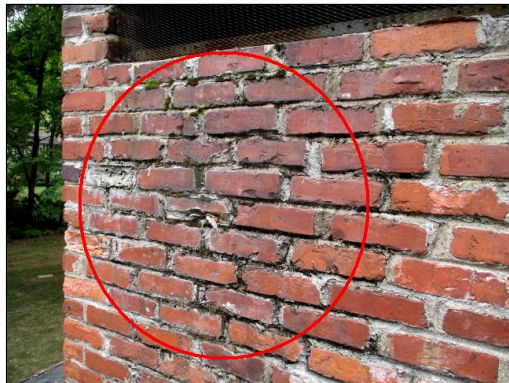
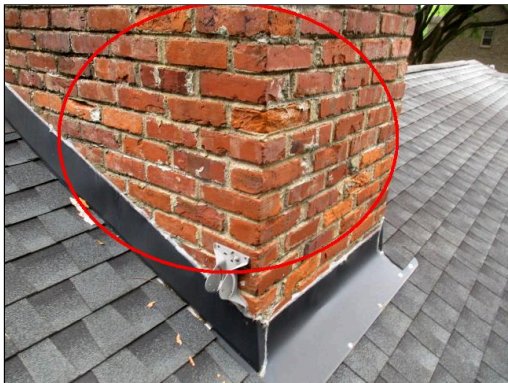
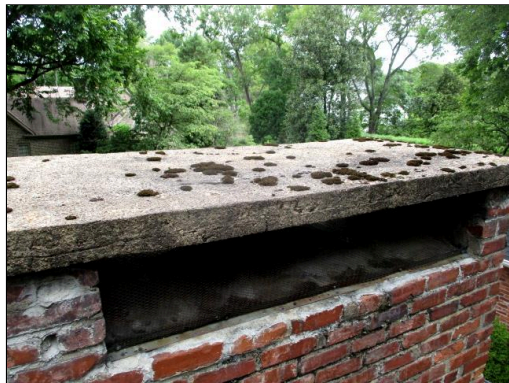
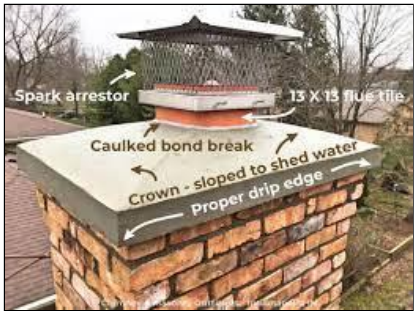
**1.2 (1)** There were defects observed on the chimney:

**Recommend** a qualified stone mason tuck-point the chimney brick to avoid more extensive repairs in the future that may include moisture intrusion into the home.

**Recommend** that a chimney sweep or stone mason repair or replace the chimney cap as needed. Magnolia recommends a chimney sweep certified by the Chimney Safety Institute of America (CSIA).

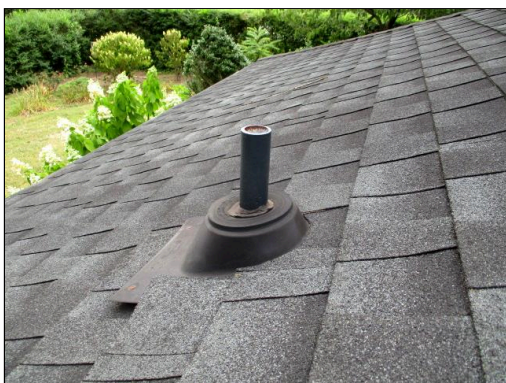
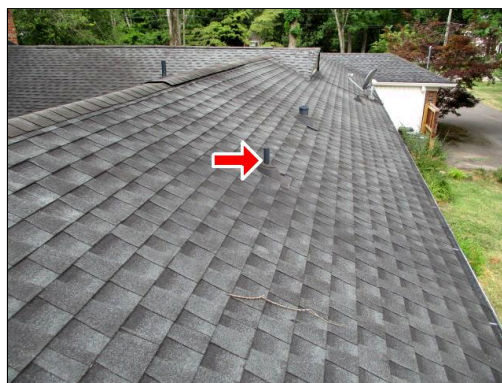
shed water. Trapping water at this location can prematurely result in dry rot and leaks in the near future.

**Recommend** a qualified roofer complete repair necessary

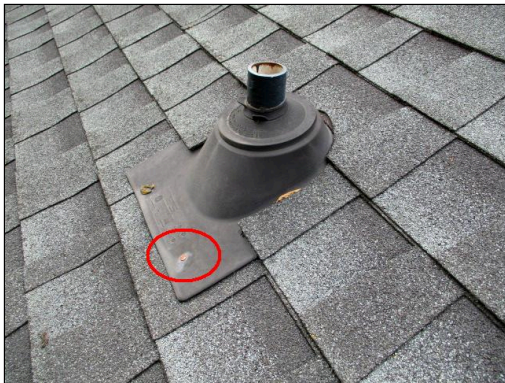
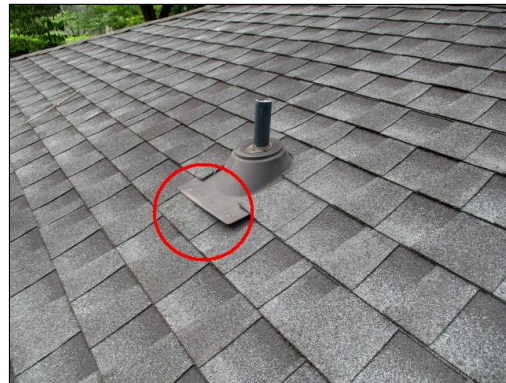
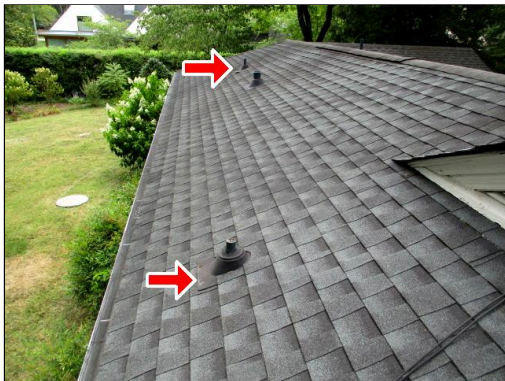
**1.2 (3)** There were defects observed with the roof boots:

**Recommend** roofing contractor apply roofing cement on all exposed nail heads

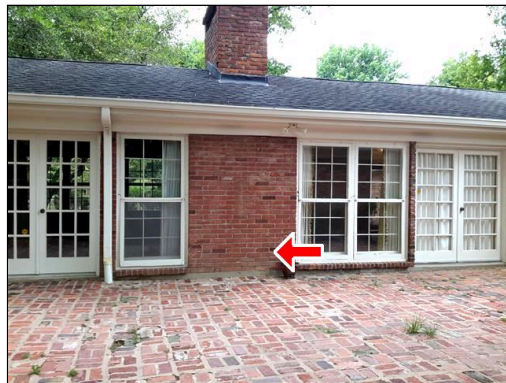
2.0 Item 6 (Picture)

**2.0 (1)** Minor cracks found on the home in multiple locations. The brick exterior is not a structural component of the home

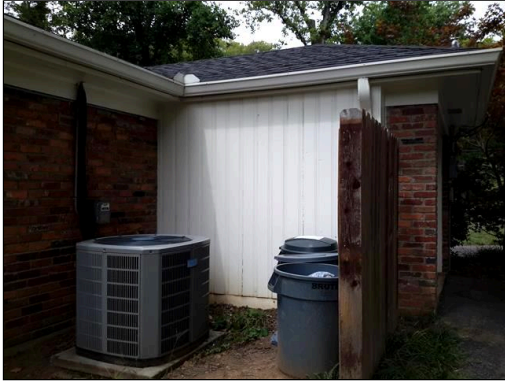
2.0 Item 11 (Picture)

**2.0** (3) Paint on the siding showed signs of deteriorating leaving wood exposed to the elements:

- Accelerated deterioration of the wood will occur if not properly coated.

**Recommend** a qualified paint contractor prep, prime and paint to prevent the need for wood repair in the future (Budget Prudently)

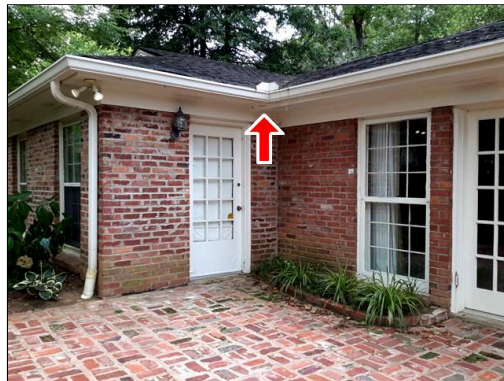
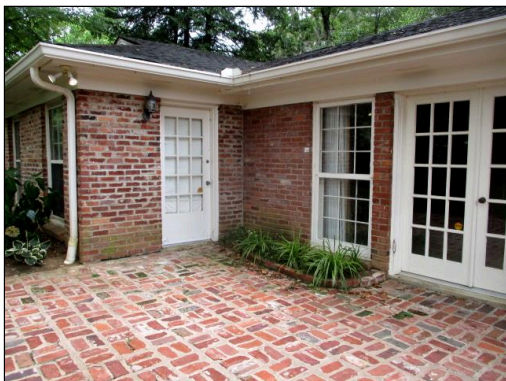
2.1 Item 4 (Picture)

**2.1 (1)** Damage/deterioration was observed on the wood trim on the home (multiple locations).

- A more exhaustive search requiring the removal of trim and siding may uncover more extensive damage; diagnoses of the scope of work is beyond the scope of Home Inspection.

**Recommend** a paint contractor or exterior specialist provide scope of work and budget for all repairs necessary. (Having an exterior specialist quote to wrap with metal is a zero-maintenance, long-term option)

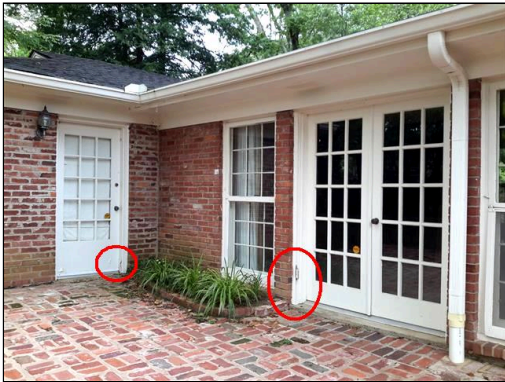
2.2 Item 1 (Picture)

**2.2** (1) Exposed wood was observed at the bottom of the door jamb:

- Accelerated deterioration will result if maintenance is deferred. This is a high-moisture area and will require on-going maintenance every 1-2 years. A long-term solution would be to replace the bottom 8 inches with a non-rot material

**Recommend** a qualified paint contractor prep, prime and paint to prevent the need for wood repair in the future. (Having an exterior specialist quote to wrap with metal is a zero-maintenance, long-term option)

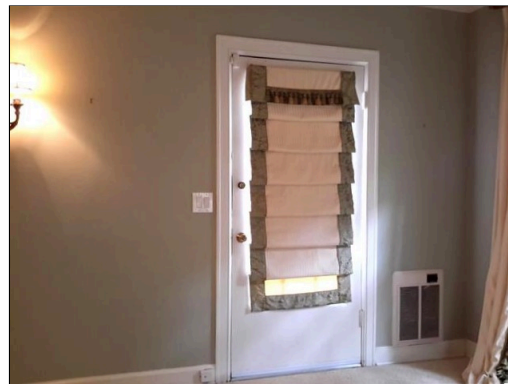
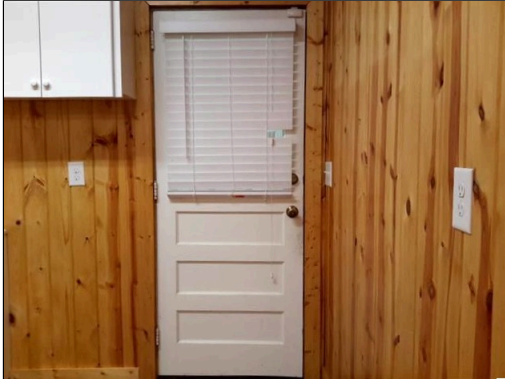
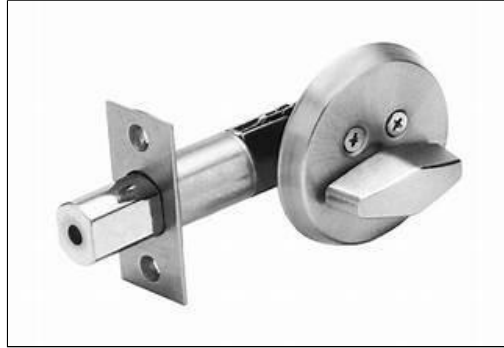
2.2 Item 7 (Picture) EXAMPLE

**2.2 (3)** Several doors on the home were in need of a new dead bolt:

- The dead bolt on the back door required a key on the interior of the home to unlock and lock the door
- The concern is if there was a fire and the key was not in the door, it would take time to find the key and you may not be able to exit in time

Consider changing the dead bolt to a standard turn style

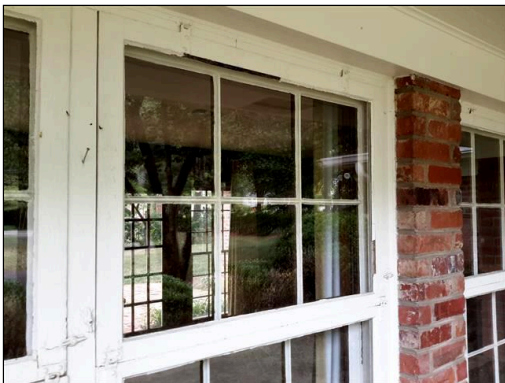
2.3 Item 1 (Picture)

**2.3 (1)** Peeling paint observed on the exterior windows:

- Accelerated deterioration, leading to more costly moisture intrusion issues is expected from exposed wood if repairs are deferred

**Recommend** priming and painting soon (Wrapping wood trim with metal is an economical, long-term solution)

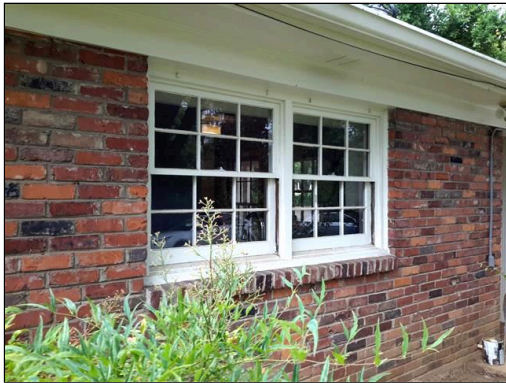
2.3 Item 5 (Picture) Missing Storm Windows

**2.3** (2) The majority of windows appeared to be covered with a storm window:

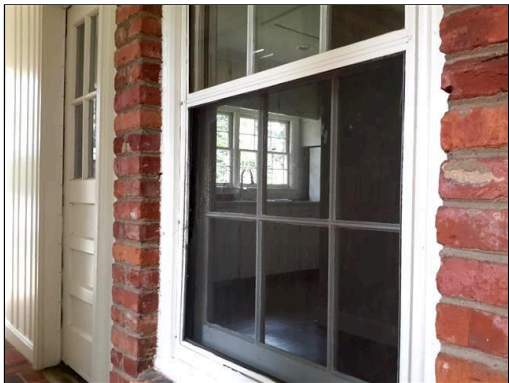
2.3 Item 6 (Picture)

**2.3 (3)** The window screens were at the end of their intended life-span and will be in need of replacement.

**Recommend** budgeting to replace the window screens in the near future.

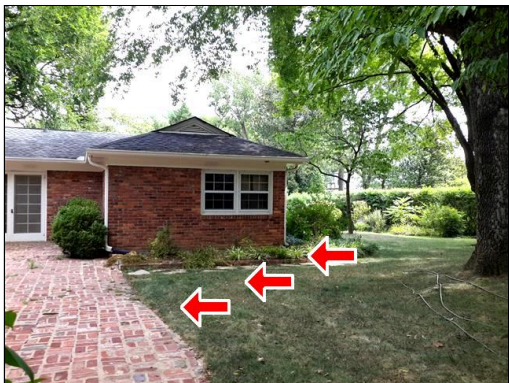
2.4 Item 1 (Picture)

**2.4** (1) There was a neutral or negative slope at the back of the home that **does not** divert water run-off away from the foundation of the home:

- This condition can result in moisture intrusion and high moisture levels in the crawlspace. In worst cases excessively high moisture levels are maintained in the soil at the foundation. Over time this can cause the soil to loosen, losing its compaction strength (ability to hold the weight of the foundation) and lead to foundation movement.
- Ideally the grading should slope 6 inches over the first 10 feet away from the house foundation.

**Recommend** re-grading/back-filling these areas to improve drainage near the foundation and help reduce the risk of future foundation damage.

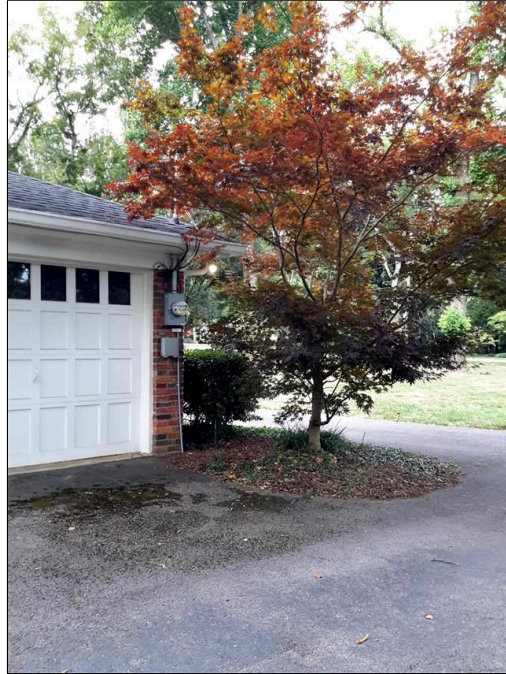
2.4 Item 5 (Picture)

**2.4 (2)** Tree limbs were observed to be in close proximity with roof or exterior trim of the home:

**Recommend** keeping tree limbs back from the home approximately 5-10 feet. On-going maintenance item

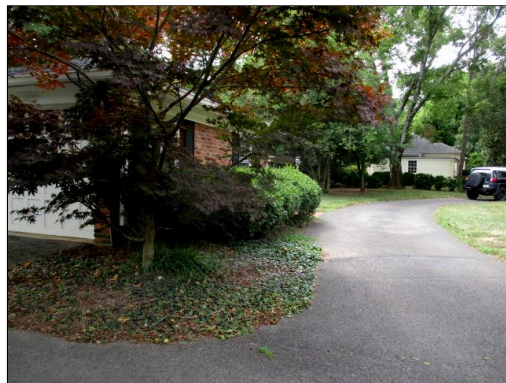
2.4 Item 7 (Picture)

**2.4 (3)** Defects were observed in the asphalt driveway:

**Recommend** filling the cracks with a color-match professional-grade epoxy grout, install a seal coat and monitor. If movement continues to occur, a qualified asphalt contractor can advise on repair options

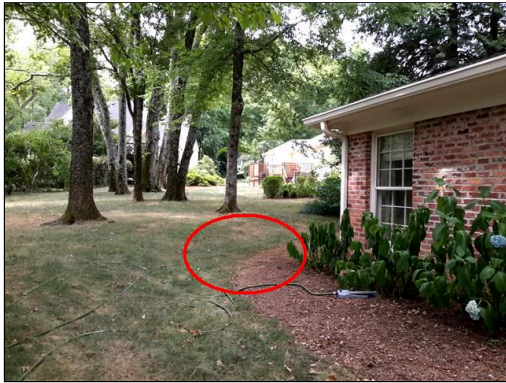
2.4 Item 8 (Picture)

**2.4 (4)** A low spot was observed on the back of the home:

**Recommend** a landscape contractor advise on options to drain this area appropriately

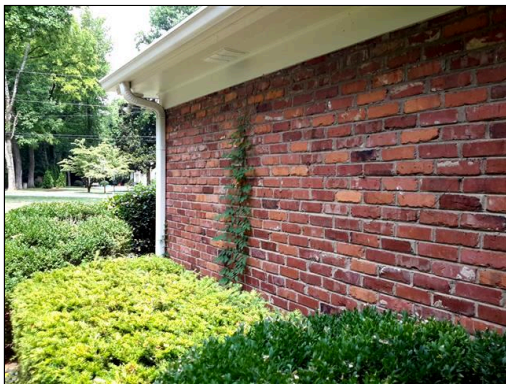
2.4 Item 9 (Picture)

**2.4 (5)** Vegetation on exterior walls can retain moisture and accelerate deterioration of the building components, even brick:

**Recommend** cutting back or the removal of heavy vegetation from exterior walls

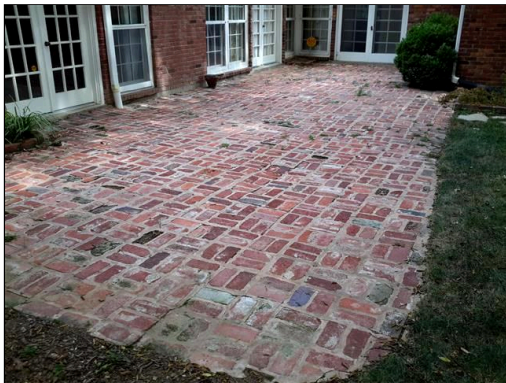
2.5 Item 1 (Picture)

**2.5 (1)** There were Moderate cracks and brick spalling in the back patio:

- This was most-likely caused by tree roots in the adjacent area
- Although defects like these are often considered cosmetic, repair costs can be substantial and require the services of a specialized contractor or structural engineer. Budget Prudently

**Recommend** a specialized concrete contractor review and provide a quote and scope of work

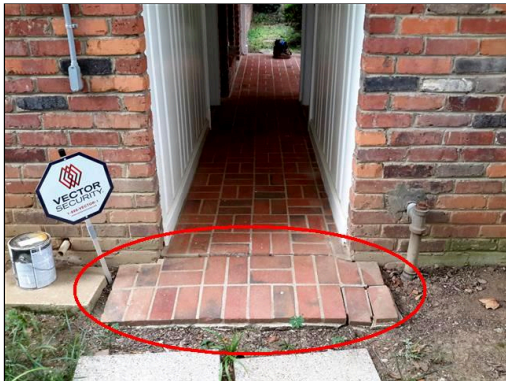
2.5 Item 3 (Picture)

**2.5 (2)** A trip hazard was observed in the side walkway (North-side of Home):

- These cracks can be typical for a home of this age

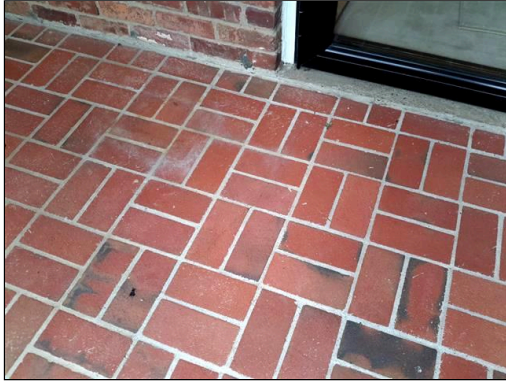
2.5 Item 4 (Picture)

**2.5** (3) There was a small crack in the front porch:

**Recommend** an exterior contractor seal the cracks with epoxy and monitor

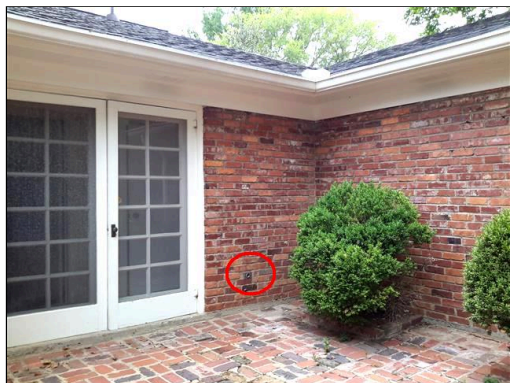
2.7 Item 3 (Picture)

WEATHERPROOF RECEPTABLE COVER

**2.7 (2)** Defects were observed with the exterior plug at the back of the home:

**Recommend** replacing the cover as soon as possible

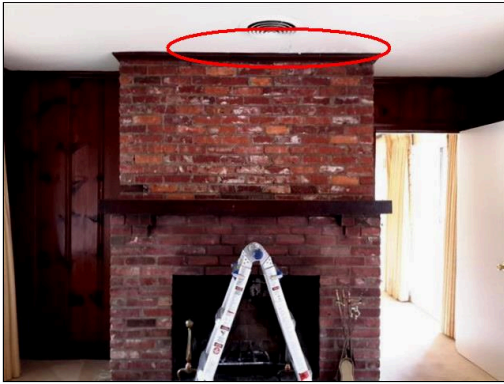
3.0 Item 1 (Picture)

**3.0 (1)** Stains in the ceiling were observed in the back living room:

- Elevated moisture levels were observed at this location
- Signs of microbial growth was present. Only results from an accredited laboratory (American Industrial Hygiene Association (AIHA), i.e) can identify Mold Test samples for potential hazard. Unless a Mold Test was previously requested, we did not test indoor air quality or determine if this growth is or is not a health hazard. A person's health is a truly personal responsibility. If you or your family members suffer from allergies or asthma, a Mold Test to determine threat level of airborne microbial particles is **recommended**. If hazardous microbial particles are identified inside the home, remediation of the source of that growth should occur before taking measures to control moisture. For more information visit: [EPA Mold Control](#)

**Recommend** a qualified roofer review the roof for necessary repairs before painting the interior. DO NOT finish paint before priming stains with a stain-block primer

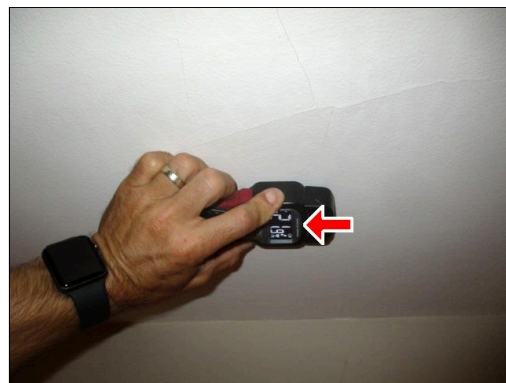
3.0 Item 4 (Picture)

**3.0 (2)** Stains in the ceiling were observed in the back bedroom:

**Recommend** a qualified roofer review the roof for necessary repairs before painting the interior. DO NOT finish paint before priming stains with a stain-block primer

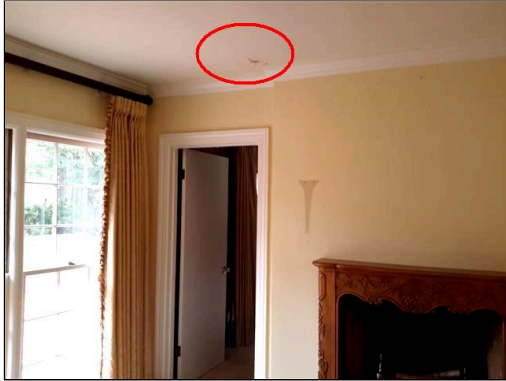
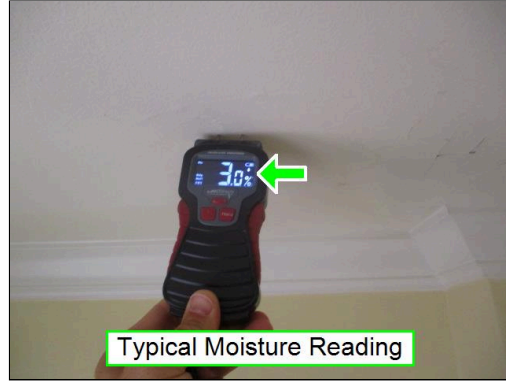
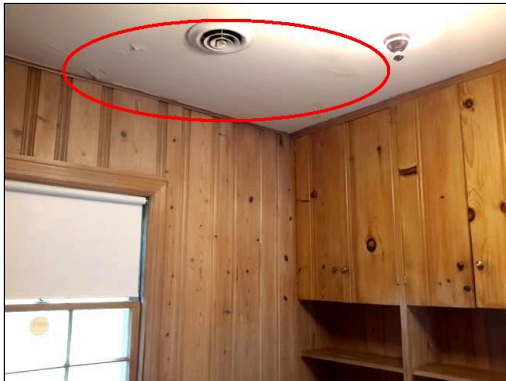
**3.0** (3) Stains in the ceiling were observed in the living room and pantry:

- There was no indication of an active leak at the time of the inspection

**Recommend** asking the seller about the history of leaks and any associated repairs. DO NOT finish paint without priming stains with a stain-block primer

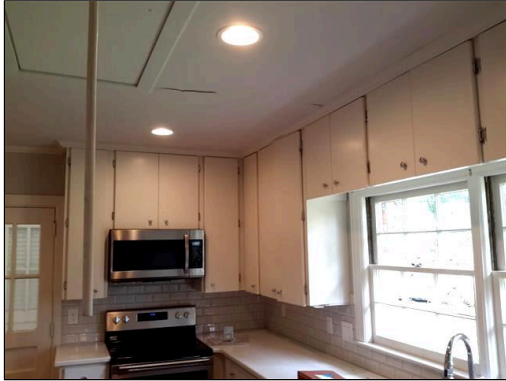
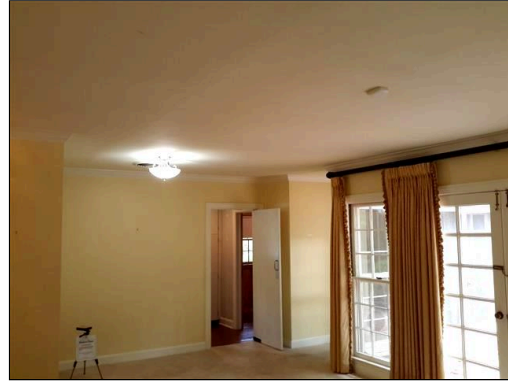
**3.0 (4)** Crack in drywall seam observed in the throughout the home:

- This can be typical for a home of this age
- Often occurring during the winter months when low humidity causes contraction or during changing seasons when both expansion and contraction occur within a 24 hour period

**Recommend** a qualified remodel painter using mesh tape when addressing this particular crack. Mesh tape help allow for more movement without resulting in additional cracks. Cosmetic Issue

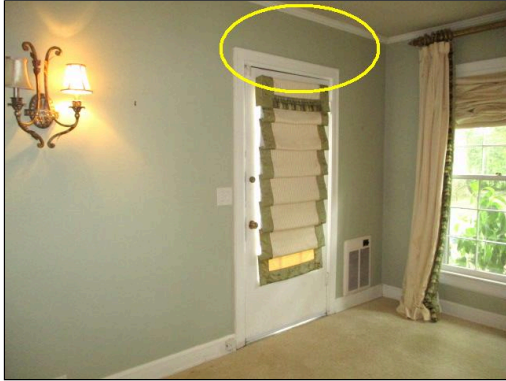
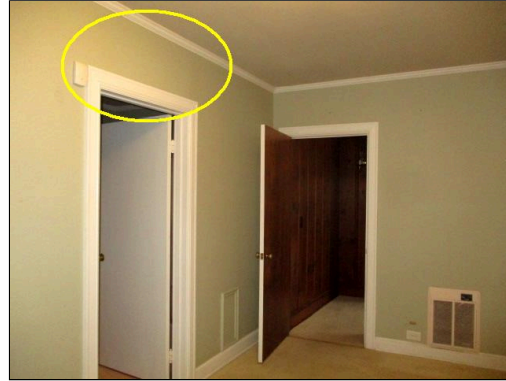
**3.1** Crack in drywall seam observed in the throughout the home:

- This can be typical for a home of this age
- Often occurring during the winter months when low humidity causes contraction or during changing seasons when both expansion and contraction occur within a 24 hour period

**Recommend** a qualified remodel painter using mesh tape when addressing this particular crack. Mesh tape help allow for more movement without resulting in additional cracks. Cosmetic Issue

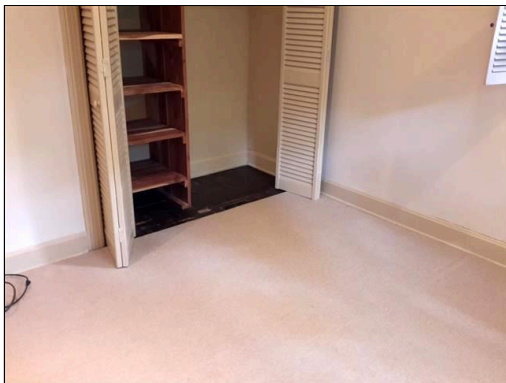
3.2 Item 1 (Picture)

**3.2** Vinyl tile in the back bedroom resembles vinyl asbestos tile. Vinyl asbestos tile was introduced in the 1950's and still commonly found in many homes built in this time period. The only means of identifying the material makeup is through lab analysis. According to the Mesothelioma Center, vinyl asbestos tile toxicity is considered low and the product is not considered friable.

The abatement of asbestos tile is not considered as dangerous as abatement of vinyl sheet flooring but the U.S. Environmental Protection Agency (EPA) always recommends contacting a professional for any abatement project.

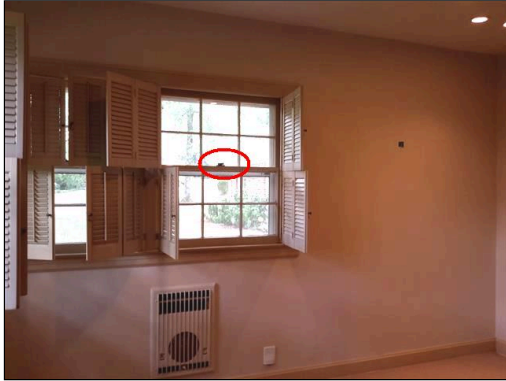
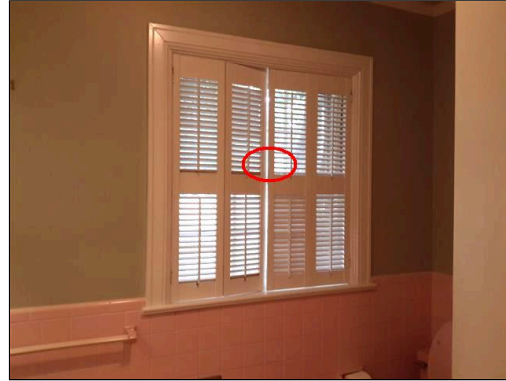
**3.3** (2) The hardware on the back bedroom and master bathroom window was in need of adjustment:

- The hardware did not engage to lock the window

Appropriate adjustments/repairs can be completed by a competent handyman.

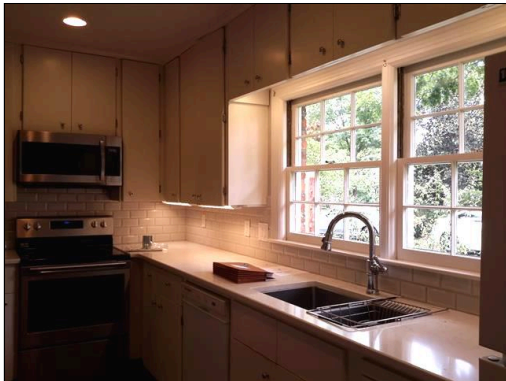
3.3 Item 4 (Picture)

**3.3** (3) A number of the original windows were not functional:

**Recommend** having at least one window operable in every room

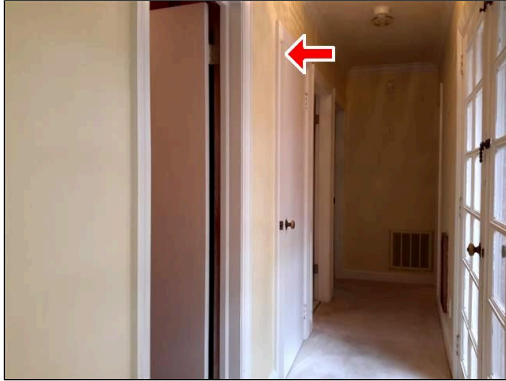
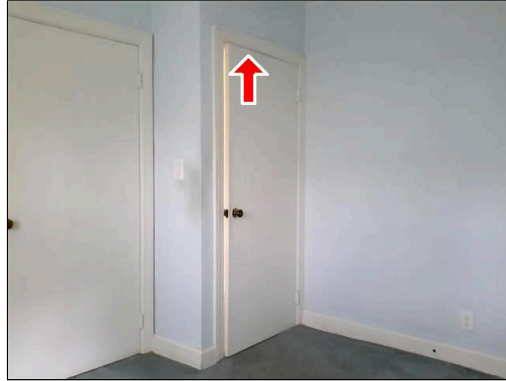
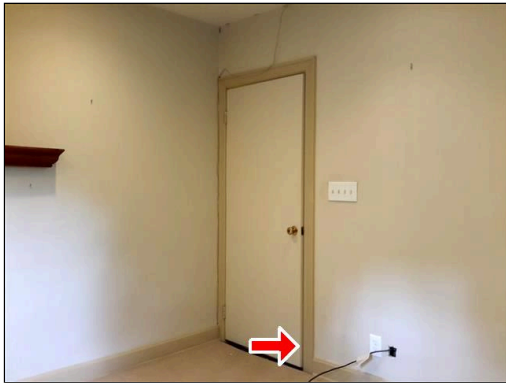
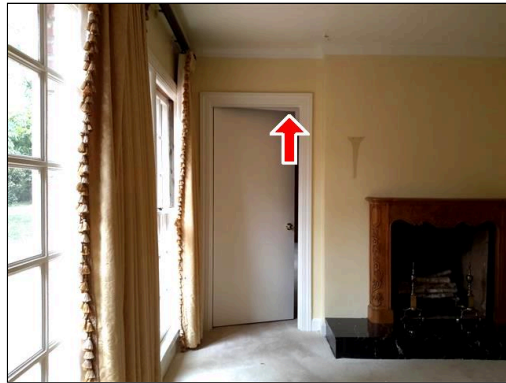
**3.4 (1)** Several interior doors were in need of adjustment:

Appropriate adjustments/repairs can be completed by a competent handyman.

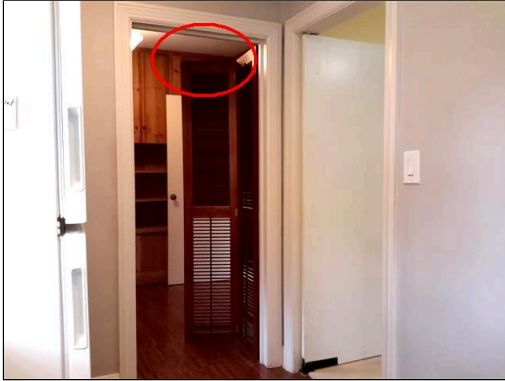
3.4 Item 5 (Picture)

**3.4** (2) The hardware on the pantry door was in need of adjustment:

- The door hardware was in need of repair

Appropriate adjustments/repairs can be completed by a competent handyman.

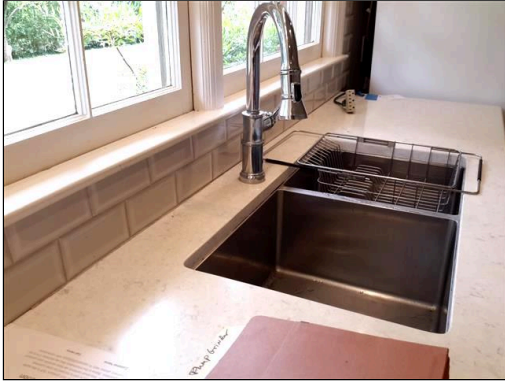
3.6 Item 1 (Picture)

**3.6** (1) Caulking was cracked on the countertop in the kitchen.

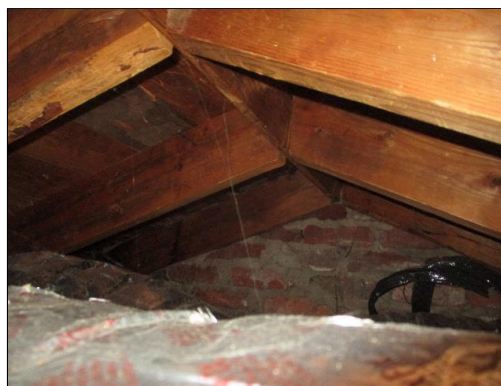
4.3 Item 2 (Picture)

**4.3 (1)** Leak stains were observed on the roof's decking and framing members.

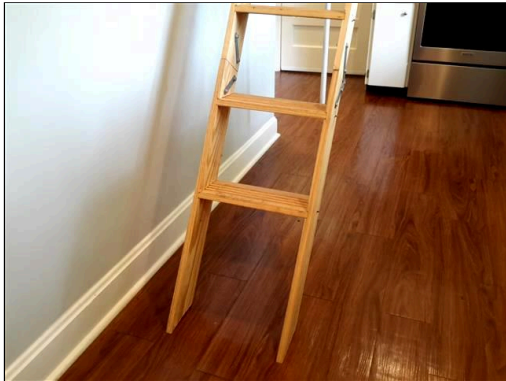
4.4 Item 1 (Picture)

**4.4** (1) The pull-down attic staircase was in need of repair:

- The pull-down attic access was missing a first step

A competent handyman should be capable of necessary repairs

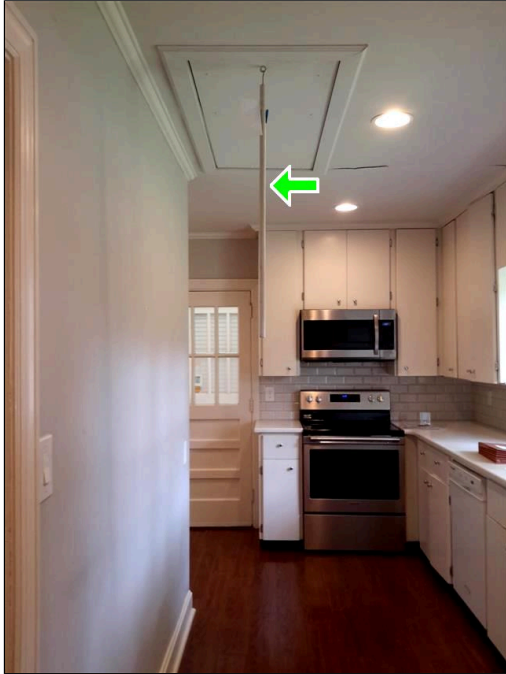
4.4 Item 5 (Picture)

**4.4 (3)** The pole used to pull the attic access down was located in the kitchen. This pole eliminates the presence of a string hanging in the hallway. Good

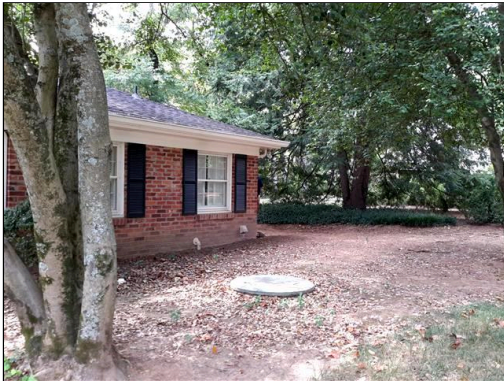
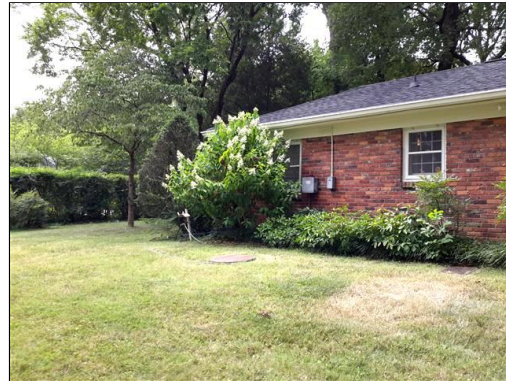
**5.0 (3)** A wastewater pump was observed:

- These are typically used to pump the home's wastewater up to the main municipal sewer line
- Inspection of the pump, tank, functionality and maintenance needs is outside the scope of a Home Inspection

**Recommend** asking the Seller about the maintenance needs of the wastewater pump system and who would be responsible for those needs or any necessary repairs (e.g. home owner or municipality) or reference the disclosure documents

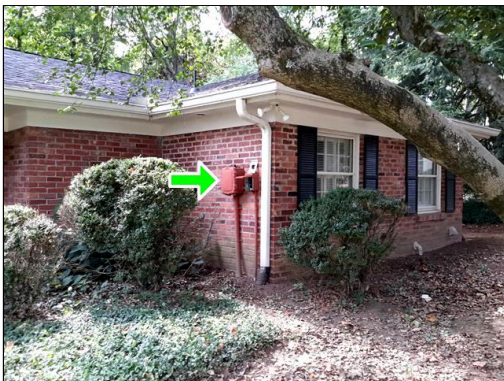
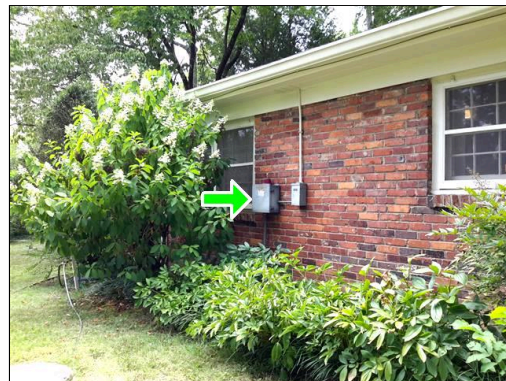
**5.0 (4)** The home appeared to be on a sewer pump system. The sewer pump box was located on the front and North-side of the home. Inspection of a sewer pump is outside the scope of a Home Inspection.

- An alarm box was installed on the back of the home in case of pump failure

**Recommend** referring to disclosure documents or contacting the HOA or local municipality for information on responsibility for maintaining the sewer pump system (Who to call for Emergency?) and any documentation of recent inspections.

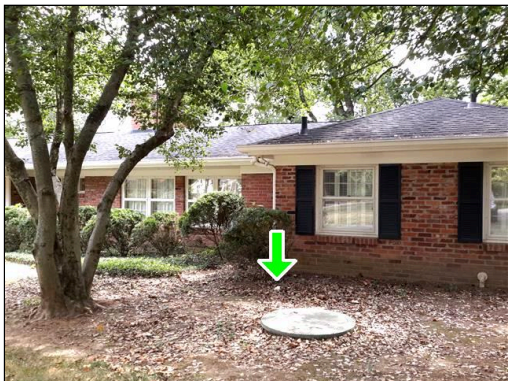
5.0 Item 7 (Picture)

**5.0** (5) Access to sewer line for maintenance at locations called 'clean-outs' were found:

- Clean-outs allow for easy access to plumbers for clearing major clogs in waste drains.
- Large equipment can be operated outside with exterior clean-outs. Good

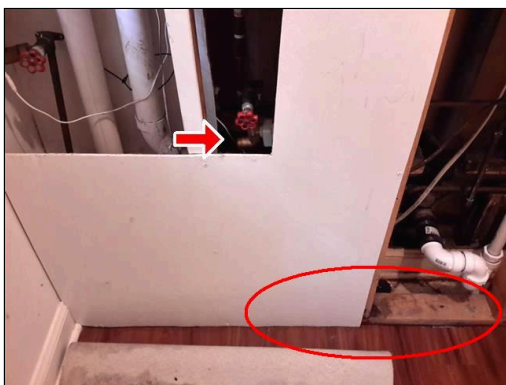
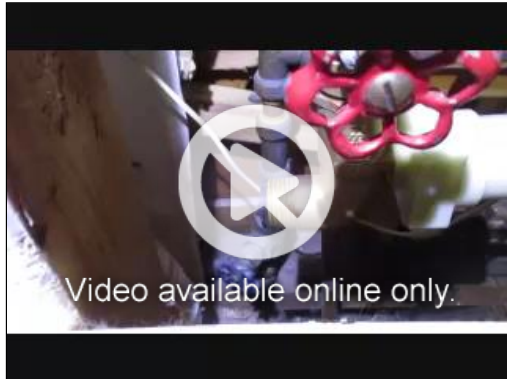
**5.1** There was an indication of a leak on the supply plumbing line:

- This was an active leak in need of immediate repair
- This leak appeared to be located under the laundry room
- Signs of microbial growth was present. Only results from an accredited laboratory (American Industrial Hygiene Association (AIHA), i.e) can identify Mold Test samples for potential hazard. Unless a Mold Test was previously requested, we did not test indoor air quality or determine if this growth is or is not a health hazard. A person's health is a truly personal responsibility. If you or your family members suffer from allergies or asthma, a Mold Test to determine threat level of airborne microbial particles is **recommended**. If hazardous microbial particles are identified inside the home, remediation of the source of that growth should occur before taking measures to control moisture. For more information visit: [EPA Mold Control](#)

**Recommend** a qualified plumber review plumbing in this area and complete appropriate repairs.

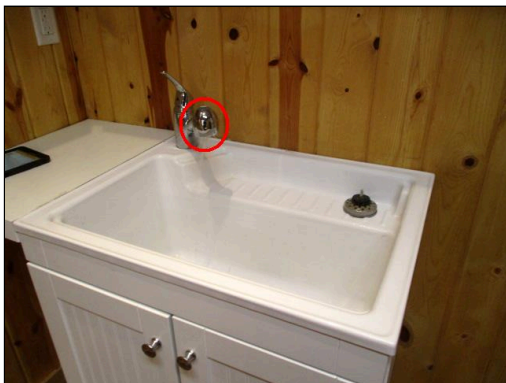
5.2 Item 1 (Picture)

**5.2** The detached studio faucet was missing the diffuser screen.

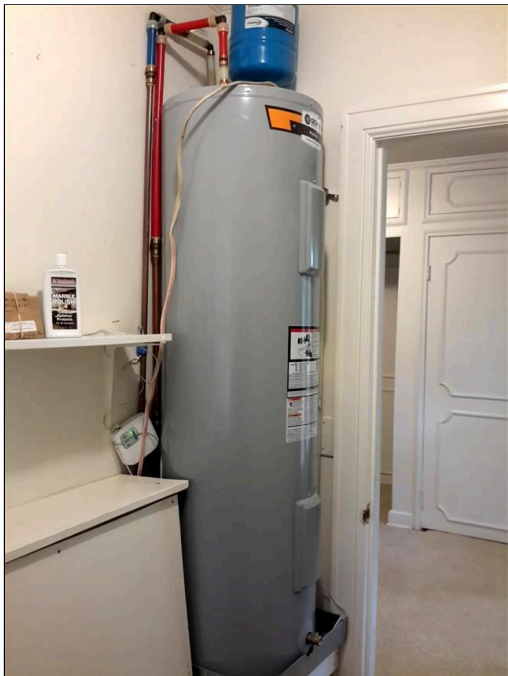
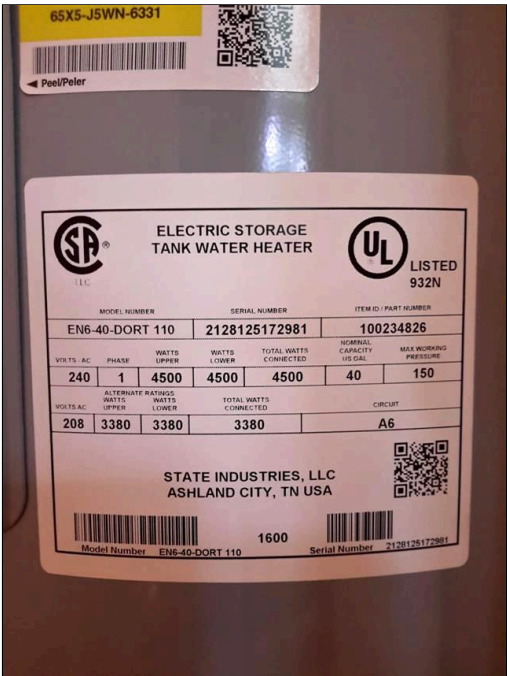
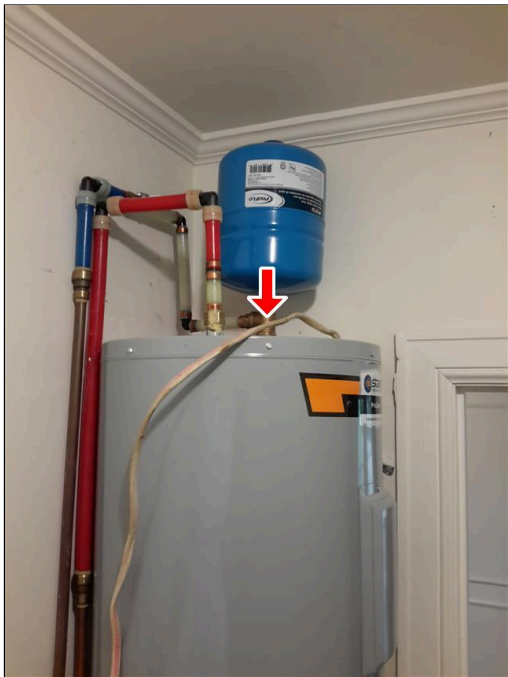
- An expansion tank was located on the water line. When the water heater makes hot water, the water in the system expands. The expansion of the warm water increases the pressure on the homes water pipes. The expansion tank absorbs the extra pressure, increasing the life expectancy of faucets and shut-off valves in the home. Good
- The TPR valve (Temperature and Pressure Relief) had an extension to catch leak pan with passive drain.

Defects were observed with the water heater:

**Recommend** a qualified electrician complete repairs necessary

**Recommend** a plumber provide options for upgrading to a larger water heater, or tankless in the future

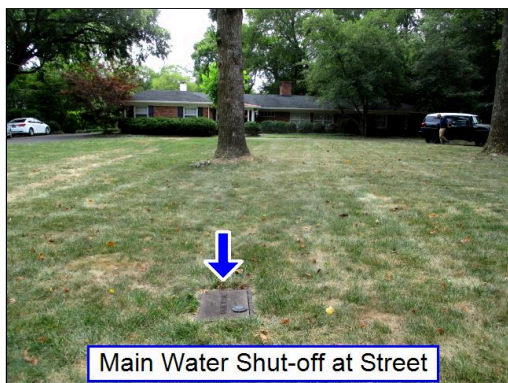
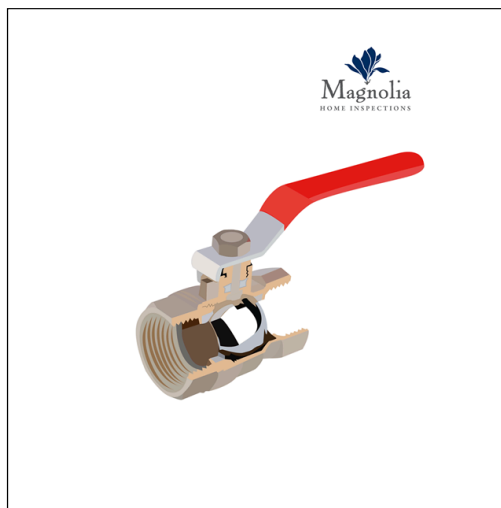
- If one does not exist, a water key will need to be used at the street meter to shut the water off
- It is prudent to have access to a main shut-off in the event of an emergency to reduce/eliminate water damage to the home in such an event

**Recommend** asking seller for knowledge of an interior water shut-off location. Have a plumber install an interior shut-off ball valve in the future if one does not exist (Considered an Upgrade)

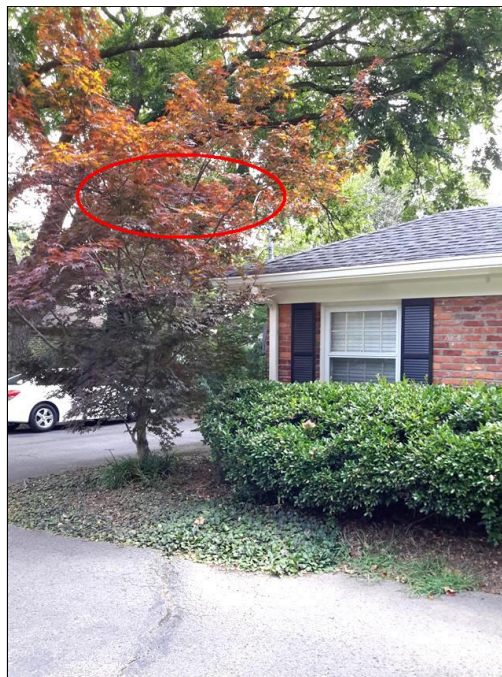
6.0 Item 2 (Picture)

**6.0** Defects were observed with the Service Entrance Conductors:

**Recommend** cutting limbs approximately 5 feet surrounding the entrance conductors

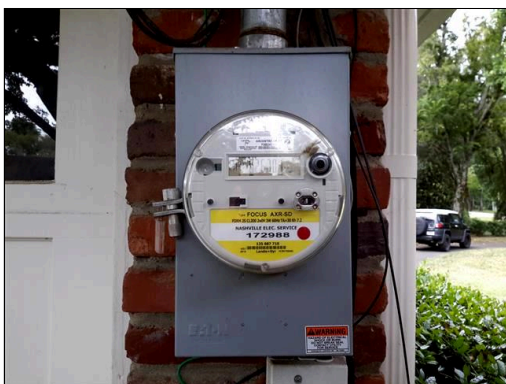
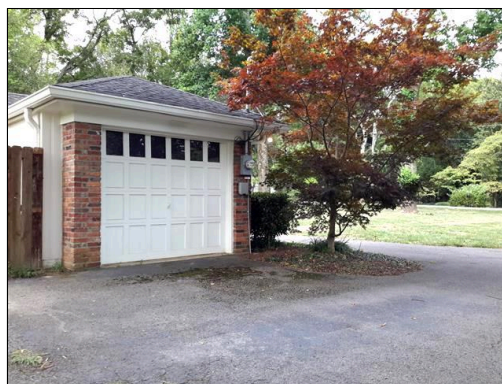
**6.1** The 200 amp meter was located on the North-side of Home:

- The meter was grounded. Good

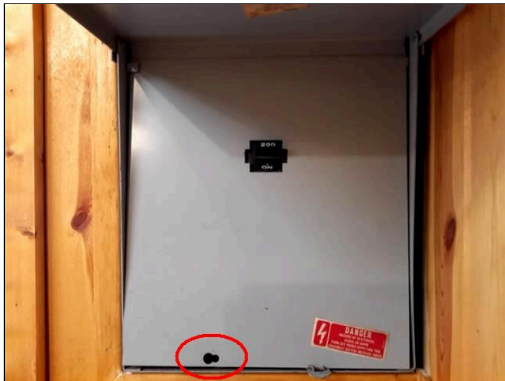
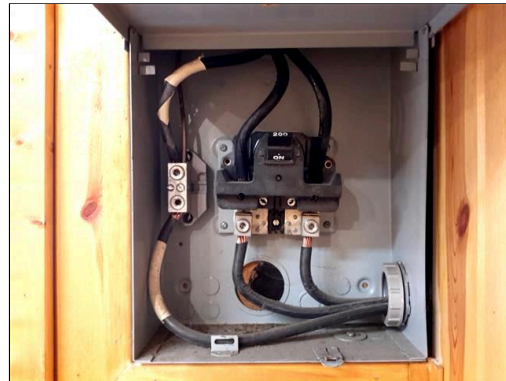
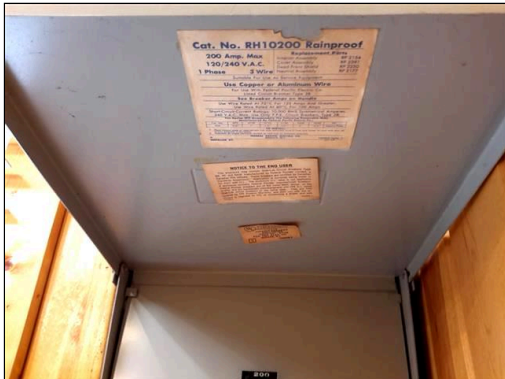
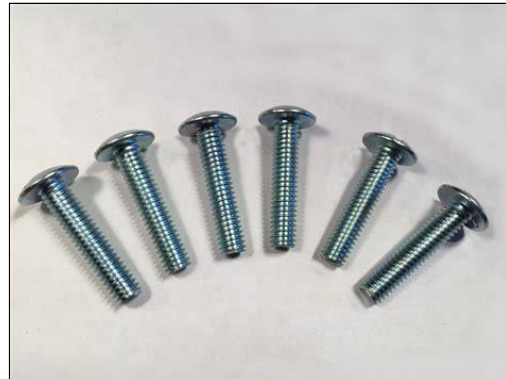
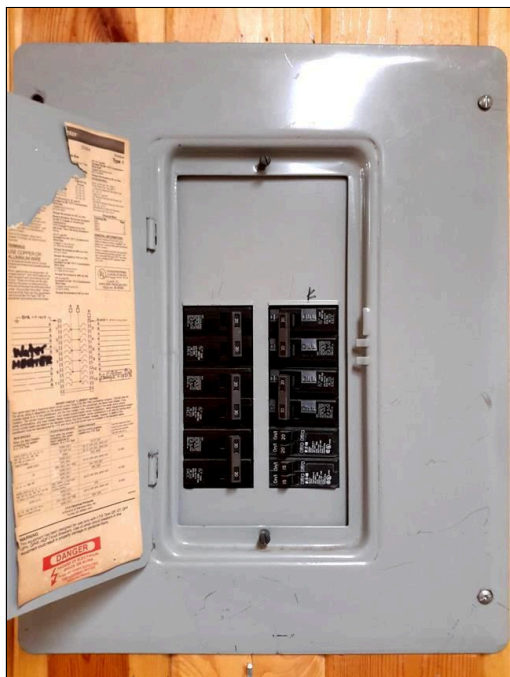
**6.2 (1)** The main service panel appeared to be a FEDERAL PACIFIC 200 amp located in the detached studio

The panel was clearly labelled and had defects:

- The service panel was made by Federal Pacific. Federal Pacific service panels (popular through the 1970's) are reputed to have a high rate of circuit breaker failure which can result in a fire or shock/electrocution. The circuit breakers inside have melted to the main 'bus bar' not allowing the breaker to ever trip, even when there's a short or overloaded circuit.
- Front panel screws were missing
- Dielectric grease was missing from the main service lugs
  1. Dielectric grease provides insulation for high voltages and prevent corrosion on the metal contacts

**Recommend** asking your insurance provider about the need for replacement of a Federal Pacific panel

**Recommend** a licensed electrical contractor provide quote for replacing the panel.

**Recommend** replacing the machine screws with fasteners appropriate for an electrical panel front

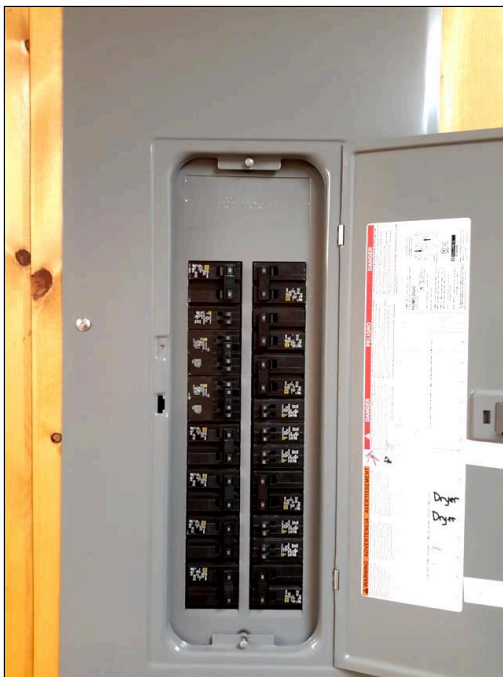
6.2 Item 10 (Picture)

The panel was not clearly labelled and had defects:

- Tandem breakers have been physically altered in order to forced into a location not intended by the manufacturer. Altering or manipulating breakers and the panel is considered a SAFETY HAZARD. There was room at the bottom of the panel for tandem breakers.

- Cloth wiring with aged rubber insulators were present in the home. The presence these wires were found in the electrical panel, currently providing electrical current to the oven only (typical of a home of this age). The rubber in these conductors are highly friable and are to be replaced if moved during a remodel or serious electrical repairs. (If the cloth-wiring conductors are to remain, it is **recommended** that your insurance provider be consulted about the presence of cloth-wrapped, rubber insulated tinned-copper conductors in the electrical panel and how this might affect your premium rates)

**Recommend** that all electrical corrections be made by a qualified electrical contractor

**Recommend** correctly labeling the panel circuit breakers before walk-through. In the event of an emergency it is necessary to shut-off power to a circuit without shutting off power to the entire home

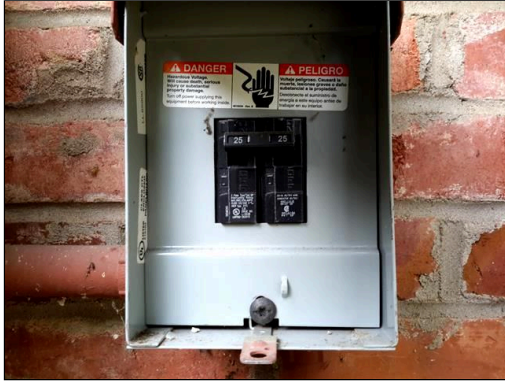
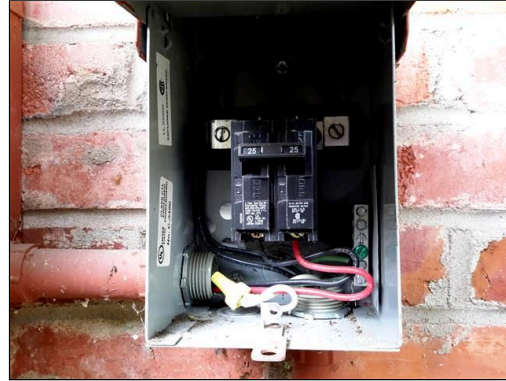
**6.2 (4)** The disconnect panel appeared to be a 25 amp located on the front of the home.

The panel was clearly labeled and the installation appeared to be clean and met standards of quality workmanship. Good
