**CITY OF BELLE MEADE  
HISTORIC ZONING COMMISSION  
REGULAR MEETING AGENDA PACKET  
JANUARY 14, 2025, 03:00 PM**

**A. The application for a Certificate of Appropriateness, #A24-31, of Dan Viner, 436 Westview Avenue, for a demolition of a single family residence.**

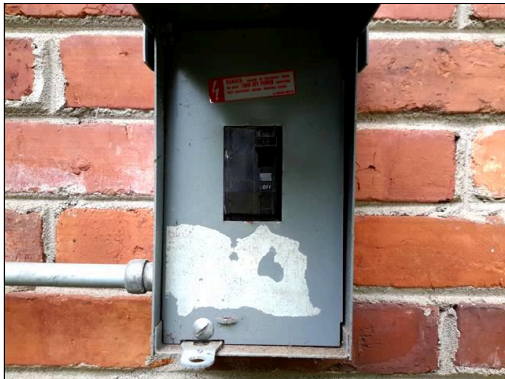
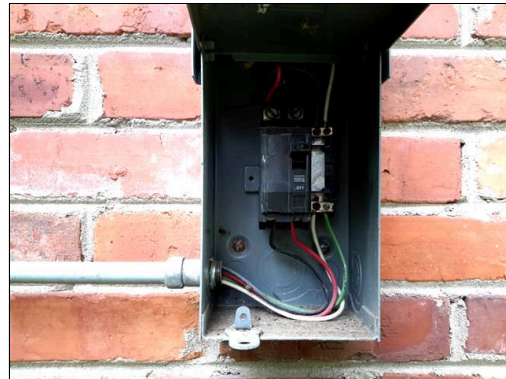
**6.2 (5)** The disconnect panel appeared to be a 20 amp located on the North-side of Home.

The panel was clearly labeled and the installation appeared to be clean and met standards of quality workmanship. Good

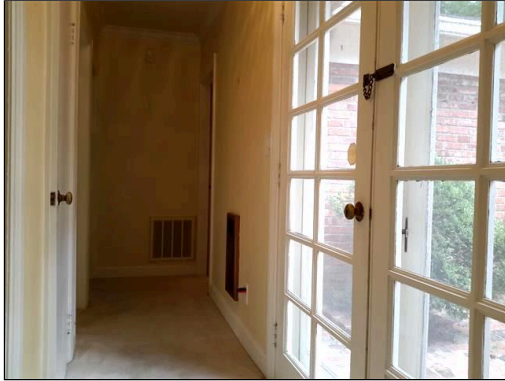
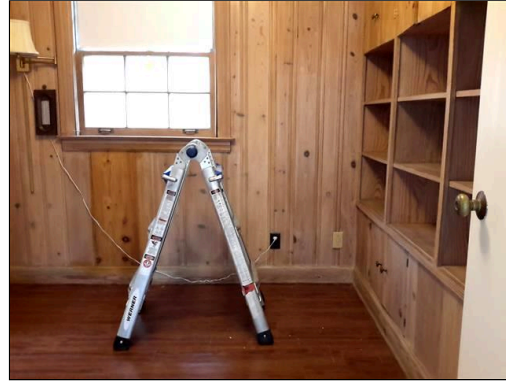
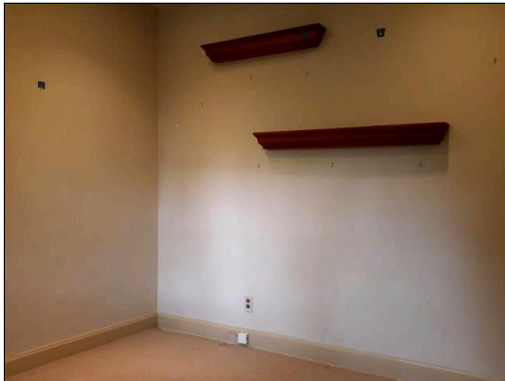
**6.4** Un-grounded 2-prong and 3-prong wall plugs were observed throughout the home:

**Recommend** labeling the ungrounded 3-prong plugs**Recommend** a qualified electrician install a GFCI breaker for this circuit and labeling the plugs as "ungrounded GFCI protected". Grounded plugs are generally recommended for expensive electronic equipment

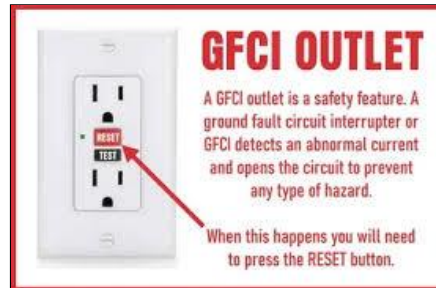
6.5 Item 2 (Picture) EXAMPLE

**SAFETY HAZARD**

**Recommend** a licensed electrician install GFCI protection for all plugs necessary as soon as possible

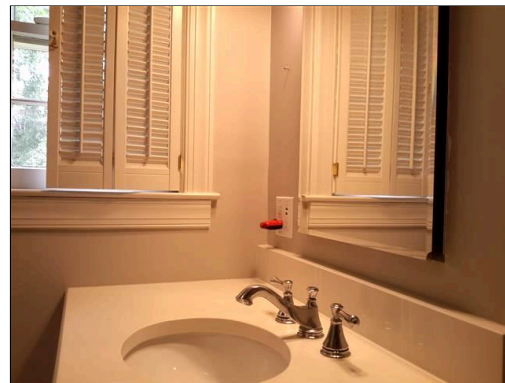
6.5 Item 4 (Picture)

**6.5** (2) The GFCI plugs in the kitchen bathroom were not grounded. Although GFCI plugs can work without a ground these plugs could not be tested for functionality without a ground.

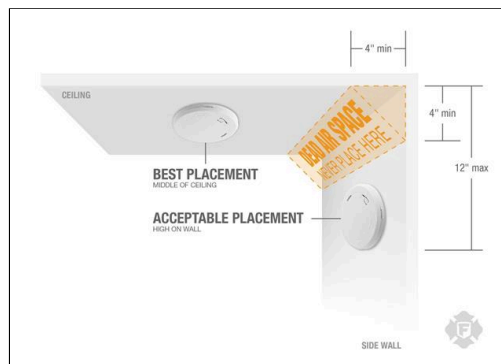
6.6 Item 2 (Picture) EXAMPLE

**6.6** The National Fire Protection Agency recommends installing smoke alarms inside each bedroom, outside each sleeping area and on every level of the home, including the basement:

**Recommend** installing in all appropriate locations

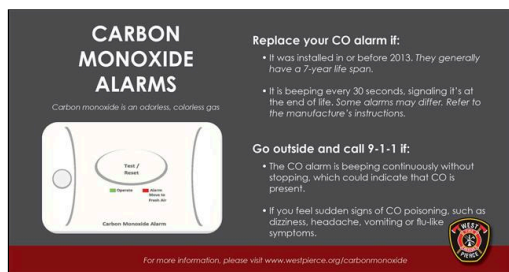
6.7 Item 1 (Picture) EXAMPLE

**6.7** The US Department of Energy recommends all living areas that are supplied by natural gas appliances be protected and monitored by an automatic carbon monoxide warning device:

- Mount the detectors on the walls at least a couple of feet below the height of the ceiling
- An alarm should be installed on every level of the home and in sleeping areas
- Place the alarm at least 15 feet away from fuel-burning appliances
- Make sure nothing is covering or obstructing the unit
- Do not place the unit in dead air spaces or next to a window or door

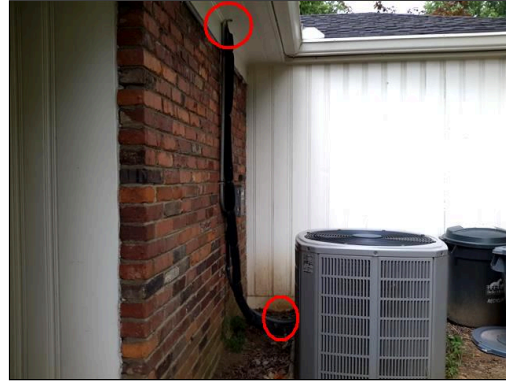
7.0 Item 6 (Picture)

**7.0 (2)** The insulation on the line-set to the condenser outside has deteriorated and is missing in several sections:

- This deficiency decreases the efficiency of the equipment's performance

**Recommend** replacing the insulation on the line-set of the HVAC unit before installing a protective covering

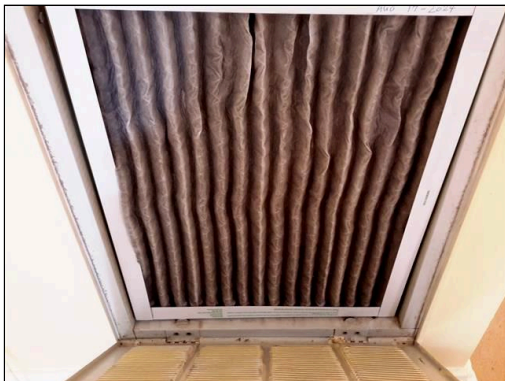
7.1 Item 1 (Picture)

**7.1 (1)** The filter for the HVAC equipment has NOT been replaced in a very long time.

- A clogged air filter can place strain on the equipment resulting in premature maintenance repairs.

Consider signing up for a filter program that reminds you (*or your tenants*) to replace the filter by delivering a new filter to the front door every 30 days.

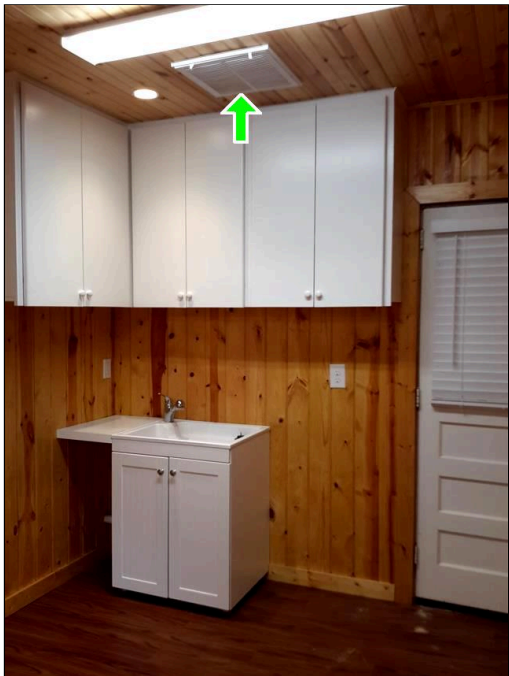
7.1 Item 2 (Picture)

**7.1** (2) A step ladder will need to be purchased in order to change the air filter at the detached garage return:

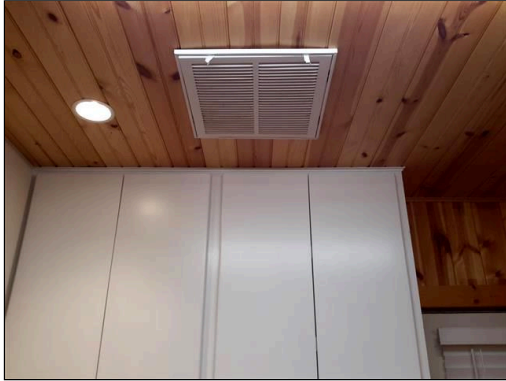
7.1 Item 5 (Picture)

**7.1** (3) There were multiple returns throughout the home - this increases the overall performance and comfort in the home by increasing circulation of conditioned air throughout the home. Good

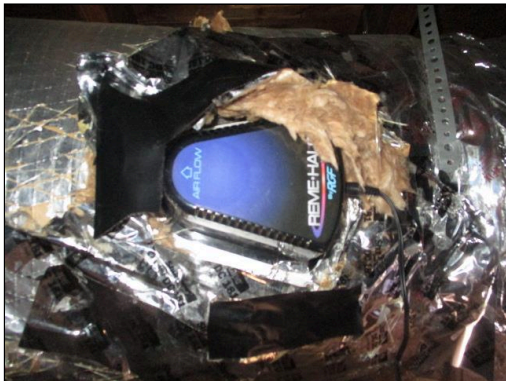
7.1 Item 6 (Picture)

**7.1** (4) A UV Light was installed on distribution equipment, located on the air handler in the attic:

- UV Lights are designed to neutralize airborne pathogens in the air before being distributed into the home.
- Inspection of auxiliary equipment is beyond the scope of a home inspection.
- UV Lights have a limited lifespan and need to be replaced on a routine schedule

**Recommend** asking the seller for more information about the equipment, maintenance and warranty.

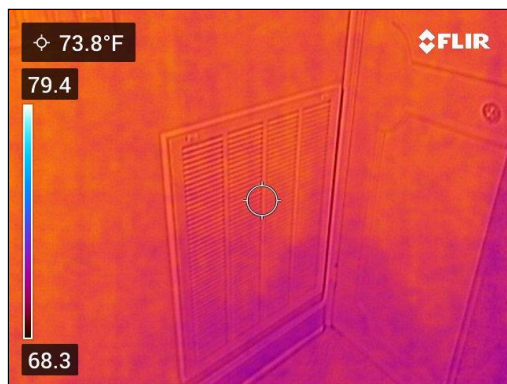
7.2 Item 3 (Picture)

- The return air temperature on your system read 66 degrees, and the supply air temperature was 46 degrees.
- This indicates a temperature variance in the normal range. Good.

This is a minimal test for functionality. A more in-depth evaluation measuring freon levels and equipment performance or need for maintenance requires a technical review with professional equipment by a qualified HVAC technician

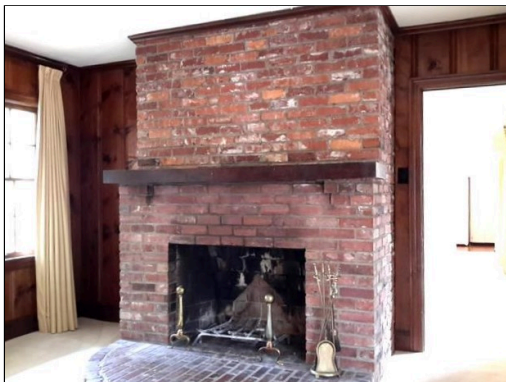
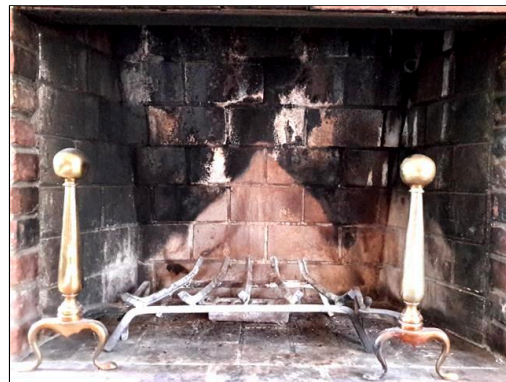
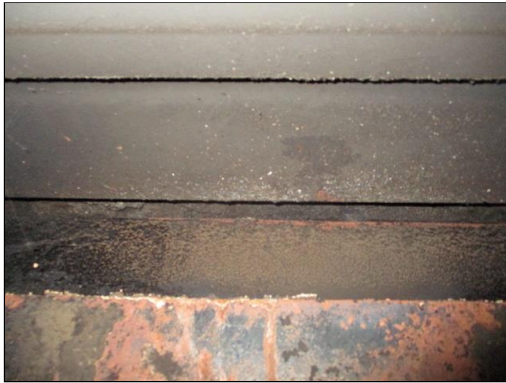
7.4 Item 1 (Picture)

**7.4 (1)** A conventional wood-burning fireplace was observed in the living room:

At the time of the inspection, the damper operated as expected and there were other deficiencies observed:

**Recommend** a chimney sweep complete maintenance necessary and perform a more detailed inspection of the interior of the chimney. Magnolia recommends a chimney sweep certified by the Chimney Safety Institute of America (CSIA).

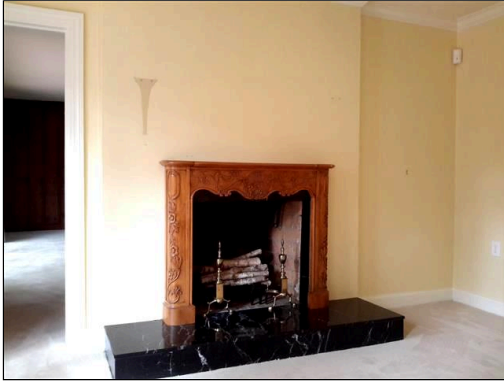
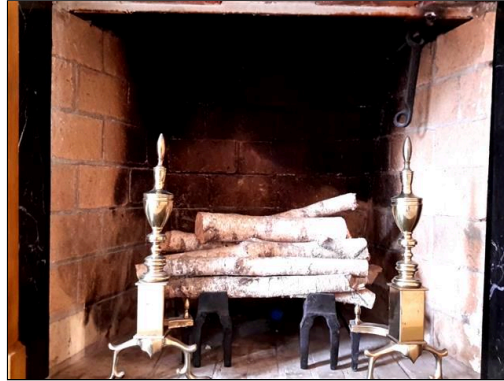
7.4 Item 5 (Picture)

**7.4 (2)** A conventional wood-burning fireplace was observed in the living room:

At the time of the inspection, the damper operated as expected and there were no deficiencies observed

Although no significant deficiencies were found, consider having a chimney sweep perform a routine cleaning and more detailed inspection when purchasing a home before the fireplace is operated. Magnolia recommends a chimney sweep certified by the Chimney Safety Institute of America (CSIA).

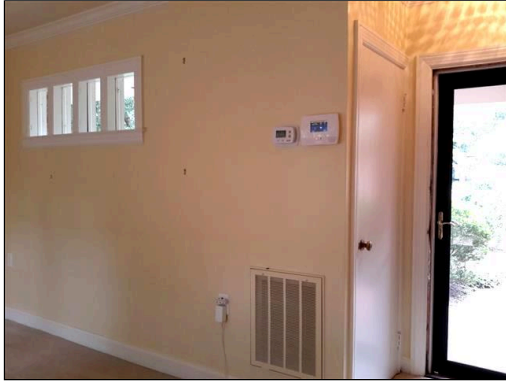
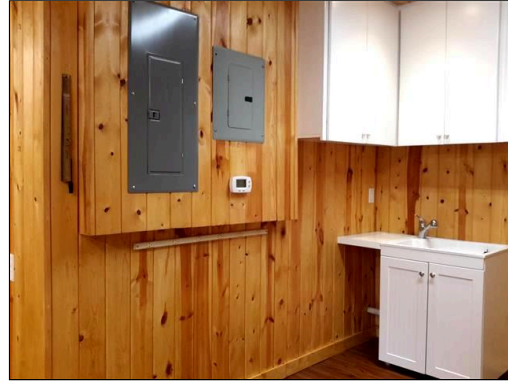
7.8 Item 1 (Picture)

**7.8** There were two thermostats installed on the North-end HVAC equipment:

- The thermostats operate dampers within the ductwork to control the direction of conditioned air within the home. This is called a Zoned System, an efficient option on a single HVAC unit, to regulate the temperature differences between upstairs and downstairs or opposite wings of a larger home
- A Zoned System works to balance the temperature of the home, to keep the downstairs warmer during the winter and the upstairs cooler during the summer. FYI

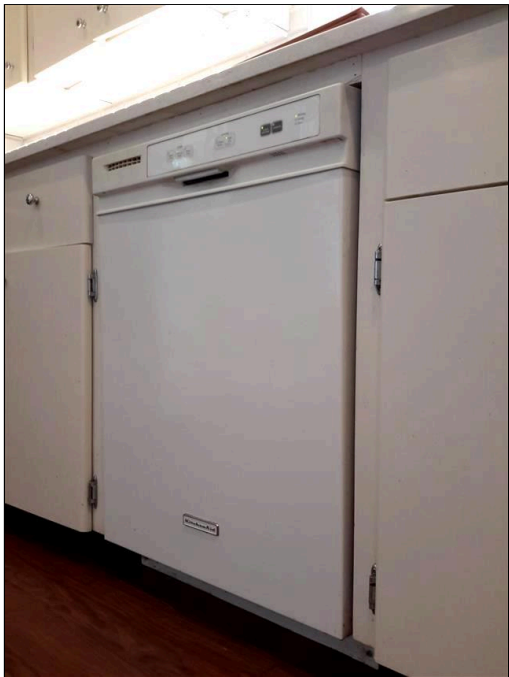
8.0 Item 1 (Picture)

**8.0** The dishwasher completed a full cycle at the time of the inspection with no defects observed.  
Good

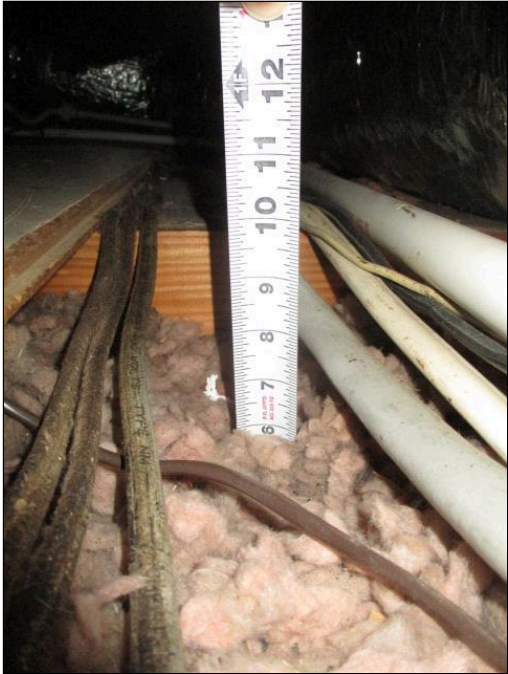
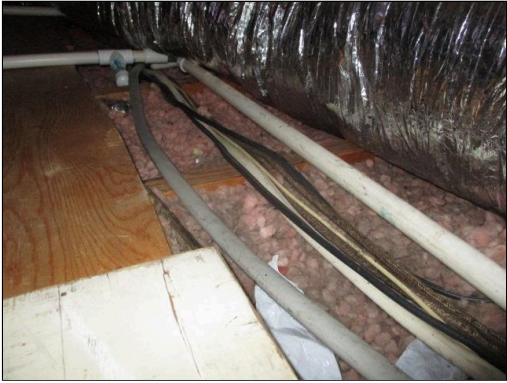
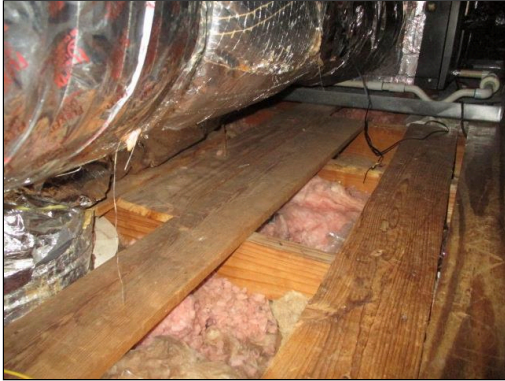
9.0 Item 1 (Picture)

- The modern recommended value for attic floors is R-38
- Increasing the depth of thermal insulation reduces energy consumption and heating/cooling costs. This investment is a minimal cost

**Recommend** adding insulation to reduce energy consumption and heating/cooling costs. A qualified insulation contractor should be advised for a quote to bring depth to meet modern standards

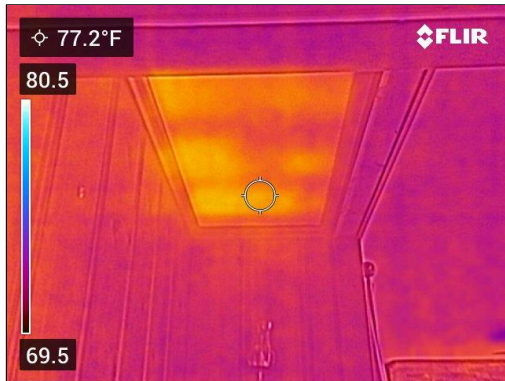
9.0 Item 5 (Picture)

**9.0 (2)** The attic was not accessible. It is safe to assume that the insulation is consistent with homes of this age with insulation installed at less than 13 R-Value. The modern recommended value for attic floors is R-38.

Budget Prudently. To reduce energy consumption and heating/cooling costs, it is **recommended** that additional thermal insulation be added to meet modern standards. A qualified insulation contractor should be advised for a quote.

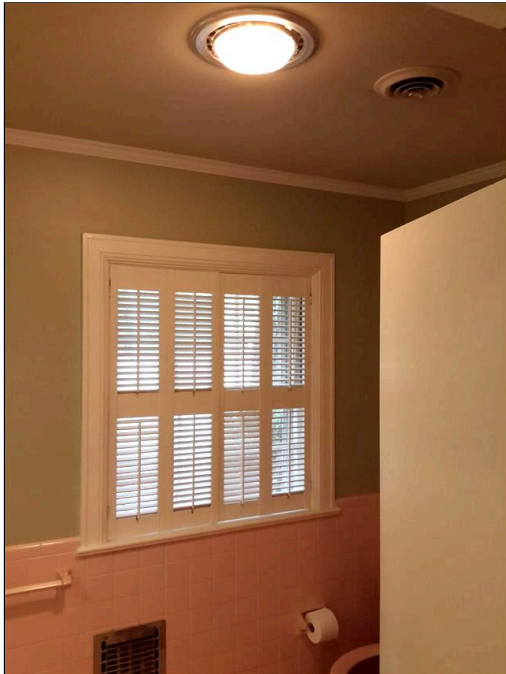
9.2 Item 1 (Picture)

**9.2** Exhaust fans in the bathrooms were noisy:
