# *Why Do You Think They Call it Brook Street?*

Friends of History Presentation – Croton Free Library  
Daniel O'Connor, P.E. Village Engineer

Date: 9/16/10

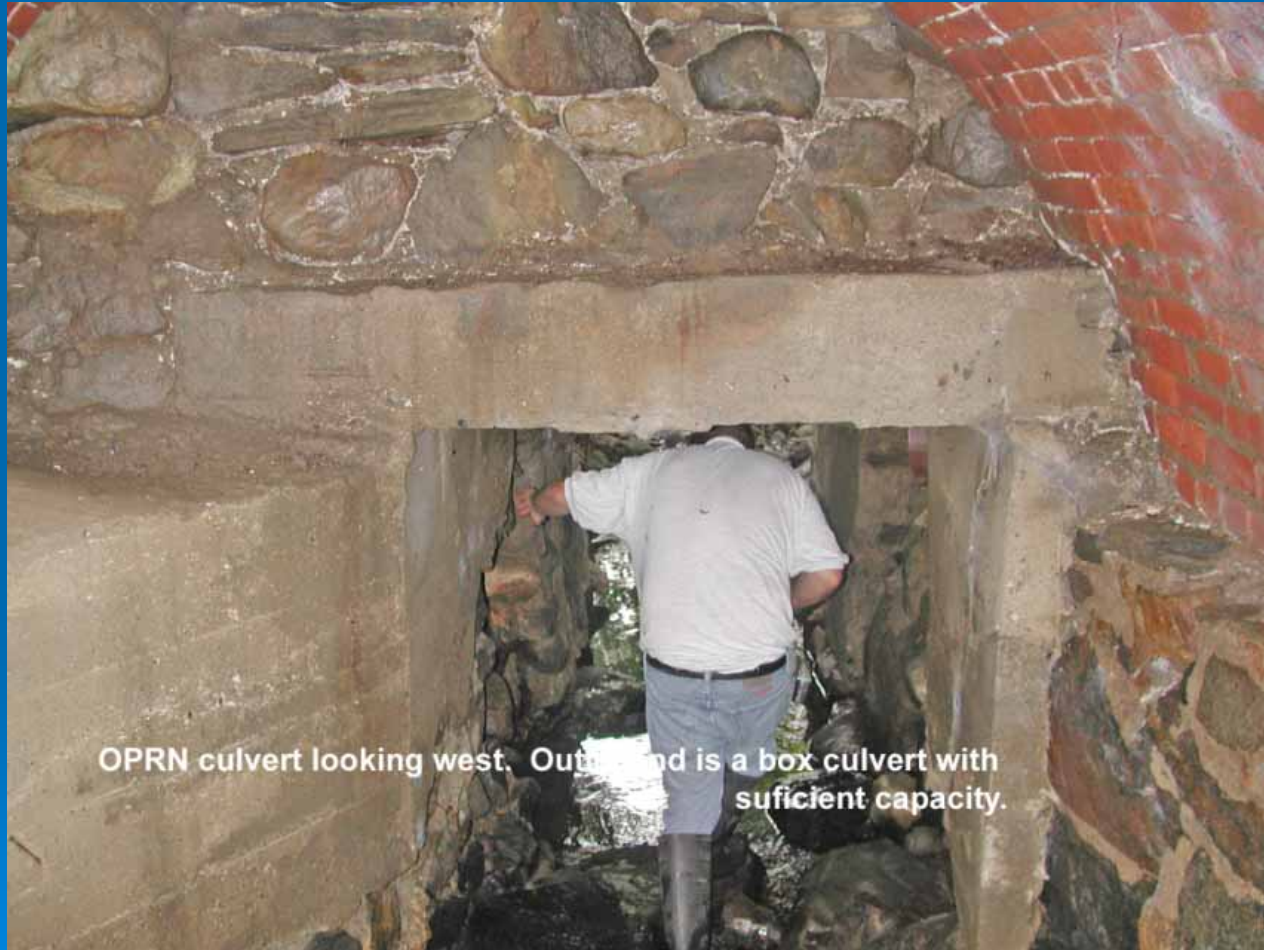
# Culvert Outlet at West side of Old Post Road North (inside view)

OPRN culvert looking west. Outlet end is a box culvert with sufficient capacity.
