Via Coconut Road

Village of Estero

Landscape Site Analysis

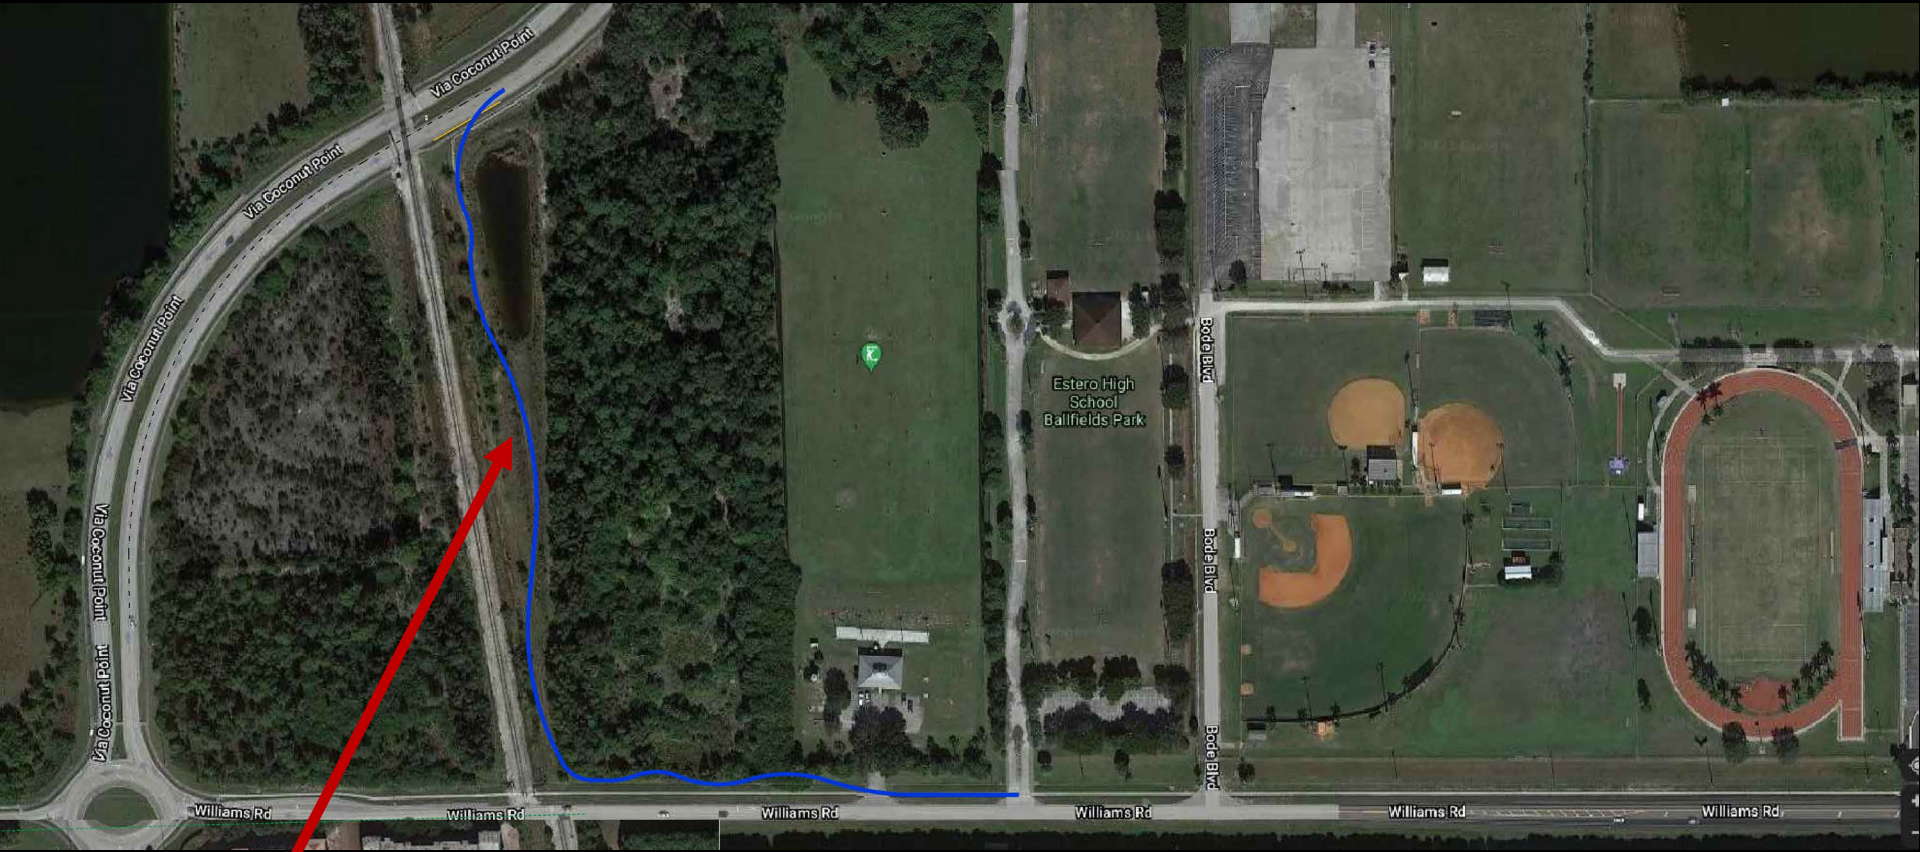
Multi-Use Path Opportunity

Village owned property east of Rail Road property provides an opportunity for a off road multi-use path

Propose creating a multi-use path to more safely connect Via Coconut Rd. and Williams Rd.

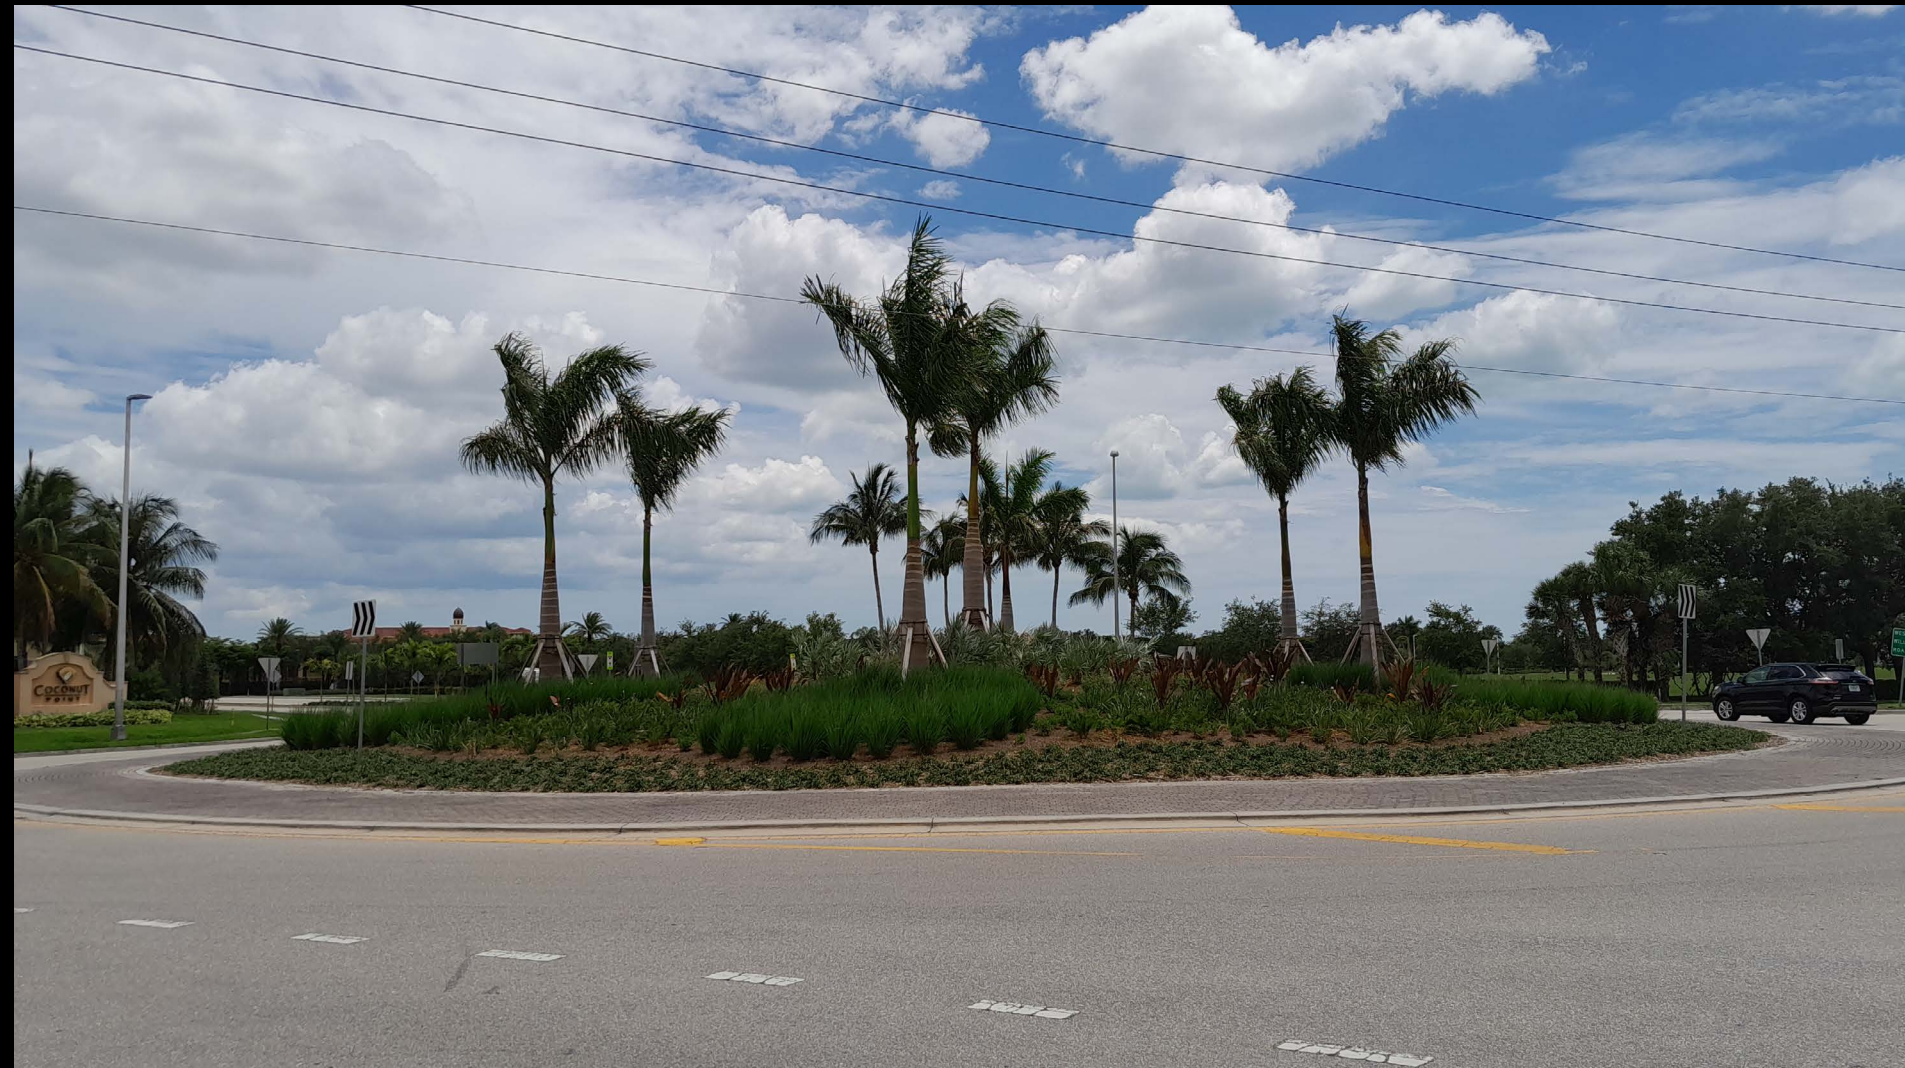
Williams Road Roundabout

Roundabout and medians were landscaped the Village and Reserve at Coconut Pt.

Future bicycle and pedestrian improvements funded by FDOT will be accommodated

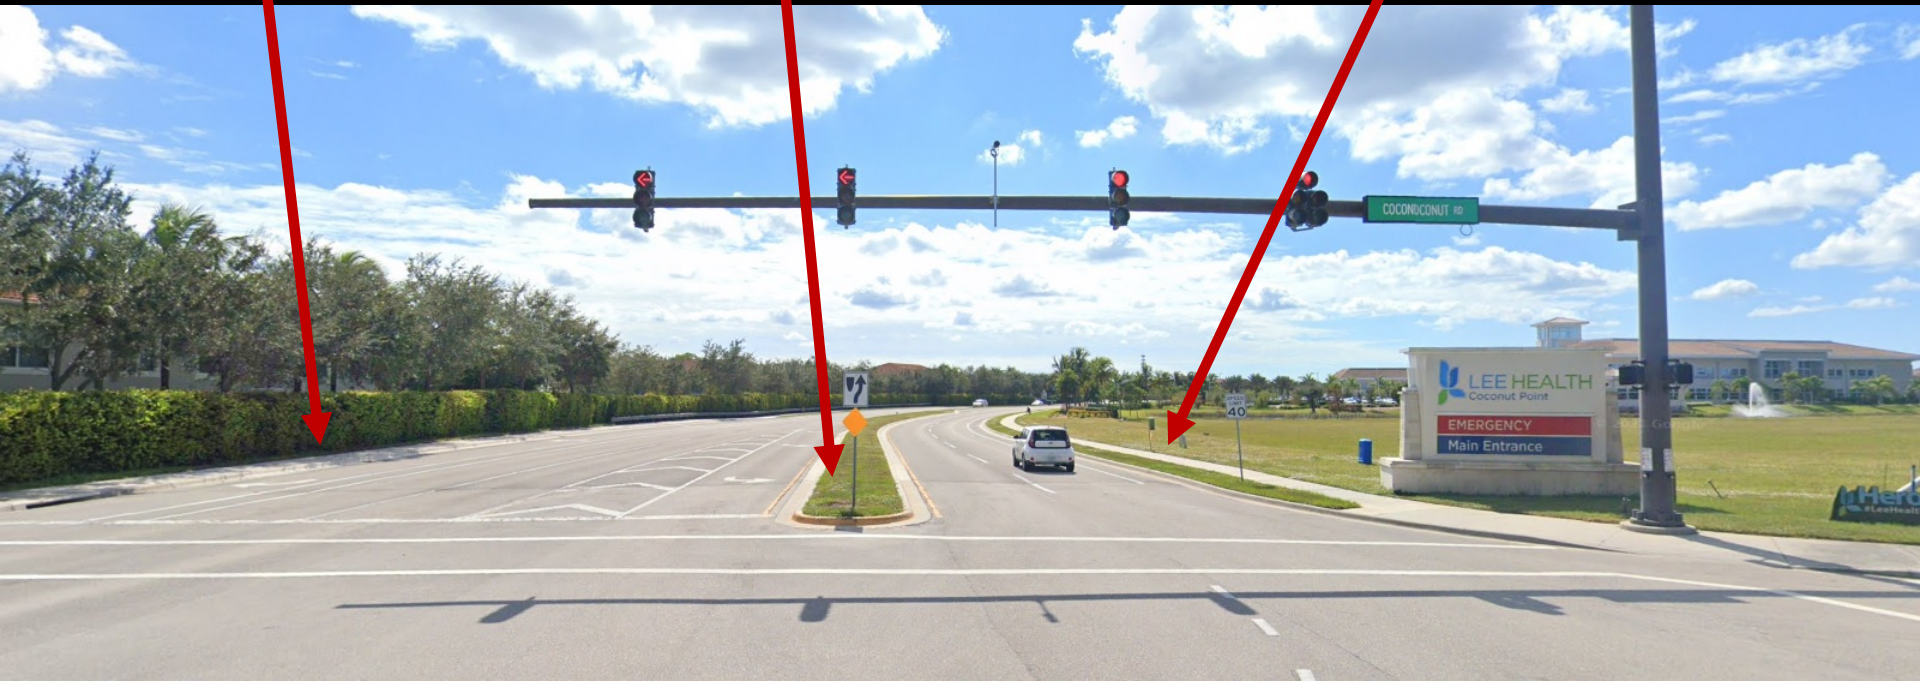
Typical – South of Coconut Road

Residential buffer and hedge.

Narrow median limited planning opportunity

Uniform spacing of sidewalk from back of curb

Compliment with low plantings to improve pedestrian experience

Work with Property Owner to obtain an easement to meander sidewalk and add varied landscaping.
