TOWN OF GUILDERLAND

**ADA PUBLIC STREETS
AND SIDEWALKS PLAN**

LAST Revised July 31, 2024

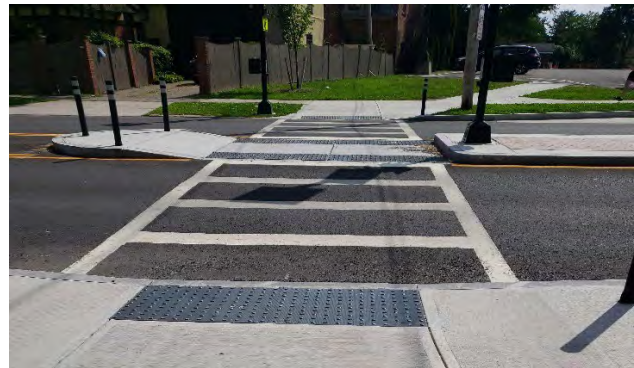
Pedestrian Refuge Island:

An area within an intersection where people wait for a break in traffic to safely cross the remainder of the intersection. Curb ramps in refuge islands must meet all the accessibility criteria of curb ramps not in refuge islands.

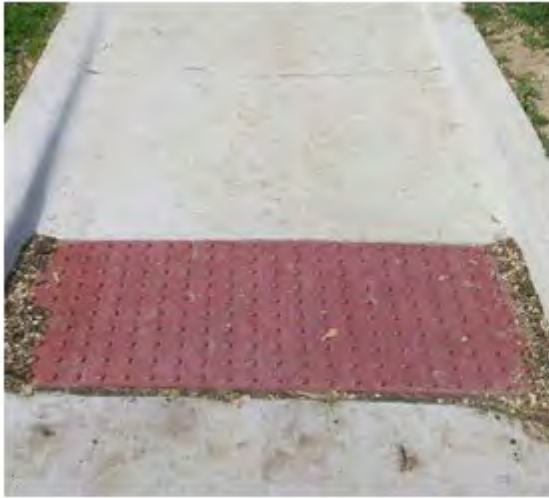
Truncated domes

Truncated Domes: Elevated, bubble-like domes on the surface of the DWS. The domes should have an approximate height of 0.2 (1/5th) inches. The domes should face the same direction as the sidewalk.

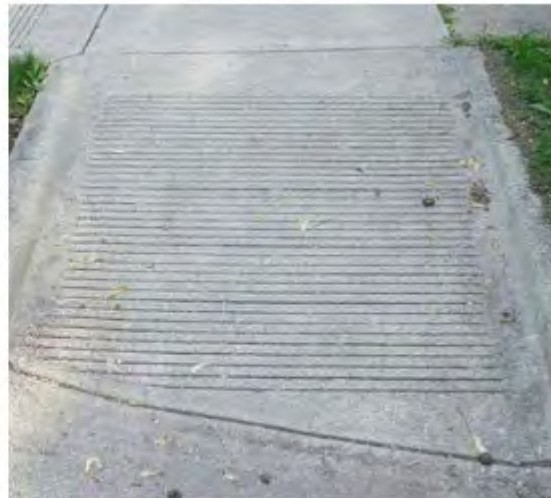
Pavement Grooves: Grooves cut into the existing concrete, facing the same direction as the sidewalk. Pavement grooves are common but are not recognized as an acceptable DWS type because they do not provide a visual contrast between the pavement and ramp.

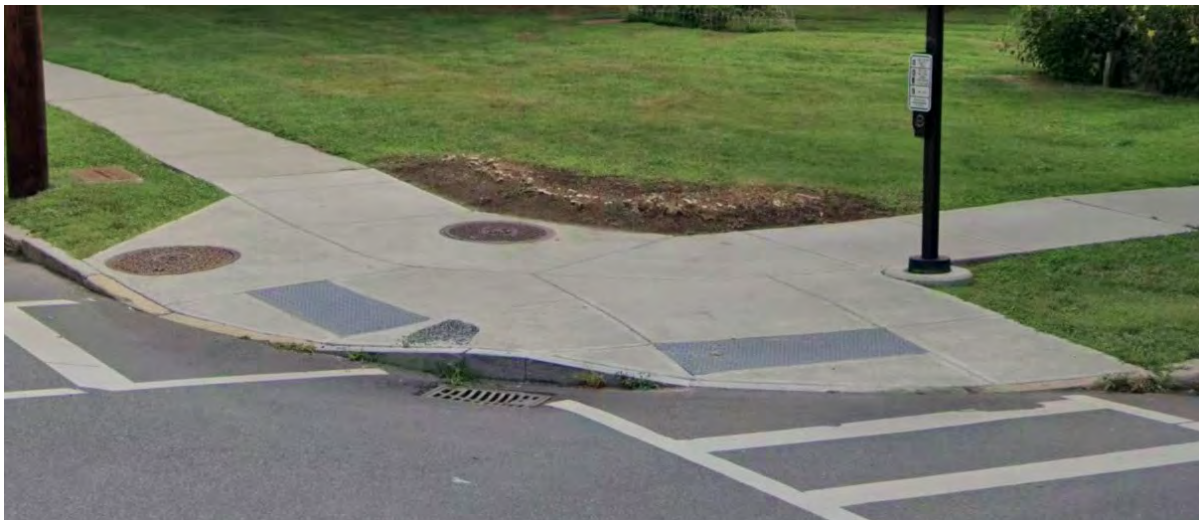
Width: The DWS should extend the full width of the curb ramp or sidewalk. The minimum width is 4 feet (48 inches).

Design Guideline

Example

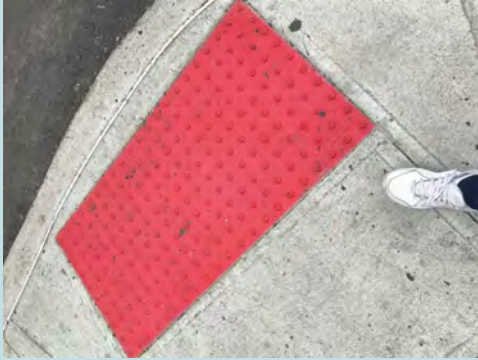
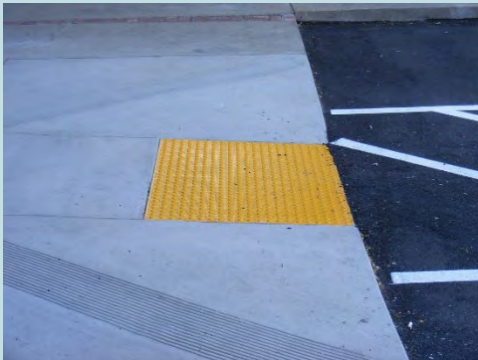
Deterioration: The DWS should be extruding from the surface so that visually impaired individuals will feel the strip.

DWS IS NOT SIGNIFICANTLY DETERIORATED

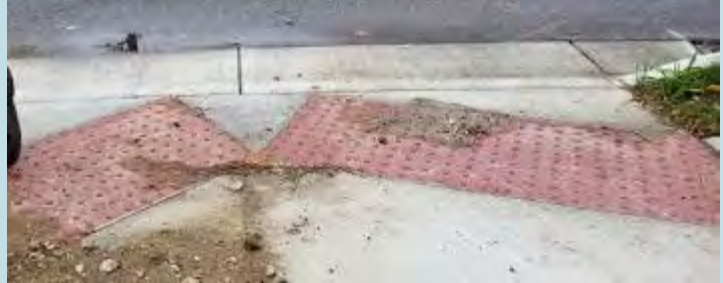
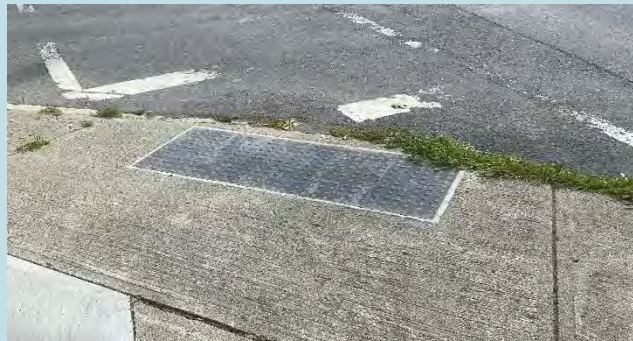
DWS IS SIGNIFICANTLY DETERIORATED

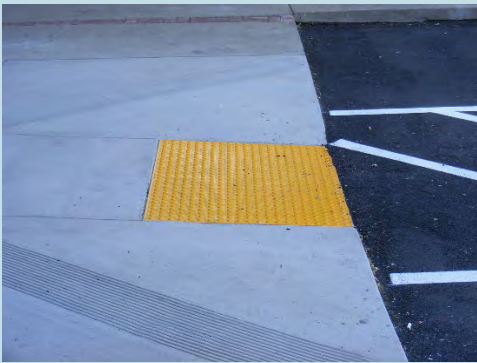
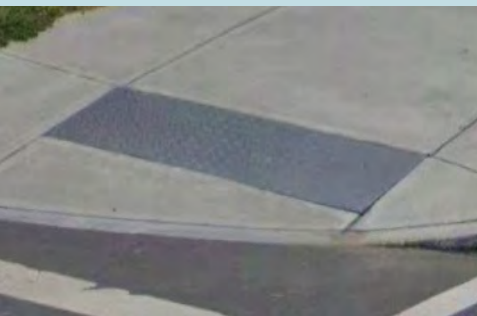
- The color should contrast from the sidewalk, it should at least be light-on-dark or dark-on-light.
- Best practices is to install a yellow DWS (as seen on bottom left image) as it is the most visible for the vision impaired, darker colors often appear as missing gaps in the sidewalk.

DWS COLOR CONTRASTS FROM CURB RAMP

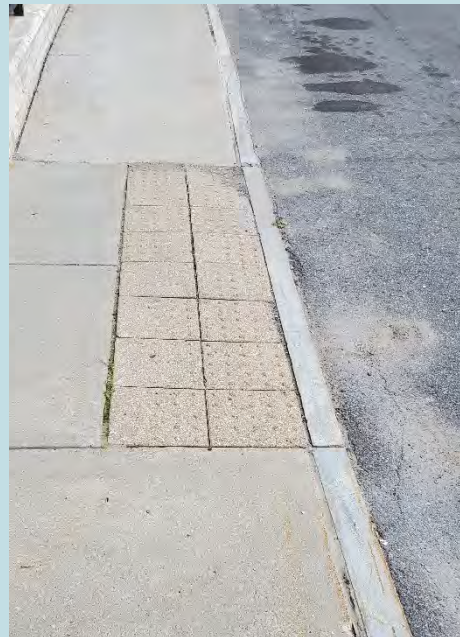
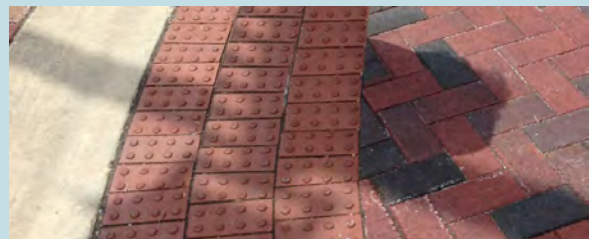
DWS COLOR DOES NOT CONTRAST FROM CURB RAMP

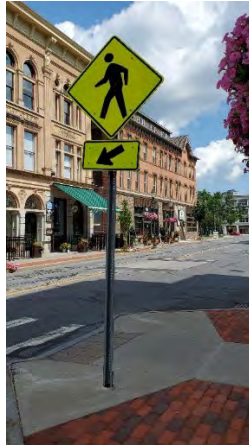
Pedestrian Sign – Not pedestrian activated: A sign marked for pedestrian crossing without a button to press. It may or may not have flashing lights.

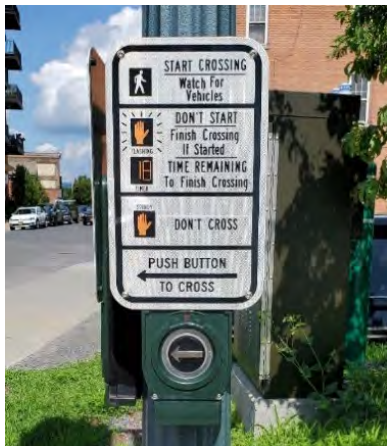
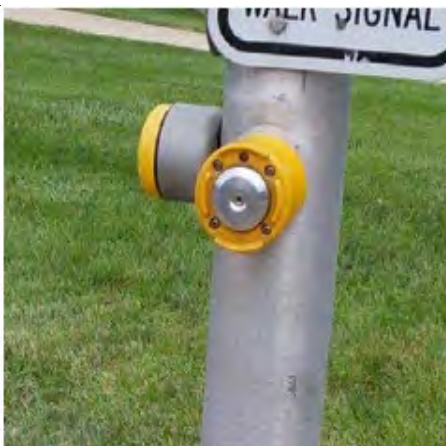
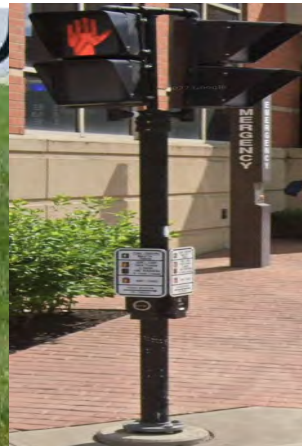
Pedestrian Signal – Pedestrian activated: A button pushed by the pedestrian, which activates a crossing signal. It may or may not have a flashing light.

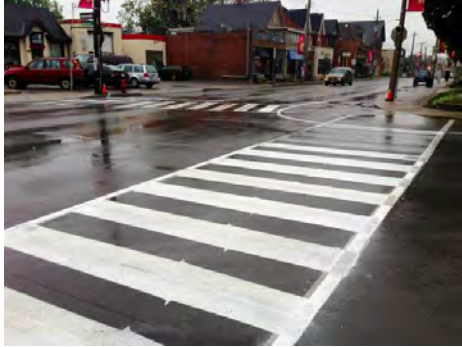
Painted

Crosswalk markings should be smooth and even with the road surface. The material of the crosswalk may differ from the typical pavement striping for aesthetic purposes. Common materials used, other than paint, are brick pavers, stamped concrete, or asphalt.

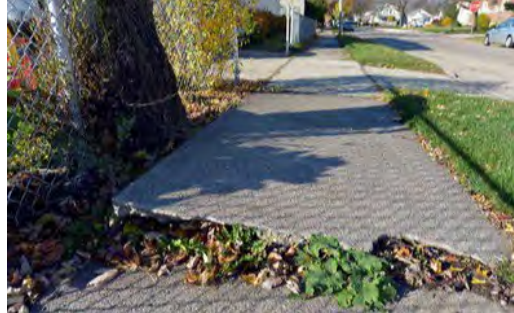
Heaving Panels

The most common condition that creates barriers to accessibility are heaving panels, meaning a vertical fault in the sidewalk panel greater than ½ inch, which were present on approximately 20 percent of all block segments assessed. The presence of heaving panels may not result in a Not Accessible or Partially Accessible rating depending on the severity and frequency of heaving. Sidewalk segments rated Mostly Accessible should be monitored alongside the five year repair timeline outlined later in this document to ensure these segments remain accessible and conditions do not worsen over time.

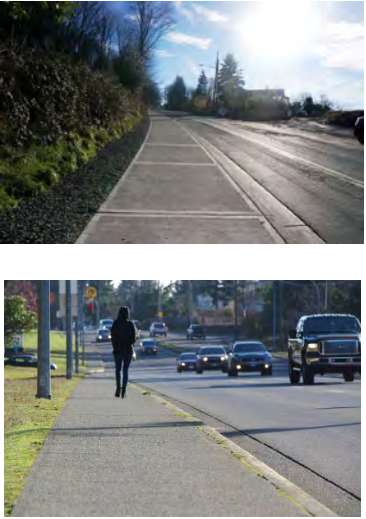
Rating	Condition	Reference Images
Fully Accessible	<ul style="list-style-type: none"> • Sidewalk is new or in like-new condition. • Sidewalk is level, no cracks, no faults, no obstructions, and adequate width. • Sidewalk is at least 4 feet (48 inches) wide.

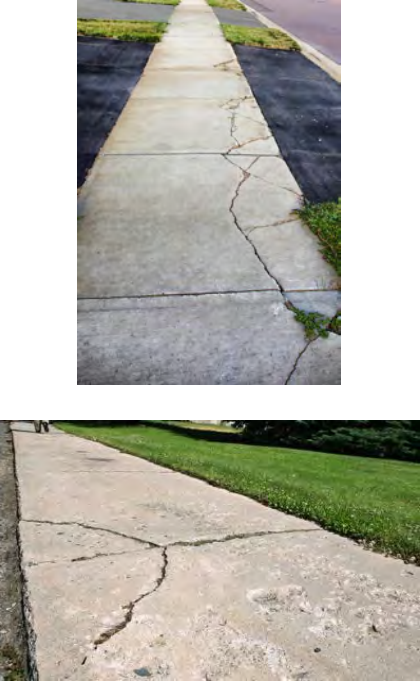
Mostly Accessible	<ul style="list-style-type: none"> • Sidewalk is in almost new or good condition. • Sidewalk is level and may have minor cracks. • Sidewalk is at least 4 feet (48 inches) wide.

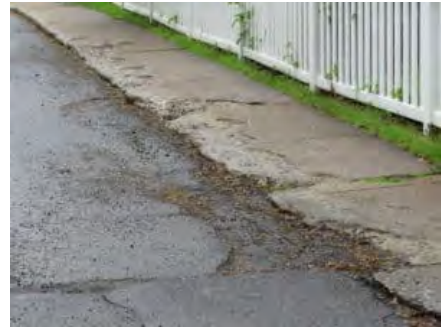
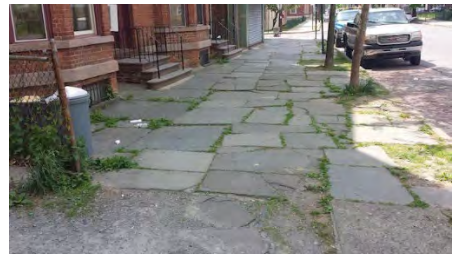
Partially
Accessible

- Small patches of broken or chipped sidewalk, and a small buildup of dirt/debris, vegetation growing between panels or cracks.
- Sidewalk may have small vertical faults larger than ½ inch but could potentially be grind down/repaired.
- Large cracks are present.
- Sidewalk is less than 4 feet wide.

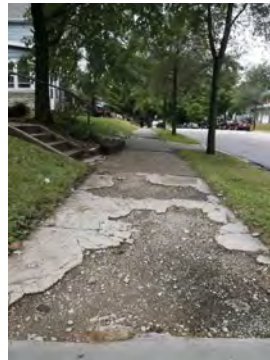
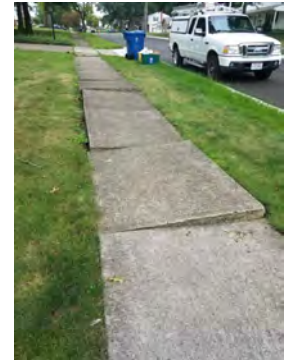
Not
Accessible

- Sidewalk may have serious accumulation of dirt/debris, establishment of vegetation or other obstructions.
- Sidewalk is uneven from faulting (greater than ½ inch) that cannot be grind down/repaired and will require replacement.
- Sidewalk is less than 4 feet wide.
